MODEL/YEAR MODÈLE /ANNÉE	DATE OF ISSUE DATE EN VIGUEUR	BULLETIN NUMBER NUMÉRO DU BULLETIN
2018 ACCORD HYBRID	APRIL 27, 2018	J-5-18

2018 ACCORD HYBRID: New Model Body Repair Information

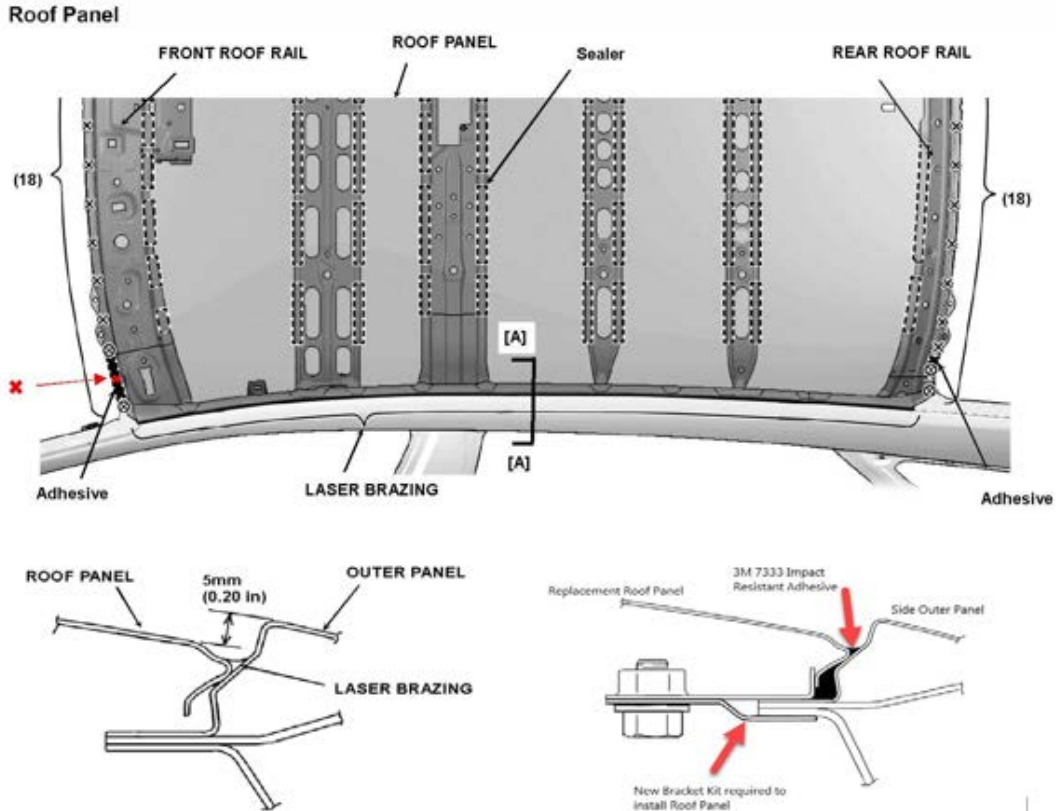
ROOF PANEL ATTACHMENT

The roof on the 2018 Accord Hybrid is attached with weld bonding in the corners as well as laser brazing along both side apertures. Replacement will require adhesive bonding, weld bonding and the purchase of rubber dams and a bracket kit that need to be welded into the apertures so the new roof panel can be bolted to them.

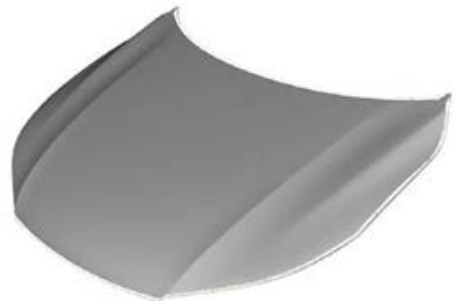
ALUMINUM PARTS & REPAIRABILITY

The hood on the 2018 Accord Hybrid is constructed from Aluminum alloy.

- Minor damage to the aluminum hood may be repaired by body shops that have dedicated aluminum repair facilities and tools.
- To prevent galvanic corrosion, some fasteners for aluminum parts are considered one-time use and must be replaced if removed as specified in the electronic service manual or body repair manual.

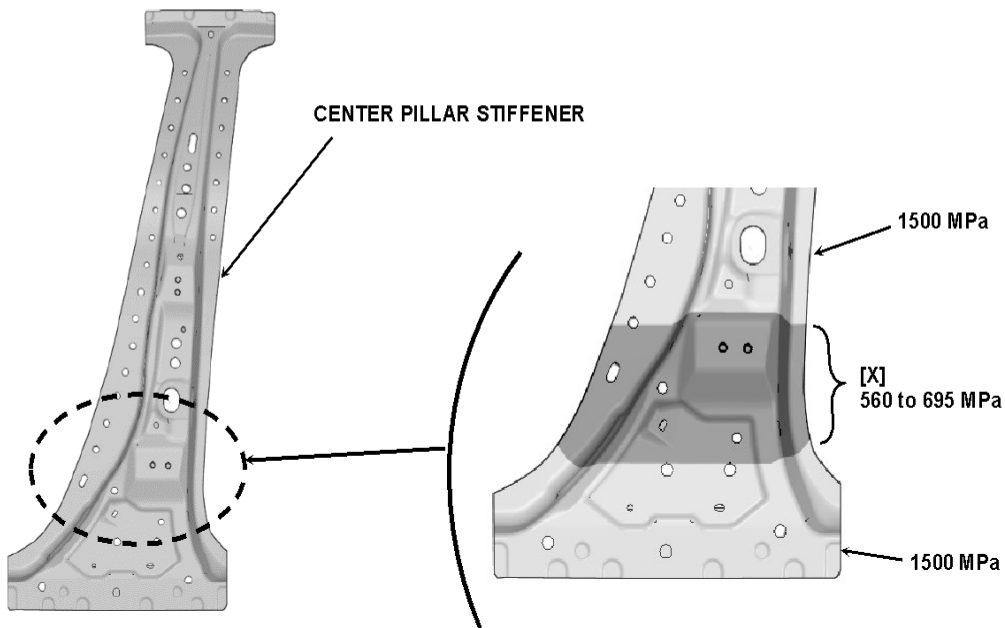
Side Sill Stiffener and Center Pillar Stiffener

NOTE: Center pillar stiffener is made from ultra high-strength steel (UHSS) (1500 MPa). However, at the [X] area which is shown in the illustration, part is made from high-strength steel (except 1500 MPa). For this reason, sectioning is possible at area [X]. Do not cut except the [X] area.
