2013 ILX & ILX Hybrid: Body Repair Information

OVERVIEW OF BODY FEATURES

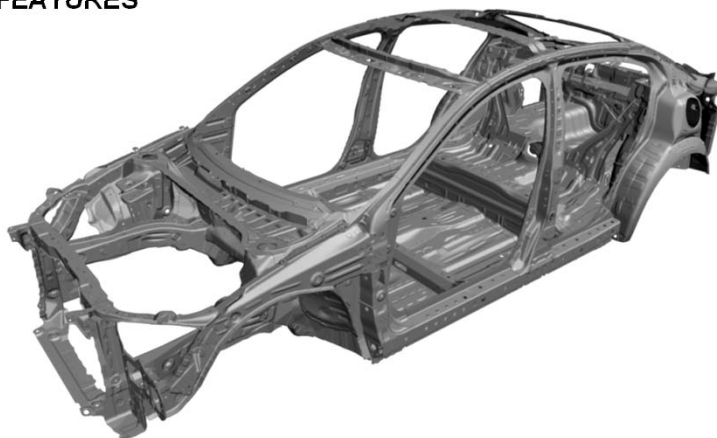
2013–15 models have these body features:

- Advanced Compatibility Engineering™ (ACE™) crash compatible body structure.
- Extensive use of high-strength steel (59%), including 5% in grades 780 and 980.
- Aluminum hood panel, front bumper beam, and rear bumper beam (ILX Hybrid models only) for weight reduction and improved fuel efficiency (not shown in this view).

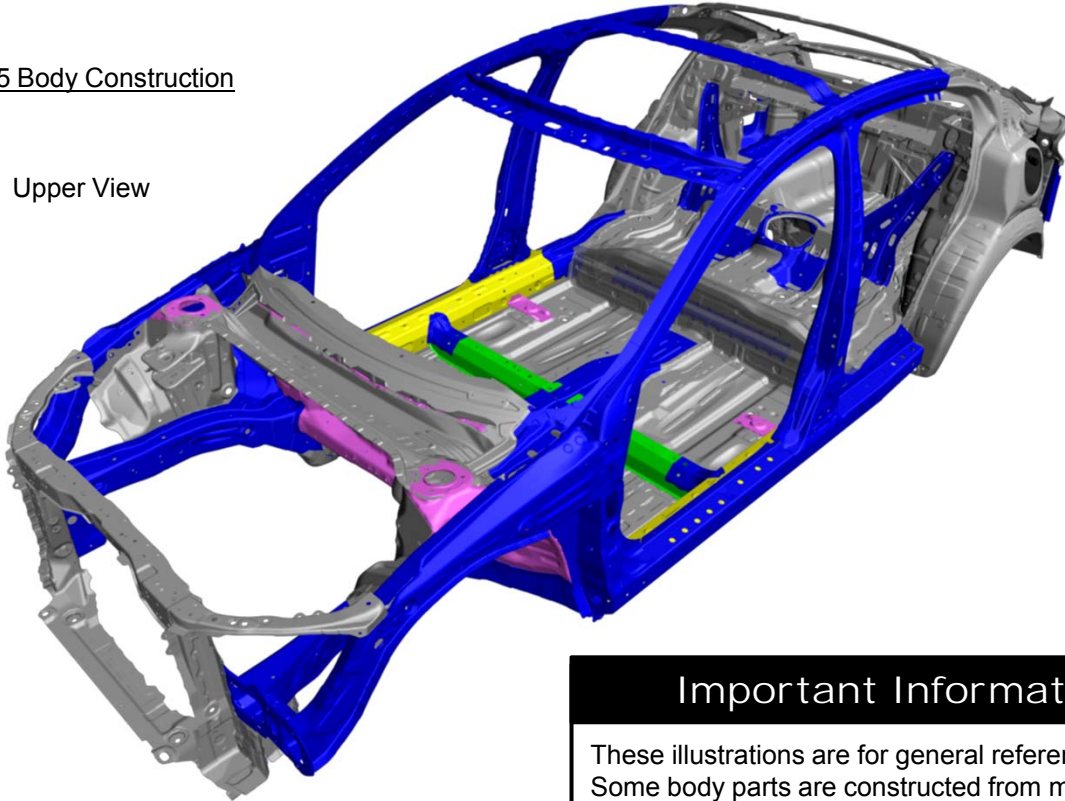
Upper View

BODY CONSTRUCTION AND HIGH-STRENGTH STEEL CONTENT - 2013–15 MODELS

- Steel parts are color coded based on their tensile strength in megapascals (MPa).
- High-strength steel is defined as any steel with a tensile strength of 340 MPa or higher.
- Steel repair and welding procedures vary depending on the tensile strength of the parts involved.

2013–15 Body Construction

These illustrations are for general reference only. Some body parts are constructed from multiple layers of different tensile strength steels. Always refer to the body repair manual body construction section for specific steel tensile strength information.

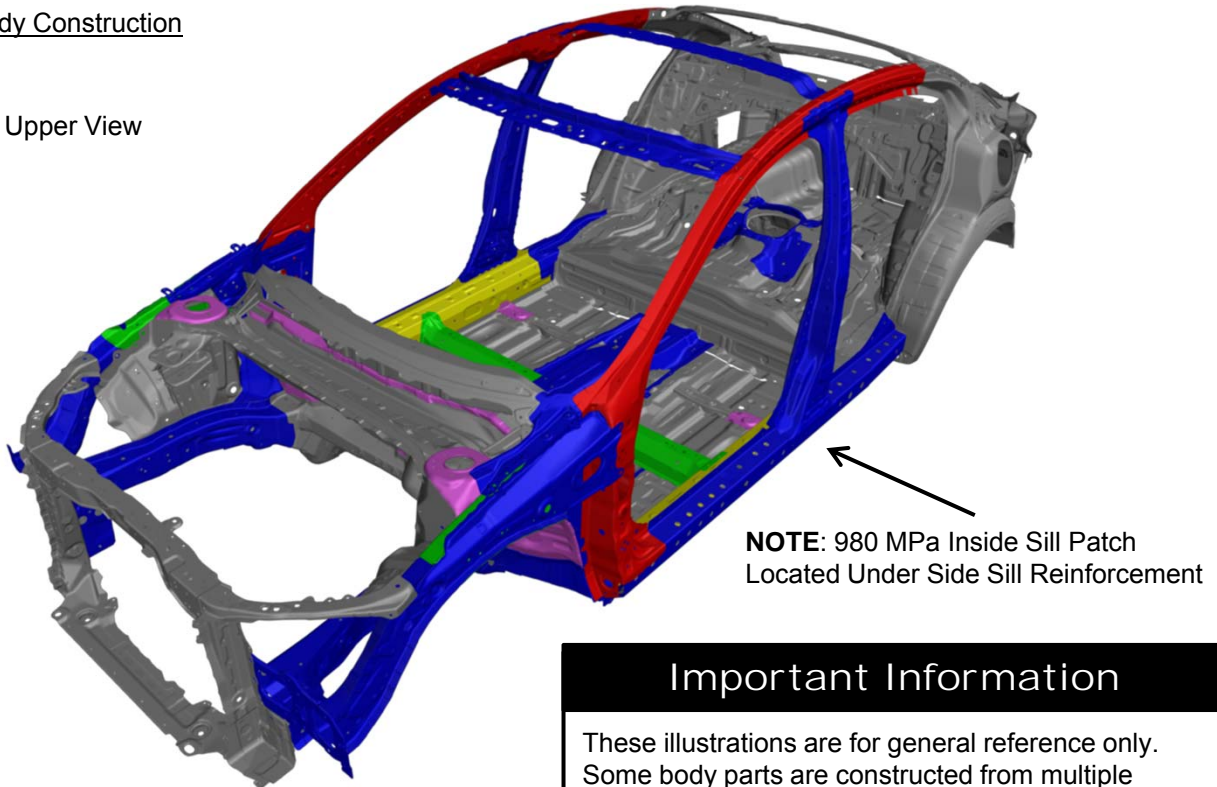
Upper View

BODY CONSTRUCTION AND HIGH-STRENGTH STEEL CONTENT - 2016 MODELS

- Steel parts are color coded based on their tensile strength in megapascals (MPa).
- High-strength steel is defined as any steel with a tensile strength of 340 MPa or higher.
- Steel repair and welding procedures vary depending on the tensile strength of the parts involved.

2016 Body Construction

These illustrations are for general reference only. Some body parts are constructed from multiple layers of different tensile strength steels. Always refer to the body repair manual body construction section for specific steel tensile strength information.

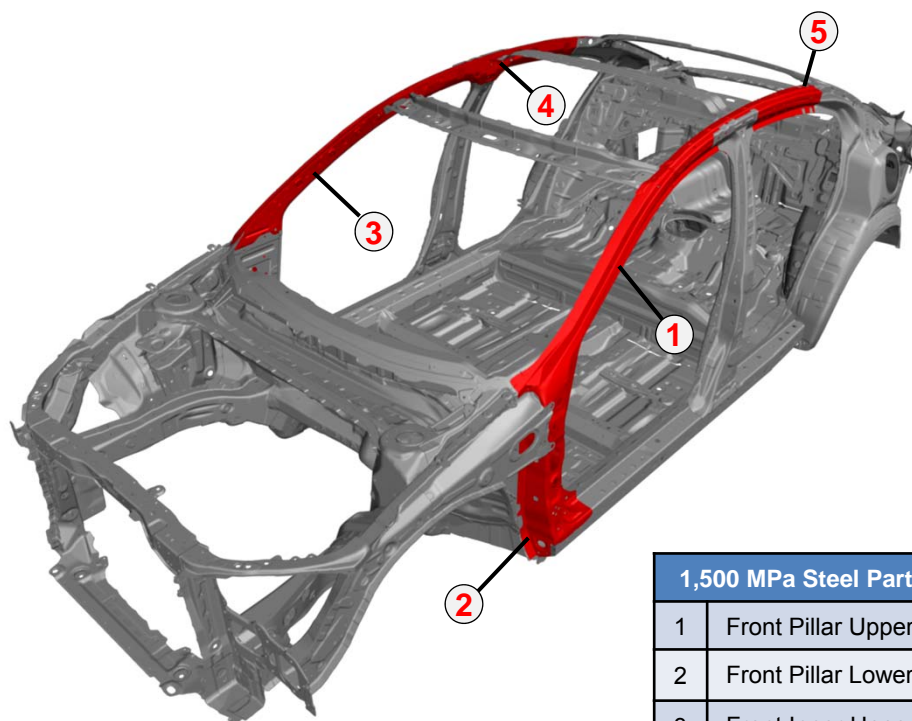
1,500 MPa steel is stronger than ordinary steel, so it can help protect vehicle occupants while reducing overall vehicle weight to improve fuel efficiency.

The numbered parts in the diagram below are constructed of 1,500 MPa steel:

1,500 MPa Steel Parts - 2016 Models	
1	Front Pillar Upper Stiffener
2	Front Pillar Lower Stiffener
3	Front Inner Upper Pillar
4	Roof Side Rail
5	Roof Side Stiffener

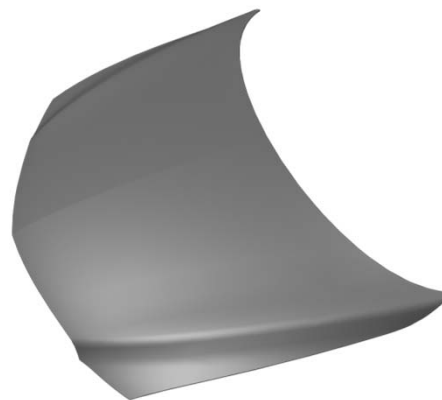
Rear Bumper Beam
(2013–14 Hybrid Only)

The hood panel, front bumper beam, and rear bumper beam (2013–14 ILX Hybrid models only) are all constructed of aluminum alloy.

- Do not repair the bumper beams if damaged (aluminum or steel).
- Minor damage to the aluminum hood may be repaired by body shops that have dedicated aluminum repair facilities and tools.
- To prevent galvanic corrosion, some fasteners for aluminum parts are considered one-time use and must be replaced if removed.

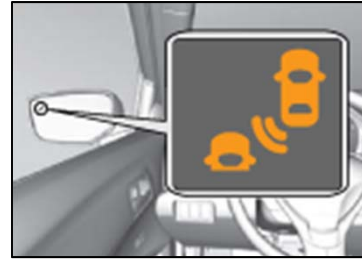
BSI Alert Indicator

Beginning with the 2016 model year, models equipped with this system can be identified by the BSI Alert Indicators located on both outside rearview mirrors.

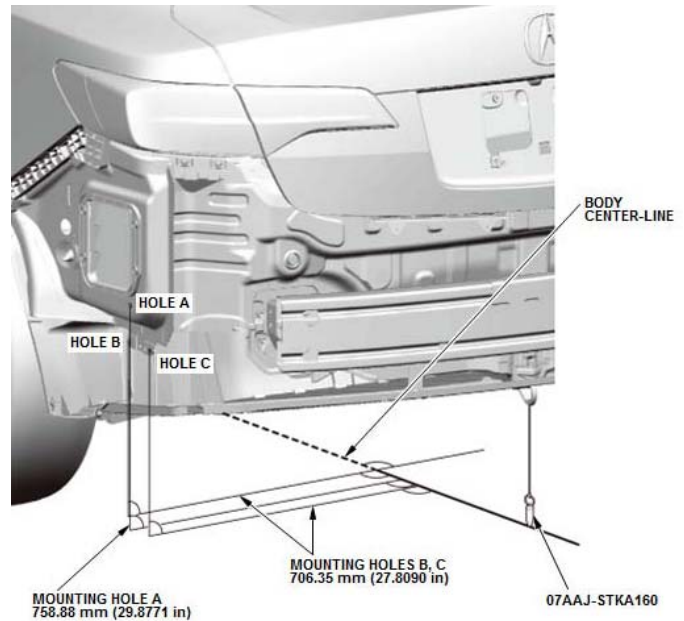
LH BSI Unit Mounting Area Check
(RH Side is symmetrical)

- The system uses two radar units, one mounted on each side of the vehicle under the rear bumper.
- The system may malfunction and set DTCs because of damage, improper repairs, or excessive foreign material on any of the following:
 - Rear bumper
 - Outer side panels
 - Radar unit mounting locations
- Several checks and inspections must be done during repairs to the radar unit mounting area. If the mounting area check is not done, an Acura dealer may not be able to properly aim the radar units.
- For more information, refer to “BSI Radar Unit Mounting Area Check” in the service manual.

- After replacing or removal and installation of one or both BSI radar units.
- After replacing/repairing the body rear outer side panel(s).
- Stored DTCs B18B8 or B1E68 - left or right side BSI radar unit azimuth off alignment.

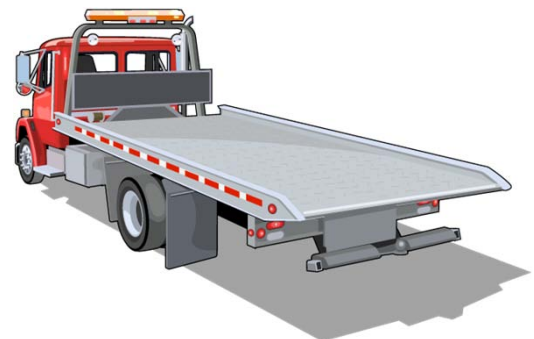
- Lift or jack only at the specified points to avoid damaging the vehicle.
- Do not lift or tow this vehicle by its bumpers, or serious damage will result.

For more information, refer to “Lift and Support Points”, in the service or body repair manual.

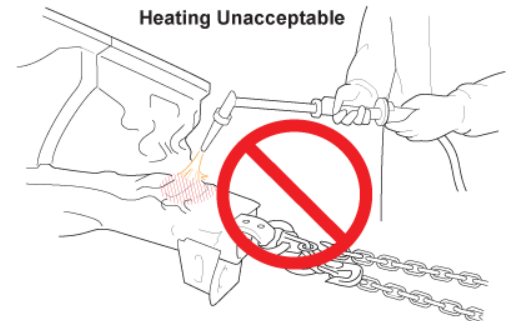
- DO NOT apply heat to any body part during straightening. This may compromise the internal structure and strength of high-strength steel parts.
- Any part that has heat applied to it during straightening MUST be replaced with new parts.
- Ignoring these instructions may significantly reduce occupant protection in any subsequent collision.

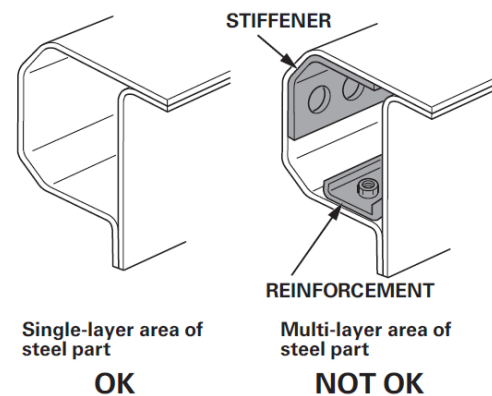
Sectioning Area Examples

- Sectioning (cut and joint) should usually be avoided except for mild steel outer panels and floor panels unless a specific procedure is provided in the body repair manual.
- However, depending on the type of vehicle damage, steel parts with a tensile strength ≤ 780 MPa may be sectioned provided ALL of the following conditions are met:
 - Sectioning must be done in a single-layer area of the part.
 - Multi-layer internal steel reinforcements and stiffeners must not be cut.
 - The repair is not in a load bearing area such as engine, transmission, or suspension mounting points.

- Replace body structural components such as stiffeners, reinforcements, and other multi-layered steel parts as assemblies that match the replacement parts configuration.
- Approved welding methods are listed in the table.
- Refer to the body repair manual section "Parts Sectioning (Cut and Joint) Guidelines", for complete information.

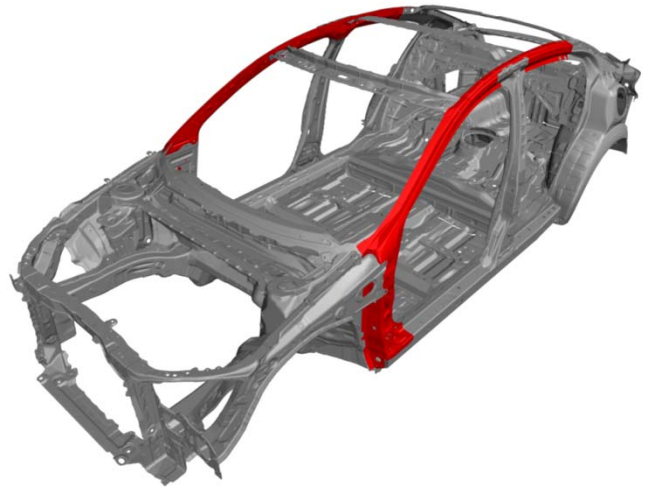
- NEVER attempt to straighten damaged 1,500 MPa steel parts because they may crack.
- 1,500 MPa steel parts MUST be replaced at factory seams using squeeze-type resistance spot welding (STRSW). DO NOT SECTION these parts!
- MIG brazed joints should be used ONLY in locations not accessible by a spot welder.
- To assure adequate weld tensile strength, always set the spot welder to the specifications provided in the body repair manual.

Parts made of Ultra High-Strength Steel (UHSS/1,500MPa/USIBOR) must be installed as a complete part. No sectioning allowed. Ultra High-Strength Steel requires special welding equipment, procedures, and settings. See the welding section of the appropriate body repair manual. Failure to use the proper equipment or follow the proper procedures can result in an unsafe repair.

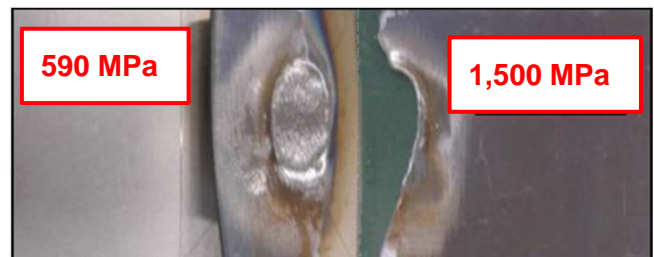
Tensile Test Results of MAG Welded 1,500 MPa Steel

- NEVER perform MAG welding on 1,500 MPa steel. The heat generated during MAG welding will significantly reduce the strength and structural integrity of 1,500 MPa steel parts.
- This photo shows tensile test results of MAG welded 1,500 MPa steel. The 1,500 MPa steel fractured first, because the welding heat reduced its strength to far below 590 MPa.
- For more information, refer to "Repair Guidelines for High-Strength Steel Parts", in the body repair manual.

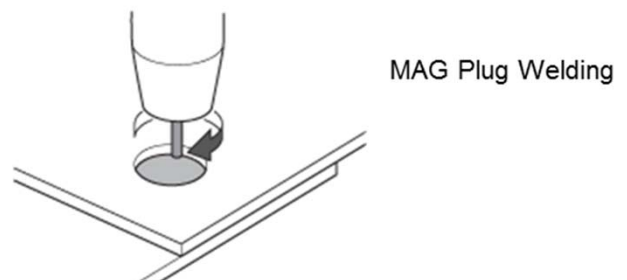
- MAG plug welding may be done when joining body components to 590–980 MPa steel parts.
- Follow the recommendations described in the body repair manual sections “Repair Guidelines for High-Strength Steel Parts”, and “MAG Welding Conditions for High-Strength Steel (Except 1,500 MPa) Parts.”

- MAG butt welding may be done only on steel parts with a tensile strength of 780 MPa and lower.
- Welding speed is critical to achieve the correct weld strength and minimize the heat affected zone (HAZ).
- Follow the recommendations described in the body repair manual sections “Repair Guidelines for High-Strength Steel Parts” and “MAG Welding Conditions for High-Strength Steel (Except 1,500 MPa) Parts.”

MAG Plug Welding

MAG Butt Welding

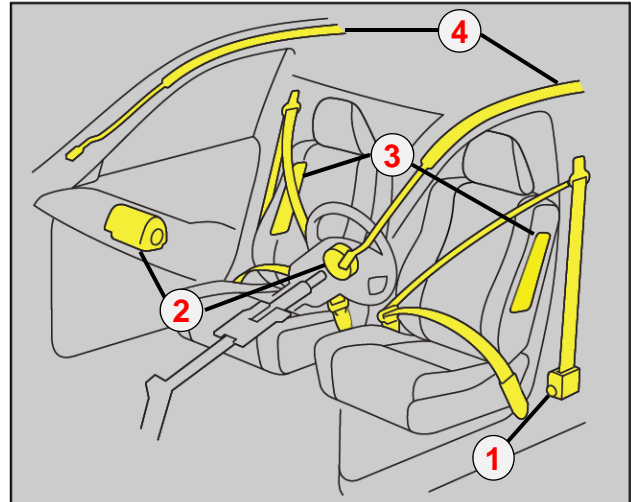
The airbag system in this vehicle includes the following components that may deploy in a collision:

1. Driver and front passenger seat belt tensioners (may deploy independently from any airbags).
2. Driver and front passenger SRS airbags.
3. Side airbags mounted in the outer driver and front passenger seat-backs.
4. Side curtain airbags mounted above the left and right side windows under the headliner.

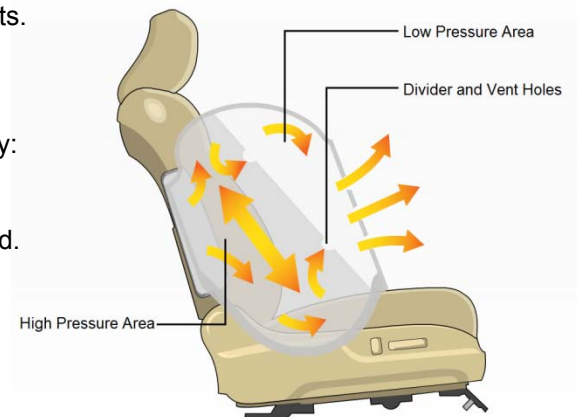
SmartVent Side Airbag

Beginning with the 2016 model year, these vehicles are equipped with SmartVent side airbag construction:

- This airbag design helps mitigate the risk of excessive airbag deployment force and risk of injury to smaller seat occupants.
- Eliminates the need for the Occupant Position Detection System (OPDS) sensor located in the front passenger's seat-back.

- Special seat covers and/or breakaway thread are used to ensure proper deployment path.
- Damaged front seat covers should be replaced, not repaired.
- Do not install non-factory seat covers, because they may alter the airbag's intended deployment path.

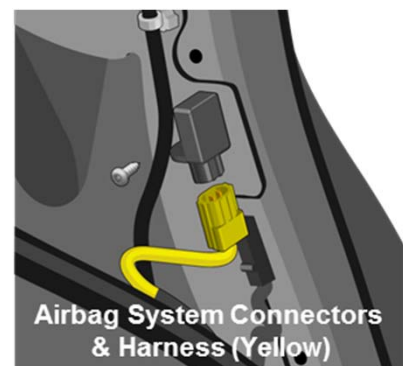
Airbag System Connectors
& Harness (Yellow)

- For easier identification, electrical connectors that contain only airbag system wiring are yellow in color.
- Many harnesses that contain primarily airbag wiring are also wrapped in yellow tape.
- Airbag system wiring that runs in a common harness, such as a floor harness, is generally not marked.
- NEVER attempt to modify, splice, or repair airbag system wiring. If airbag system wiring is damaged, replace the wiring harness(es).

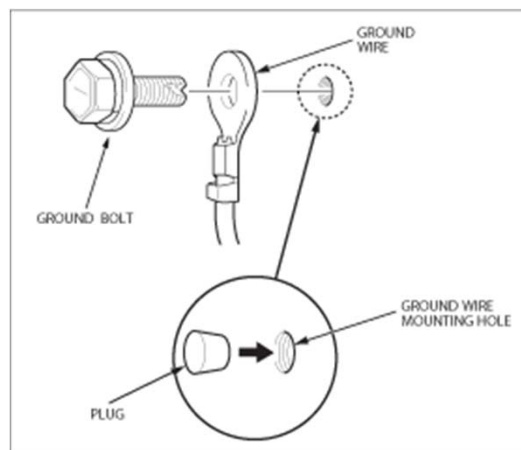
- Painting over electrical ground locations may cause electrical systems such as Vehicle Stability Assist (VSA) to malfunction and set DTCs that may be difficult to diagnose.
- Protect the ground wire and the ground wire mounting hole threads with a bolt or silicone plug when priming or painting.

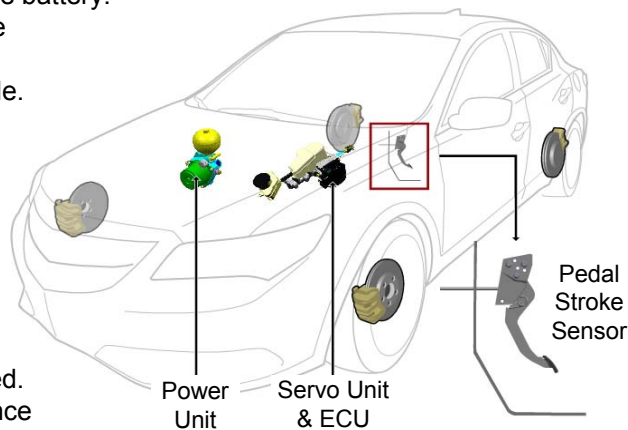
Advanced Hydraulic Booster Diagram

An advanced hydraulic booster brake system is used to convert as much of the vehicle's kinetic energy as possible into electricity and store it in the battery.

- The system enables to maximize the regenerative brake force depending on the brake pedal pressure available.
- Some brake system components appear significantly different than traditional brake systems.
- The amber BRAKE SYSTEM indicator comes in the event of advanced hydraulic booster brake system malfunction.
- Special brake fluid replacement and bleeding procedures are required. Contact an Acura dealer for assistance if necessary.

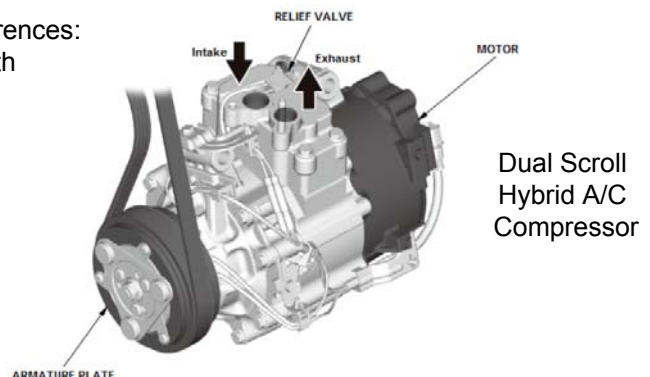
Dual Scroll Hybrid A/C Compressor

- A dual scroll hybrid A/C compressor that can use both mechanical (belt drive) and high-voltage electric power (motor drive) to compress refrigerant.
- Mechanical side uses a normal electric A/C clutch.
- Electric motor side uses a brushless, three-phase motor driven by a controller in the IPU.
- An electric heater coolant pump circulates engine coolant through the heater core under certain conditions such as idle stop during cold weather.

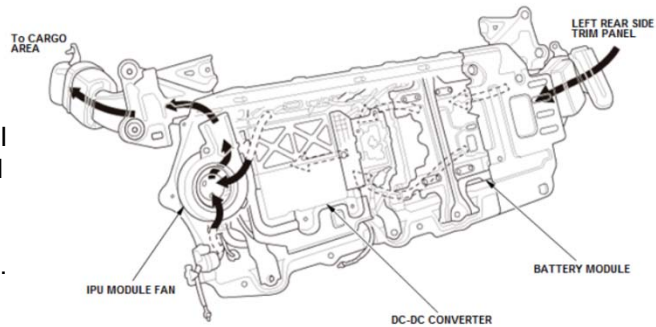
The battery module, the MPI module, and the DC-DC converter generate heat during charge/discharge.

- These components must be kept within a specific temperature range for optimum performance.
- The IPU is equipped with a fan and ducts to cool these parts and assure proper battery performance.
- When the temperature of the battery module, the MPI module, or the DC-DC converter exceeds a specified value, the MCM operates the IPU module fan. Cooling air is drawn into the battery module from the left side of the rear seat and exhausted into the trunk.

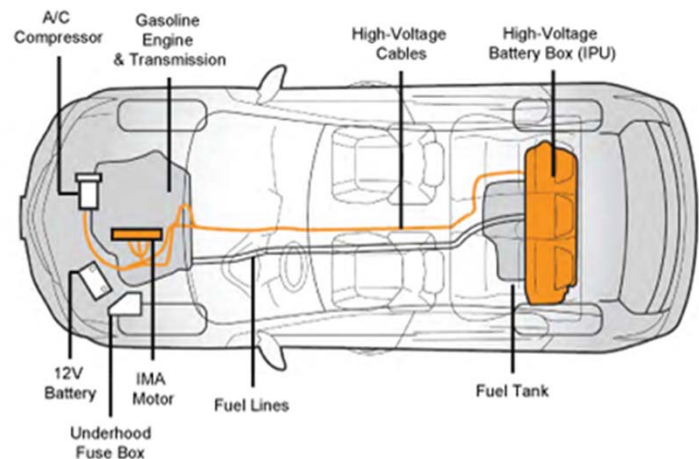
The IPU contains the following components:

- Battery module
- Motor control module (MCM)
- DC-DC converter
- Motor power inverter.

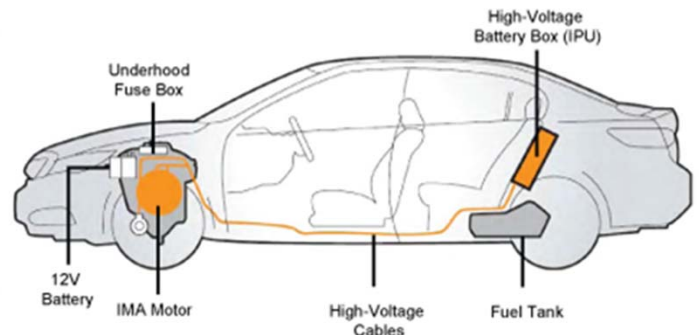
- High voltage is identified using bright orange colored cables and coverings.
- A damaged high-voltage lithium-ion battery can emit toxic fumes, and the organic solvent used as electrolyte is flammable and corrosive. Always wear protective equipment.
- High temperatures may damage the high voltage battery module. For example, when drying paint in a heated paint booth, the temperature must not exceed 150 °F (65 °C).
