## 2016 Pilot: Body Repair Information

2016 Pilot Model Series

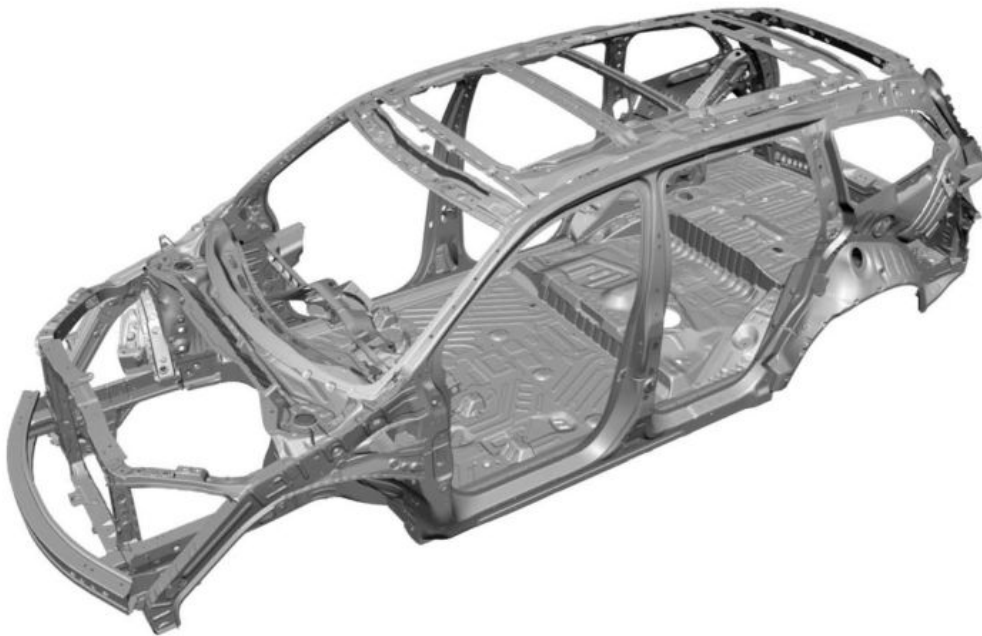
- Next-Generation Advanced Compatibility Engineering™ (ACE™) body structure.
- Body construction using 60% high-tensile-strength steel (HSS), including 21% ultra-high-strength steel (UHSS - 980 MPa and higher).
- Reinforced cabin with 1,500 MPa front door outer stiffener rings and reinforced roof structure.
- 3-bone platform with additional stiffeners.
- Composite body inner structure (CBIS) applied at multiple locations to increase body rigidity and strength.

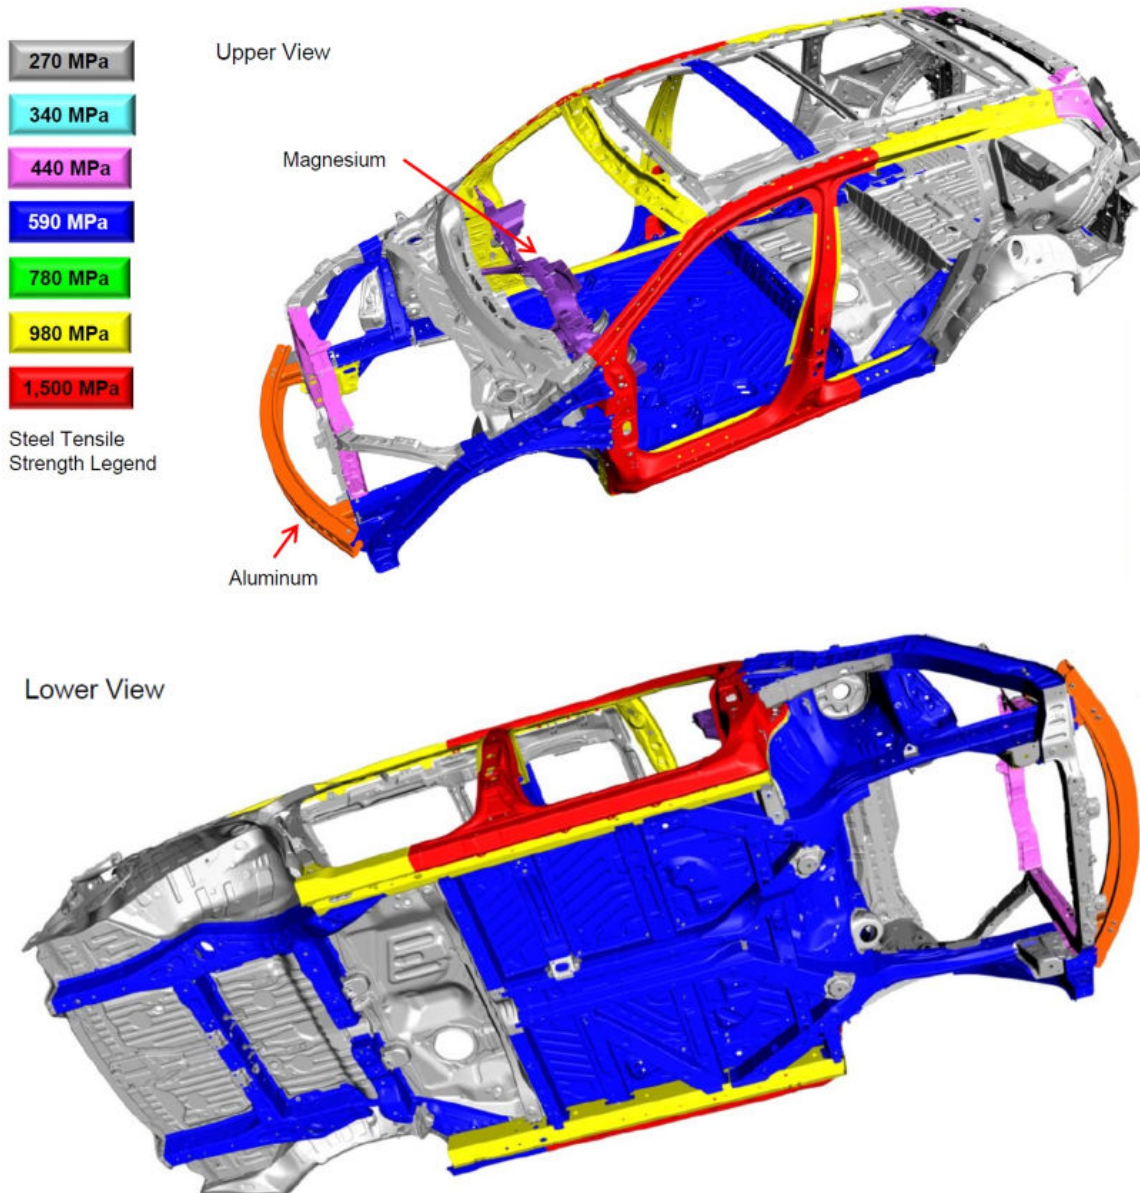
- Steel parts are color-coded based on their tensile strength in megapascals (MPa).
- High strength steel (HSS) is defined as any steel with a tensile strength of 340 MPa or higher.
- Ultra-high-strength steel (UHSS) is defined as any steel with a tensile strength of 980 MPa or higher.
- Steel repair and welding procedures vary depending on the tensile strength of the parts involved.

These illustrations are for general reference only. Some body parts are constructed from multiple layers of different tensile strength steels. Always refer to the body repair manual body construction section for specific steel tensile strength information.

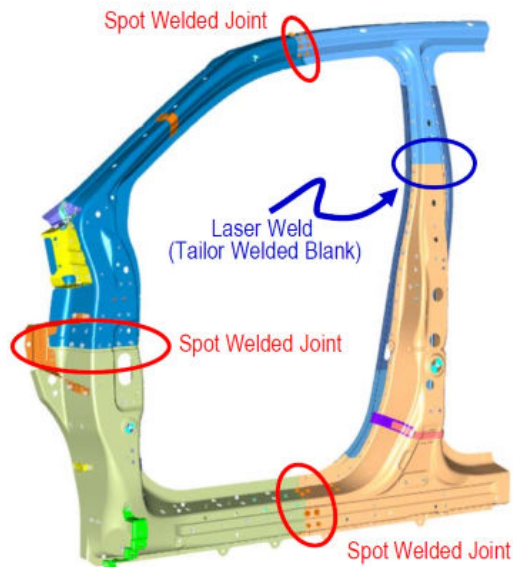
Door Outer Stiffener Ring Construction

- The door outer stiffener rings are constructed of 1,500 MPa steel.

The door outer stiffener ring **must** be replaced as a single assembly if it is damaged.

- The stiffener rings are constructed from multiple stampings that are spot welded together at the factory.
- With the door ring assembled and installed, there is no spot welder access to these factory joints, so they **cannot** be repaired.
- The door ring service part is sold as a complete assembly.
- **Do not** substitute MAG welding or MIG brazing for these factory spot welds on the door ring.

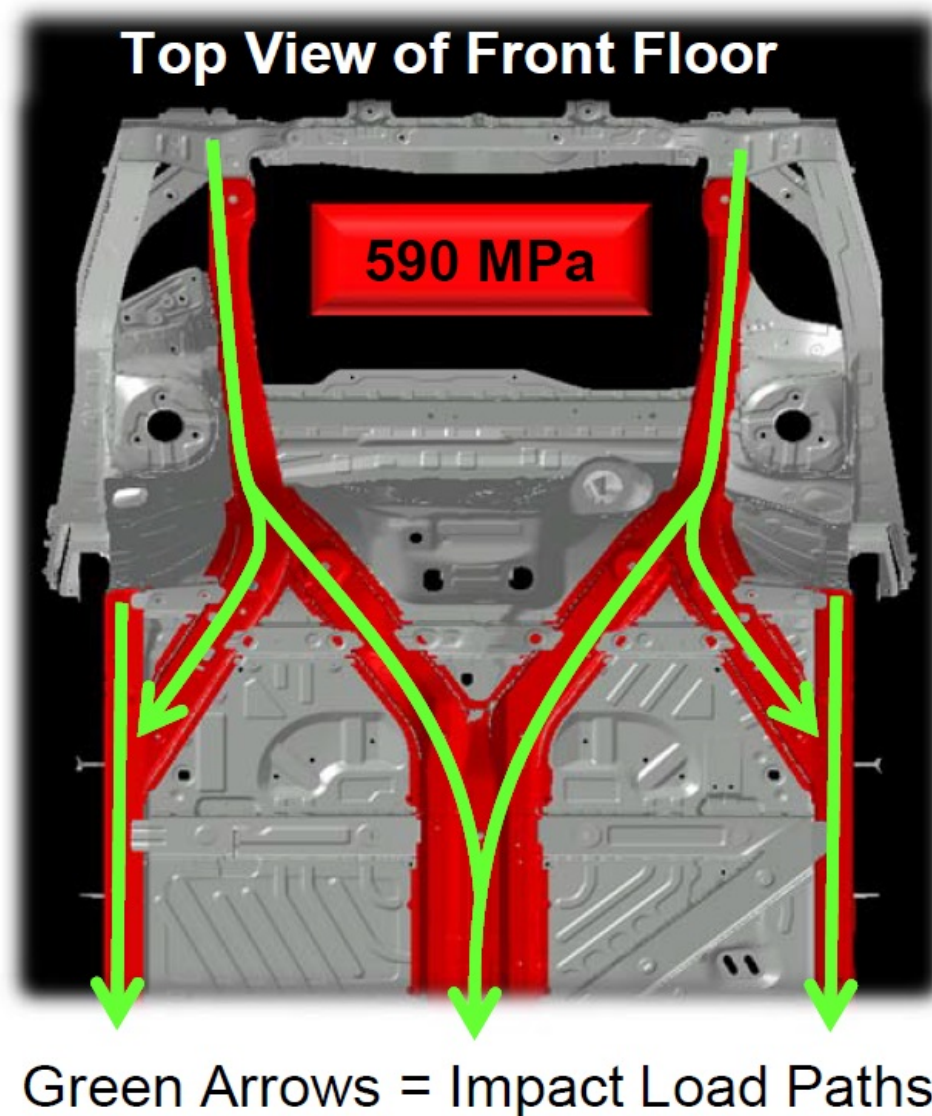
A 3-Bone platform structure is used on this vehicle.

- The structure improves impact load management around the cabin while reducing weight.
- Additional floor reinforcements may require replacement or spot weld removal if damaged in a collision.
- Limited sectioning allowed to the front side frame and rear frame B parts. Refer to the body repair manual for complete information.

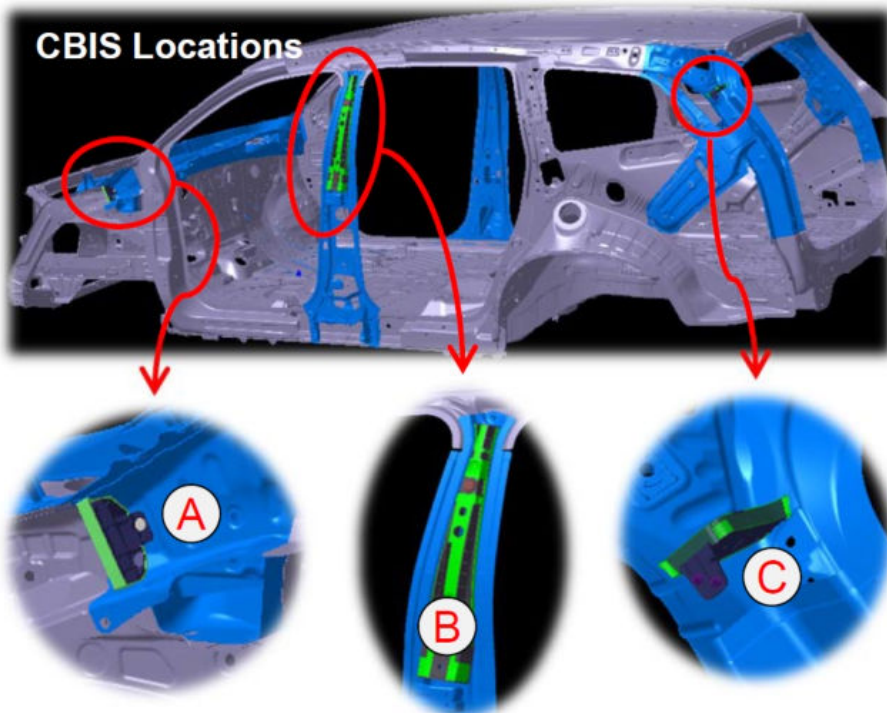
- Factory CBIS uses L&L Products L-5520 expanding structural foam (Not commercially available), which expands during the E-coat bake process.
- CBIS is applied at the following locations:
  - Dashboard upper A (Elite models with panoramic roof only).
  - Upper center pillar with composite insert B.
  - Rear pillar upper C.

- CBIS locations B & C have the structural foam pre-installed and baked.
- CBIS locations A & D require a special room-temperature cured, 2-part epoxy, expandable structural adhesive (L&L Products L-0504 or equivalent) to replicate these joints.
- Because of their limited shelf life, the adhesive must be ordered at the same time as the replacement parts.
- Once the adhesive/foam is applied, the parts can be assembled and welded. The repair adhesive material will cure at room temperature in 24 hours.

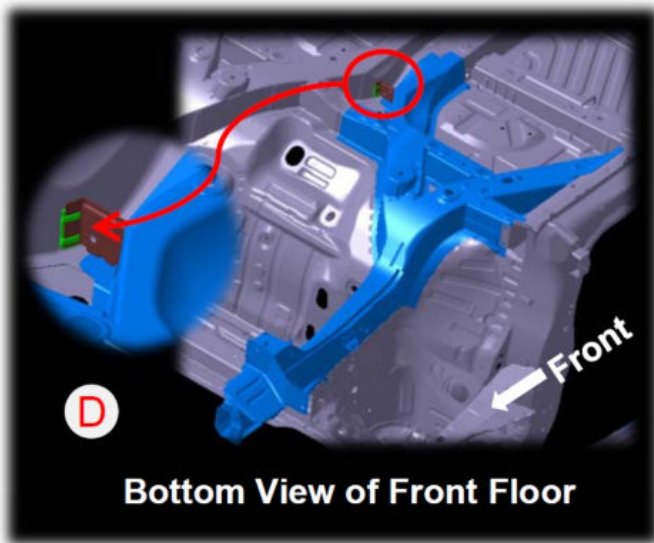
- Center frame bracket D.

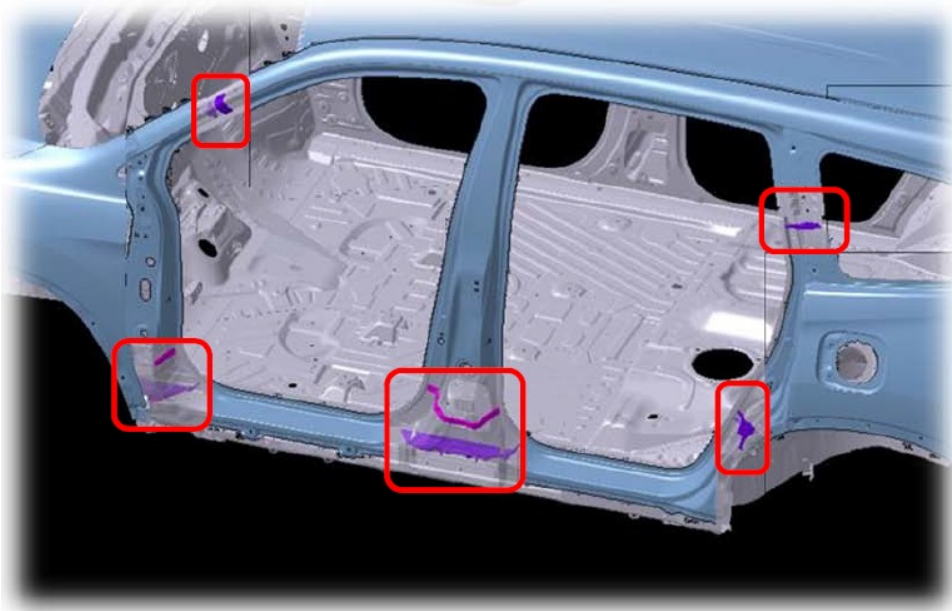
A combination of molded, extruded, and tape acoustic separators are applied in various body locations.

- These are applied within the body pillars.
- They are designed to block the noise paths into the cabin from hollow body cavities.
- Repairs are similar to previous models using commercially available products.

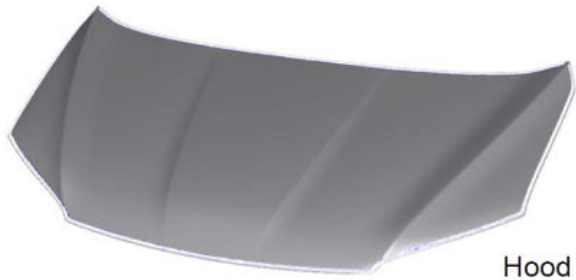
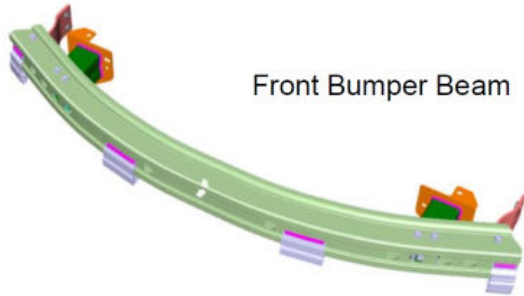
All of the parts shown use aluminum alloy construction.

- Do not repair bumper beams if they are damaged.
- Minor damage to the aluminum hood may be repaired by body shops that have dedicated aluminum repair facilities and tools.
- To prevent galvanic corrosion, some fasteners for aluminum parts are considered one-time use and must be replaced if removed.

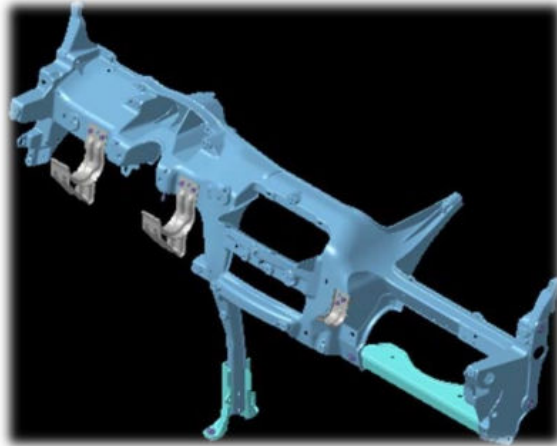
Steering Hanger Beam

The steering hanger beam provides mounting for the steering column and dashboard components.

- The beam is constructed from magnesium alloy for weight savings.
- Do not repair the steering hanger beam if it is damaged.
- Special threaded collar bolts are used in five body mounting locations of the beam to compensate for any variation in body dimensions.
- A specific installation and bolt tightening procedure is required.
- Refer to "Dashboard/Steering Hanger Beam Removal and Installation" in the electronic service manual for complete information.

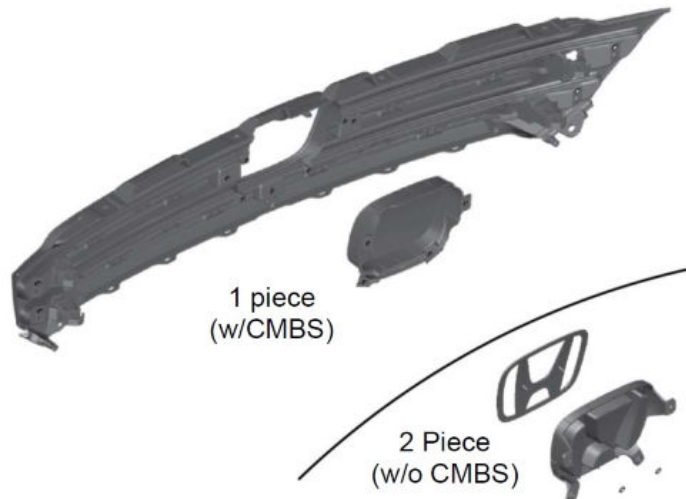
Front Grille Emblem & Bases

- This unit senses through the front grille emblem base.
- This part, and its Honda emblem, are specially designed to prevent radar interference.
- Installing the wrong front grille emblem base will cause the CMBS indicator to come on and DTC P2583-97 (dust or dirt on the millimeter wave radar) to set.
- The Honda emblem with a flat lens integrated into the base is the correct radar-compatible part.
- The Honda emblem with the raised texture and is a separate part from the emblem base is the incorrect part.

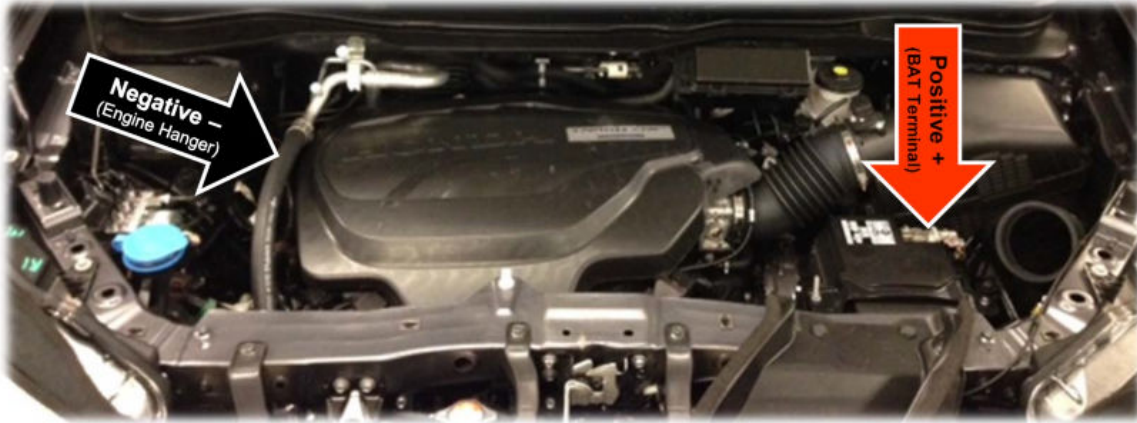
12-Volt Battery Under Hood Jump Starting/Charging/Testing Locations

This vehicle uses a 12-volt battery sensor on the negative battery cable at the battery terminal.

- This sensor is fragile and can be damaged during jump starting or battery charging/testing procedures.
- To avoid damage to the battery sensor and the chance of electrical sparks, do not use the negative battery post for these procedures. Instead, connect the negative jumper cable or the testing/charging equipment's negative cable to the engine hanger bracket located on the passenger's side of the engine under the plastic engine cover.
