2013 RDX: Body Repair Information

(Supersedes original publication issued **December 2013**. Revision includes 2016 model info)

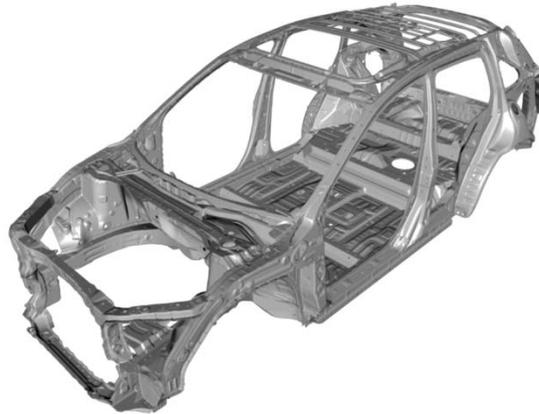
2013–15 models have these body features:

- Advanced Compatibility Engineering™ (ACE™) crash compatible body structure
- Body construction using 56% high tensile strength steel, including 25% in grades 780, and 1,500 MPa
- Aluminum hood panel and front bumper beam for weight reduction and improved fuel efficiency (not shown in this view)

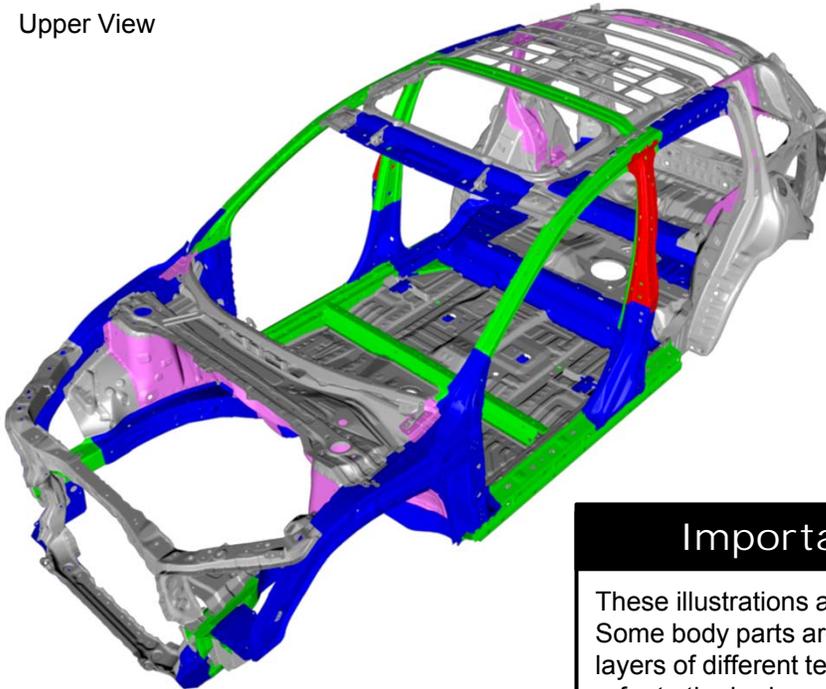
Upper View

- Steel parts are color coded based on their tensile strength in megapascals (MPa).
- High-strength steel is defined as any steel with a tensile strength of 340 MPa or higher.
- Ultra-high-strength steel (UHSS) is defined as any steel with a tensile strength of 980 MPa or higher.
- Steel repair and welding procedures vary depending on the tensile strength of the parts involved.

2013–15 Body Construction

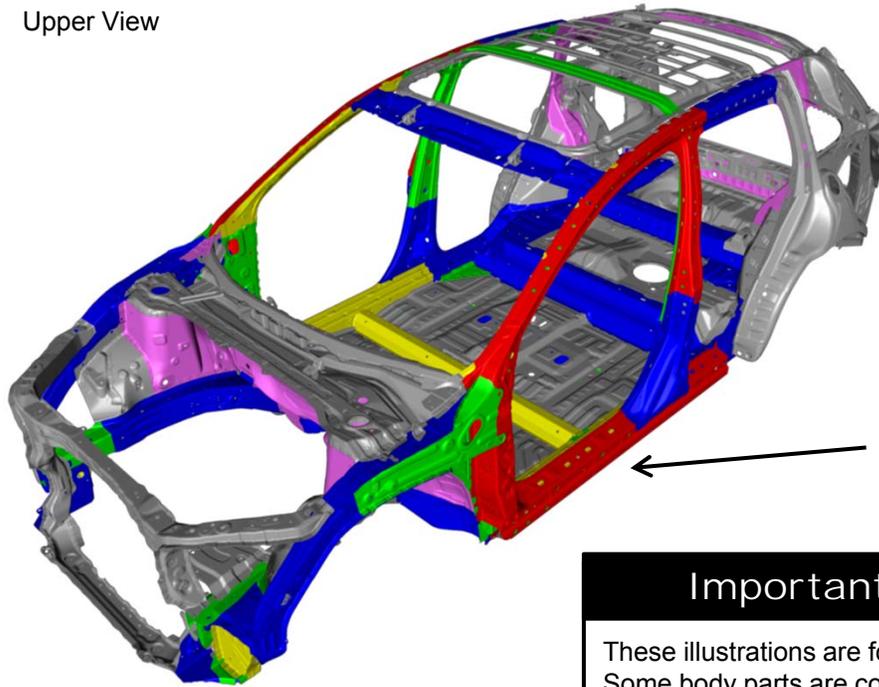
Upper View

2016 Body Construction

NOTE: 1,500 MPa Side Sill Patch & Inside Sill Stiffener Located Under Side Sill Reinforcement

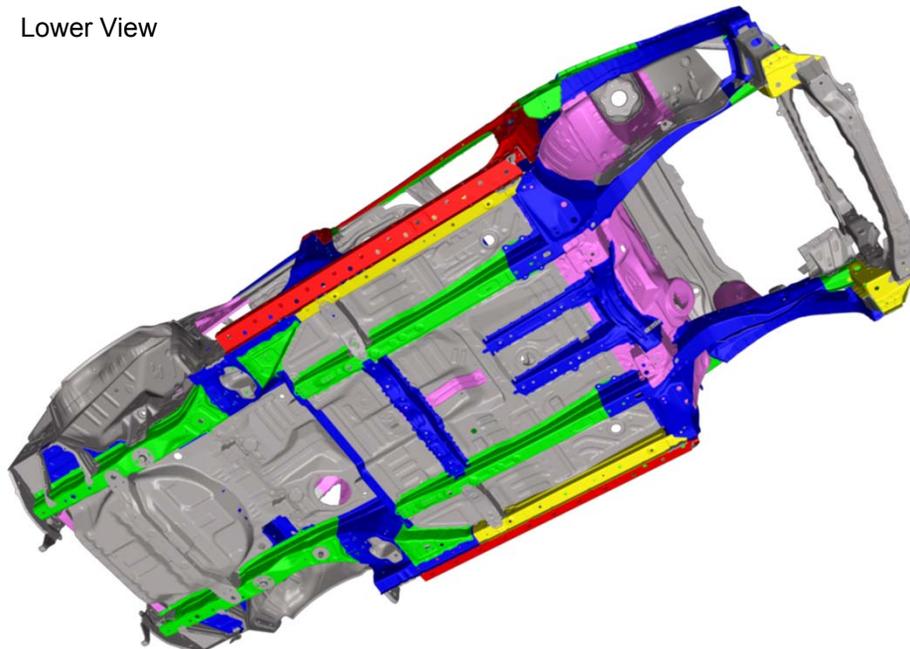
Lower View

- Steel parts are color coded based on their tensile strength in megapascals (MPa).
- High-strength steel is defined as any steel with a tensile strength of 340 MPa or higher.
- Ultra-high-strength steel (UHSS) is defined as any steel with a tensile strength of 980 MPa or higher.
- Steel repair and welding procedures vary depending on the tensile strength of the parts involved.

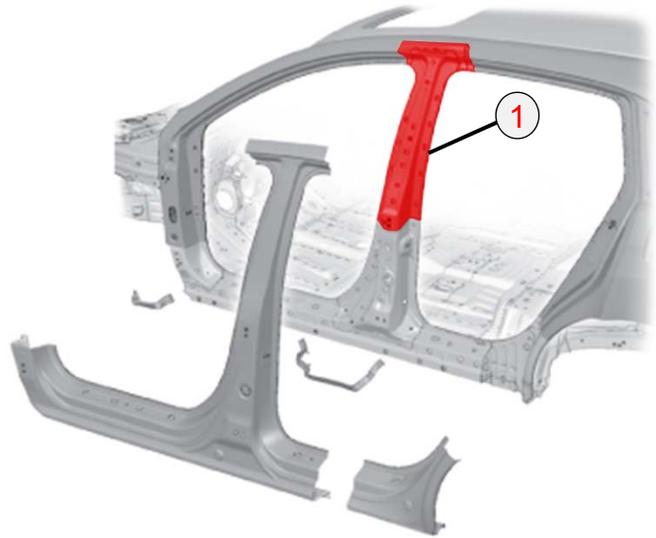
The numbered part in the diagram shown here is constructed of 1,500 MPa steel.

1,500 MPa Steel Parts – 2013-15 Models	
1	Center Pillar Upper Stiffener (Both Sides)

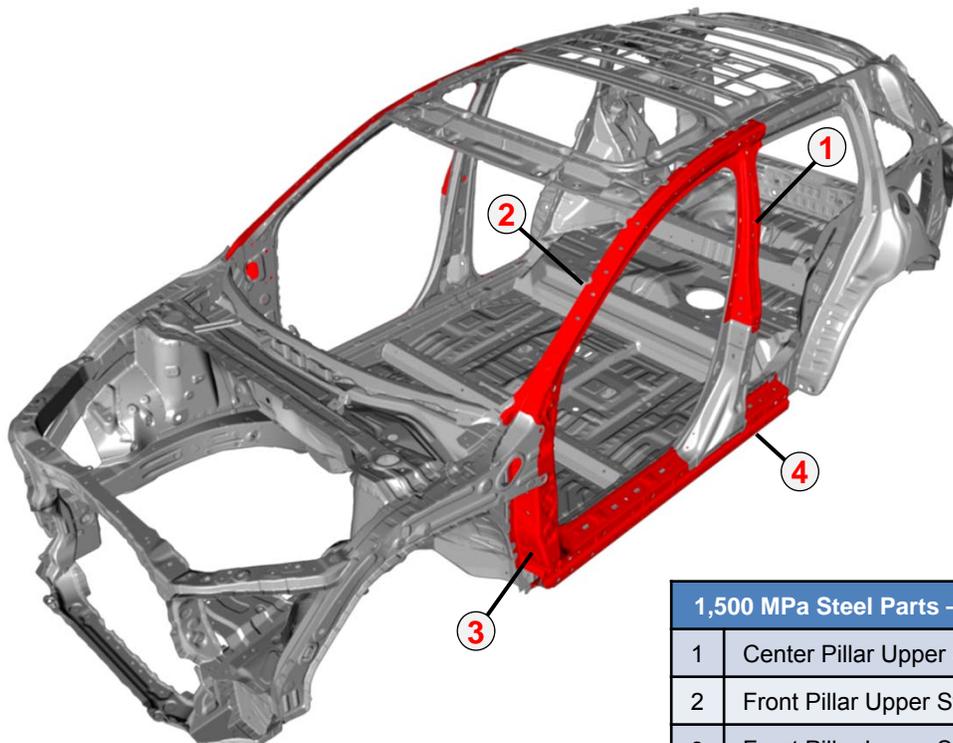
The numbered parts in the diagram below are constructed of 1,500 MPa steel.

1,500 MPa Steel Parts – 2016 Models	
1	Center Pillar Upper Stiffener
2	Front Pillar Upper Stiffener
3	Front Pillar Lower Stiffener
4	Side Sill Reinforcement & Patch, Inside Sill Stiffener (3 parts)

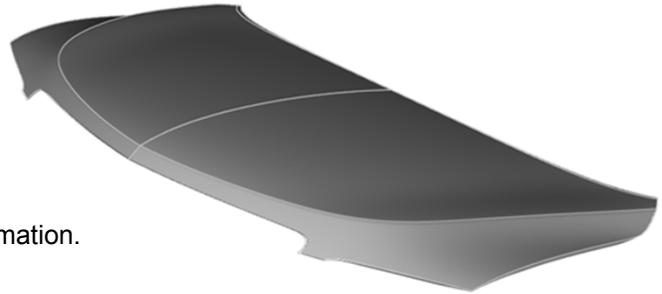
The hood panel and front bumper beam are constructed of aluminum alloy.

- Do not repair damaged bumper beams.
- The aluminum hood may be repaired by body shops that have a dedicated aluminum repair facility and separate tools.
- To prevent galvanic corrosion, some fasteners for aluminum parts are considered one-time use and must be replaced if removed. Refer to the electronic service manual or body repair manual for more information.

Hood Panel

Front Bumper Beam

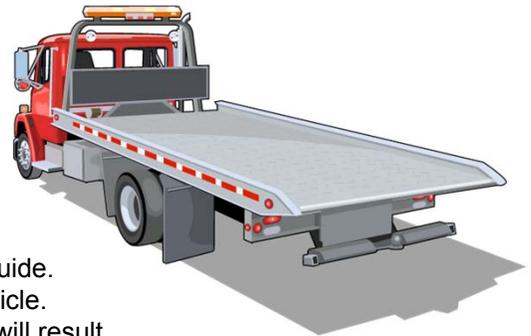
- Lift or jack only at the specified points to avoid damaging the vehicle.
- Do not lift or tow this vehicle by its bumpers, or serious damage will result.

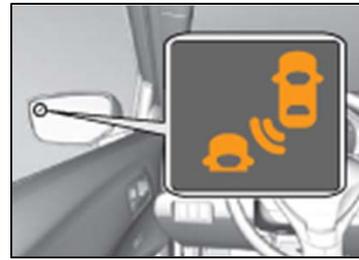
BSI Alert Indicator

Beginning with the 2016 model year, models equipped with this system can be identified by the BSI Alert Indicators located on both outside rearview mirrors.

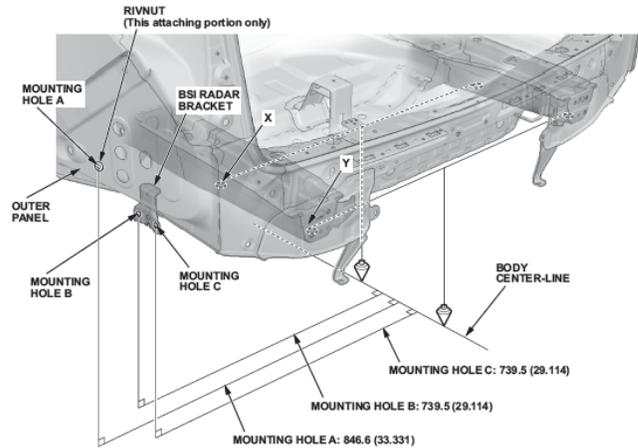
- The system uses two radar units, one mounted on each side of the vehicle under the rear bumper.
- The radar units are also used along with the multi-view rear camera to monitor rear cross traffic when reversing.
- The system may malfunction and set DTCs because of damage, improper repairs, or excessive foreign material on any of the following:
 - Rear bumper
 - Outer side panels
 - Radar unit mounting locations
- Several checks and inspections must be done during repairs to the radar unit mounting area. If the mounting area check is not done, an Acura dealer may not be able to properly aim the radar units.
- For more information, refer to “BSI Radar Unit Mounting Area Check,” in the electronic service manual.

LH BSI Unit Mounting Area Check
(RH Side is symmetrical.)

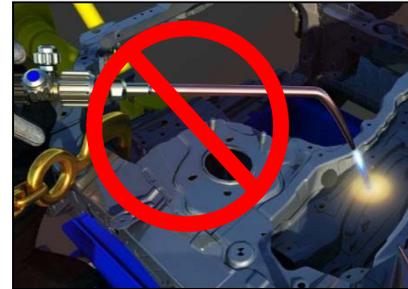
- **Do not** apply heat to any body part during straightening. This may compromise the internal structure and strength of high-strength steel parts.
- Any part that has heat applied to it during straightening **must** be replaced with new parts.
- Ignoring these instructions may significantly reduce occupant protection in any subsequent collision.

Do not heat during straightening

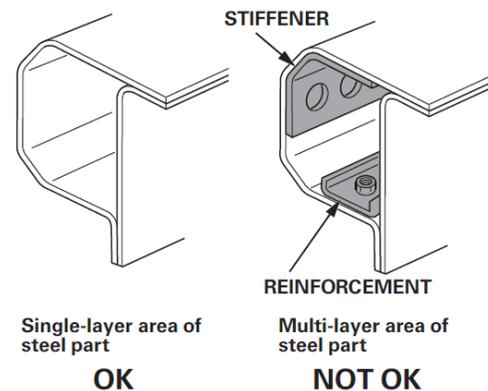
- Sectioning must be done in a single-layer area of the part.
 - Multi-layer internal steel reinforcements and stiffeners must not be cut.
 - The repair is not in a load-bearing area such as engine, transmission, or suspension mounting points.

Sectioning Area Examples

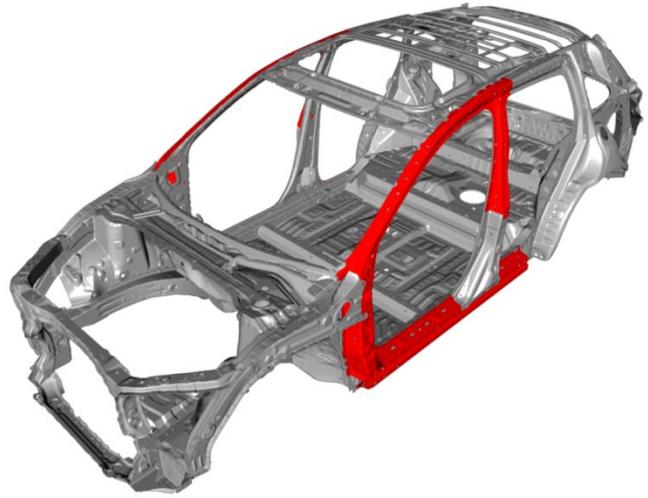
- **Never** attempt to straighten damaged 1,500 MPa steel parts because they may crack.
- 1,500 MPa steel parts **must** be replaced at factory seams using squeeze-type resistance spot welding (STRSW). **Do not section these parts!**
- MIG brazed joints should be used **only** in locations not accessible by a spot welder.
- To assure adequate weld tensile strength, always set the spot welder to the specifications provided in the body repair manual.

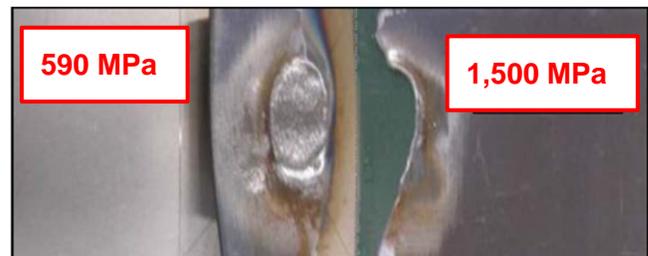
- **Never** perform MAG welding on 1,500 MPa steel. The heat generated during MAG welding will significantly reduce the strength and structural integrity of 1,500 MPa steel parts.
- This photo shows tensile strength test results of MAG welded 1,500 MPa steel. The 1,500 MPa steel fractured first, because the welding heat reduced its strength to far below 590 MPa.
- For more information, refer to “Repair Guidelines for High-Strength Steel Parts,” in the body repair manual.

Tensile Test Results of MAG-Welded 1,500 MPa Steel

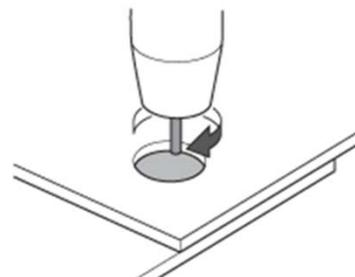
- MAG plug welding may be done when joining body components to 590–980 MPa steel parts.
- Follow the recommendations described in the body repair manual sections “Repair Guidelines for High-Strength Steel Parts”, and “MAG Welding Conditions for High-Strength Steel (Except 1,500 MPa) Parts.”

MAG Plug Welding

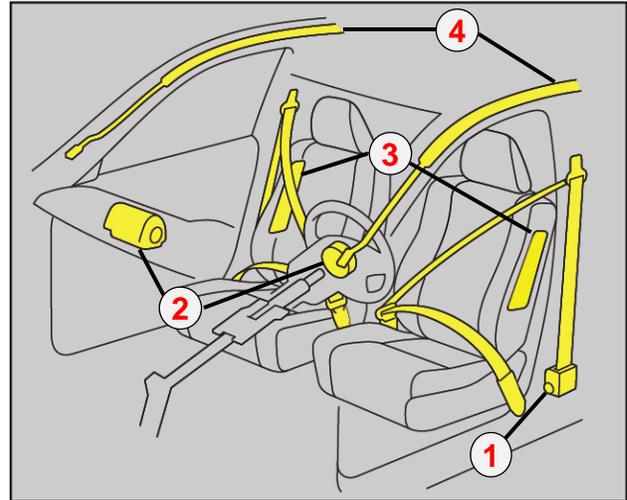
1. Driver's and front passenger's seat belt tensioners (may deploy independently from any airbags).
2. Driver's and front passenger's SRS airbags.
3. Side airbags mounted in the outer driver and front passenger seat-backs.
4. Side curtain airbags mounted above the left and right side windows under the headliner.

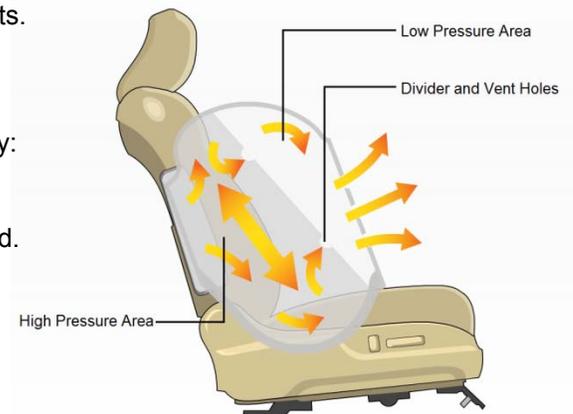
- This airbag design helps mitigate the risk of excessive airbag deployment force and risk of injury to smaller seat occupants.
- Eliminates the need for the occupant position detection system (OPDS) sensor located in the front passenger's seat-back.

SmartVent Side Airbag

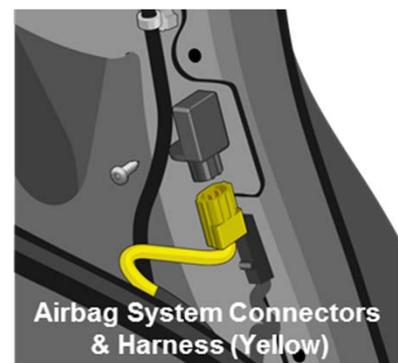
- For easier identification, electrical connectors that contain only airbag system wiring are yellow in color.
- Many harnesses that contain primarily airbag wiring are also wrapped in yellow tape.
- Airbag system wiring that runs in a common harness, such as a floor harness, is generally not marked.
- **Never** attempt to modify, splice, or repair airbag system wiring. If airbag system wiring is damaged, replace the wiring harness(es).

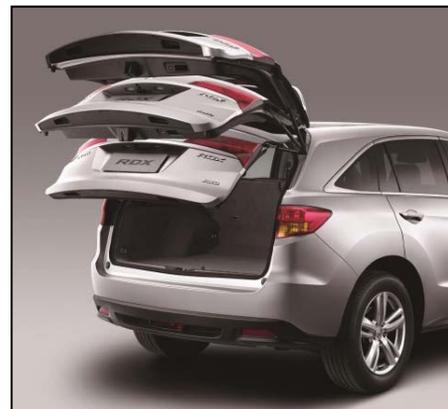
- The power tailgate will not be able to open or close automatically until it is reset when:
 - The battery is disconnected, or the No. A29 (10 A) fuse in the under-hood fuse/relay box is removed while the power tailgate is operating.
 - Certain power tailgate components have been replaced.
- Refer to “Resetting the Power Tailgate Control Unit” in the electronic service manual for complete information.

Power Tailgate

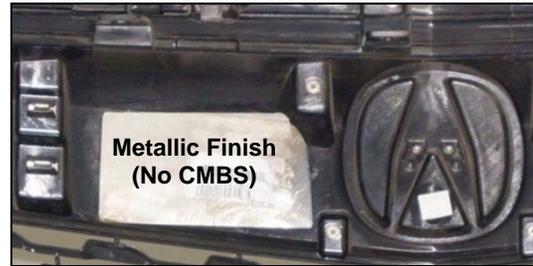
- This unit senses through the front grille upper molding.
- To prevent radar interference, a special black coating is used on the back side of the molding. This coating also significantly increases the part's cost.
- Installation of the wrong grille molding will cause the CMBS indicator to come on and DTC P2583-97 (dust or dirt on the millimeter wave radar) to set.
- To check for this without removing the bumper, remove the front bulkhead cover and look down at the back side of the front grille upper molding.
- If the back side of the grille molding has a metallic finish, the wrong grille upper molding was installed.
- **Do not** paint or apply any coverings or coatings to grille parts that the millimeter wave radar unit senses through! These can negatively affect CMBS operation.

Back Side View of Grille Molding (w/o CMBS)

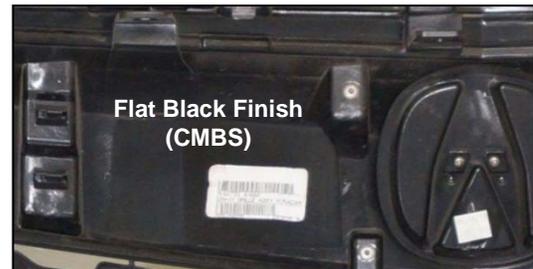
Back Side View of Grille Molding (w/CMBS)

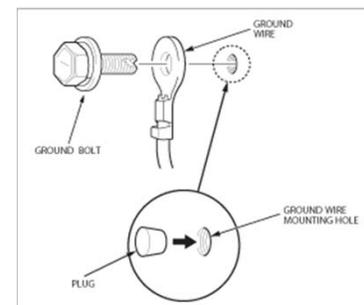
- Painting over electrical ground locations may cause electrical systems such as vehicle stability assist (VSA), to malfunction and set DTCs that may be difficult to diagnose.
- Protect the ground wire and the ground wire mounting hole threads with a bolt or plug when priming or painting.
