Applies To: **2013 Accord – ALL**
December 21, 2013

Low Tire Pressure Indicator Is On With No DTC or DTC 151-11 in VSA System

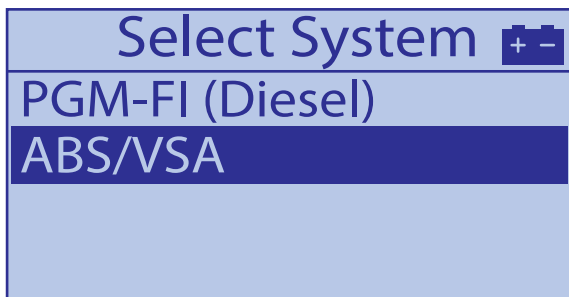
1. Connect a fully charged jumper battery to the vehicle and leave it connected during the entire update procedure to maintain a steady voltage.
2. Apply the parking brake and make sure the headlights are in the OFF position.
3. Turn the ignition switch to ON (II), or press the engine start/stop button to select the ON mode, and turn all accessories off.
4. Connect the MVCI to the vehicle.
5. Press the ENTER button on the MVCI to see the User Config menu. Select CM Update Mode, then press ENTER.
6. Select Reprogramming, then press ENTER.
7. The CM Update Mode software screen appears. Press ENTER to continue.
NOTE: The FW VER must be 3.01.37 or later and Database Update must be 15 November 2013 or later.
8. The Select System screen appears. Select ABS/VSA, then press ENTER.
NOTE: If the VSA update is the only available update, it will automatically go to the VSA selections.

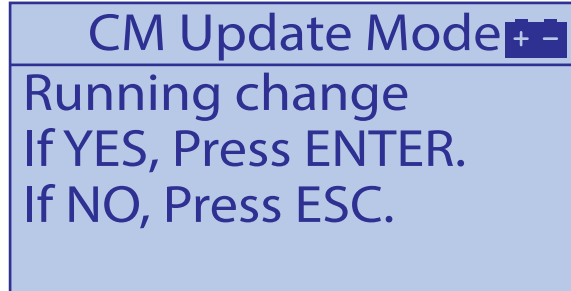
10. Scroll down and select "Running change, IF YES, Press ENTER". Press ENTER again to start reprogramming.
