2018 Odyssey Model Series: Body Repair Information

2018 Odyssey Model Series

OVERVIEW OF BODY FEATURES

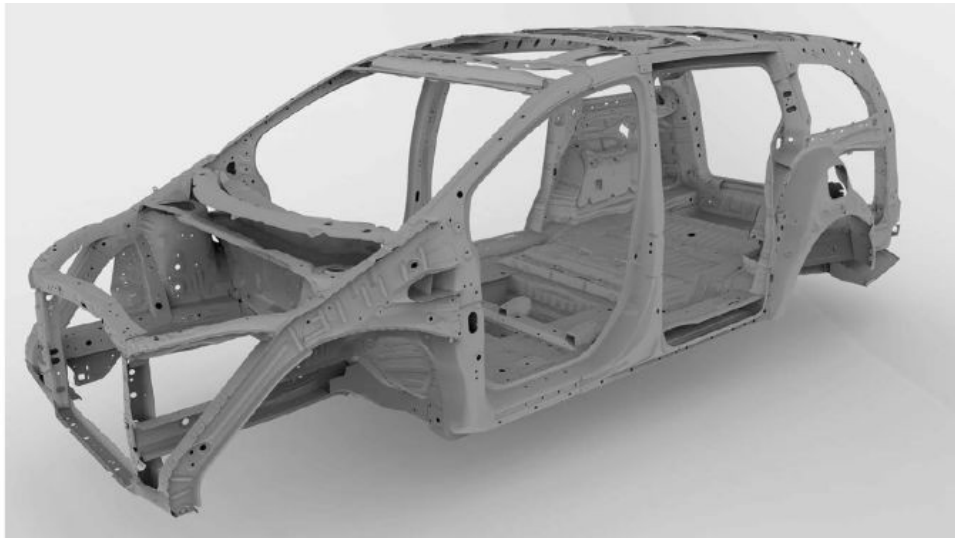
- Next-Generation Advanced Compatibility Engineering™ (ACE™) body structure.
- Body construction using 60% high-tensile-strength steel (HSS), including 21% ultra-high-strength steel (UHSS - 0 98 MPa and higher).
- Reinforced cabin with 1,500 MPa front door outer stiffener rings and reinforced roof structure.
- 3-bone platform with additional stiffeners.
- Composite body inner structure (CBIS) applied at multiple locations to increase body rigidity and strength.

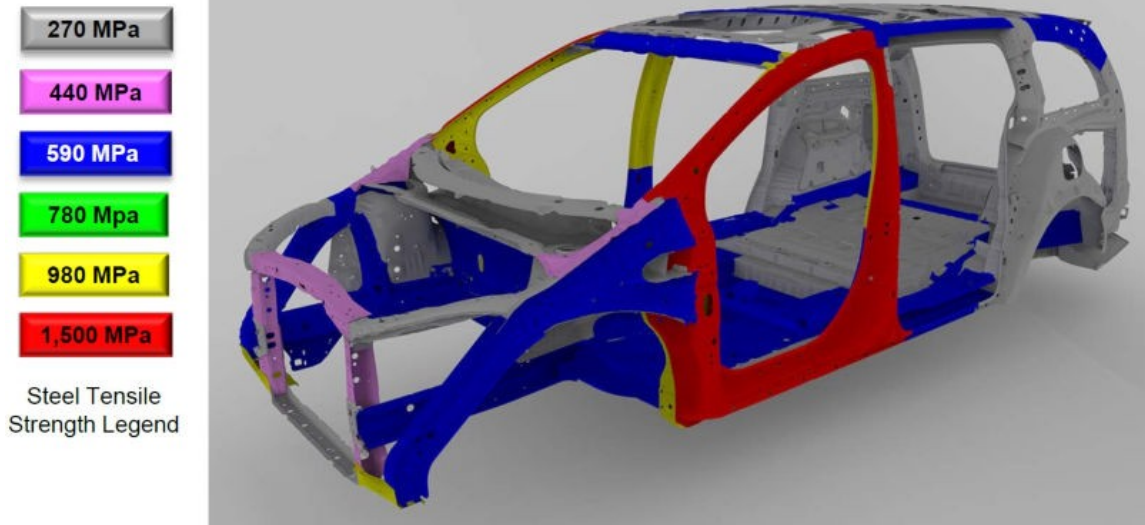
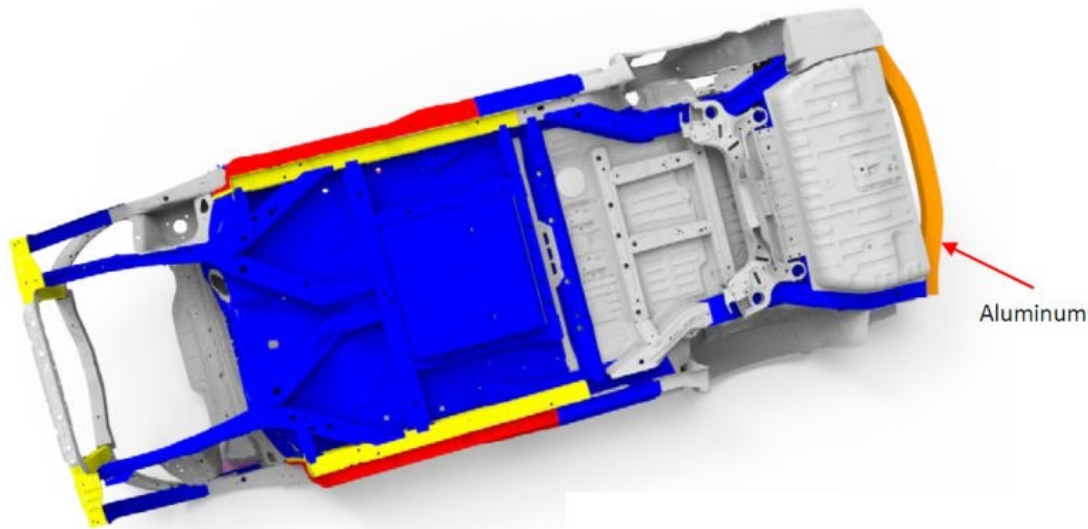
BODY CONSTRUCTION AND HIGH-STRENGTH STEEL CONTENT

- Steel parts are color-coded based on their tensile strength in megapascals (MPa).
- High strength steel (HSS) is defined as any steel with a tensile strength of 340 MPa or higher.
- Ultra-high-strength steel (UHSS) is defined as any steel with a tensile strength of 980 MPa or higher.
- Steel repair and welding procedures vary depending on the tensile strength of the parts involved.

These illustrations are for general reference only. Some body parts are constructed from multiple layers of different tensile strength steels. Always refer to the body repair manual body construction section for specific steel tensile strength information.

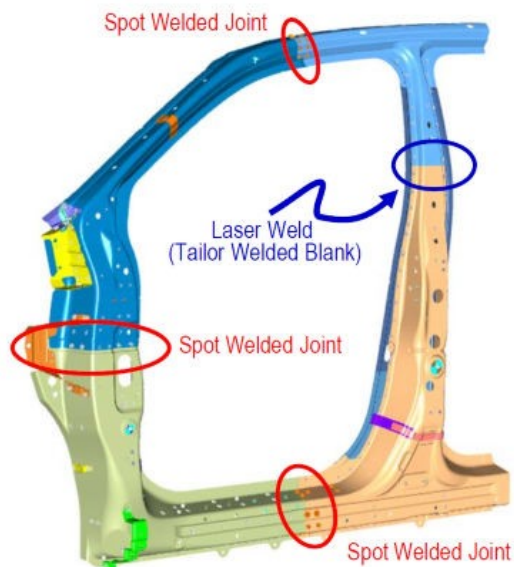
Door Outer Stiffener Ring Construction

- The door outer stiffener rings are constructed of 1,500 MPa steel.

The door outer stiffener ring **must** be replaced as a single assembly if it is damaged.

- The stiffener rings are constructed from multiple stampings that are spot welded together at the factory.
- With the door ring assembled and installed, there is no spot welder access to these factory joints, so they **cannot** be repaired.
- The door ring service part is sold as a complete assembly.
- **Do not** substitute MAG welding or MIG brazing for these factory spot welds on the door ring.

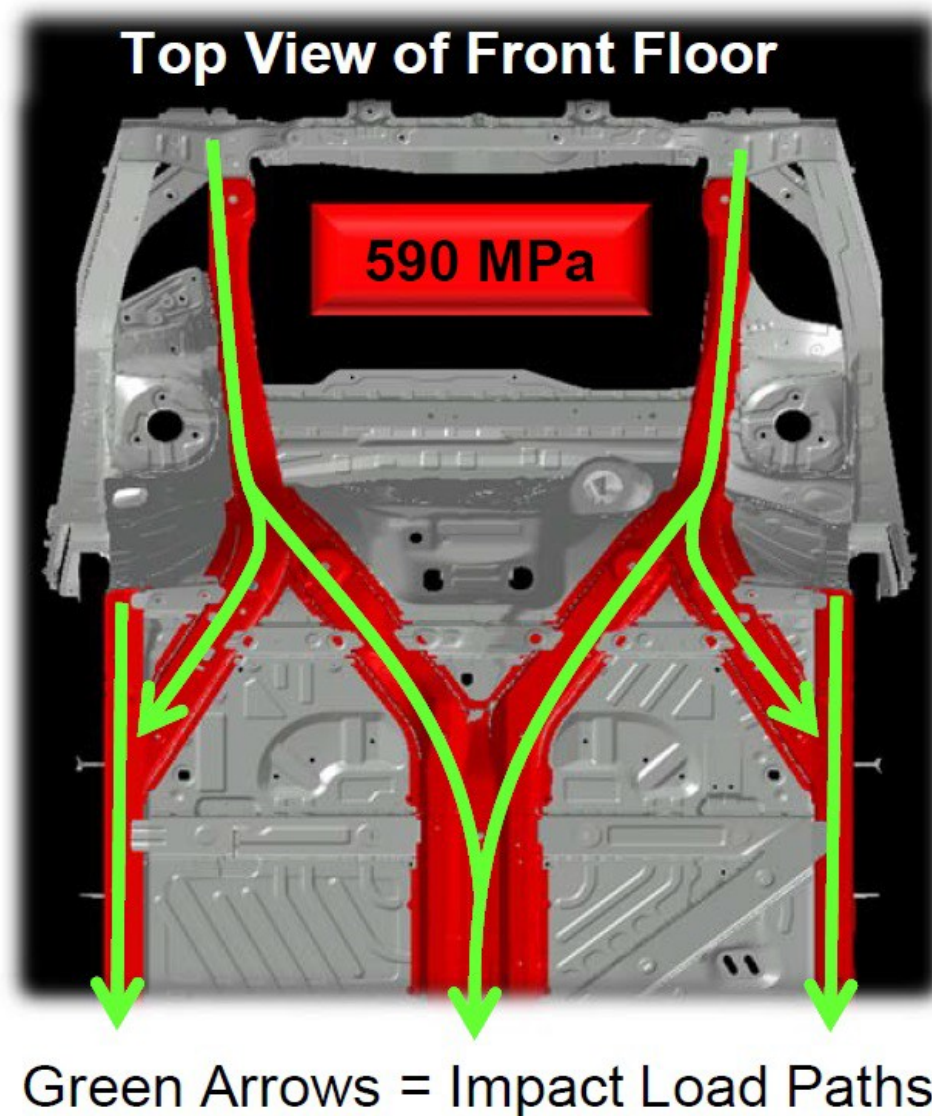
3-BONE PLATFORM STRUCTURE

A 3-Bone platform structure is used on this vehicle.

- The structure improves impact load management around the cabin while reducing weight.
- Additional floor reinforcements may require replacement or spot weld removal if damaged in a collision.
- Limited sectioning allowed to the front side frame and rear frame B parts. Refer to the body repair manual for complete information.

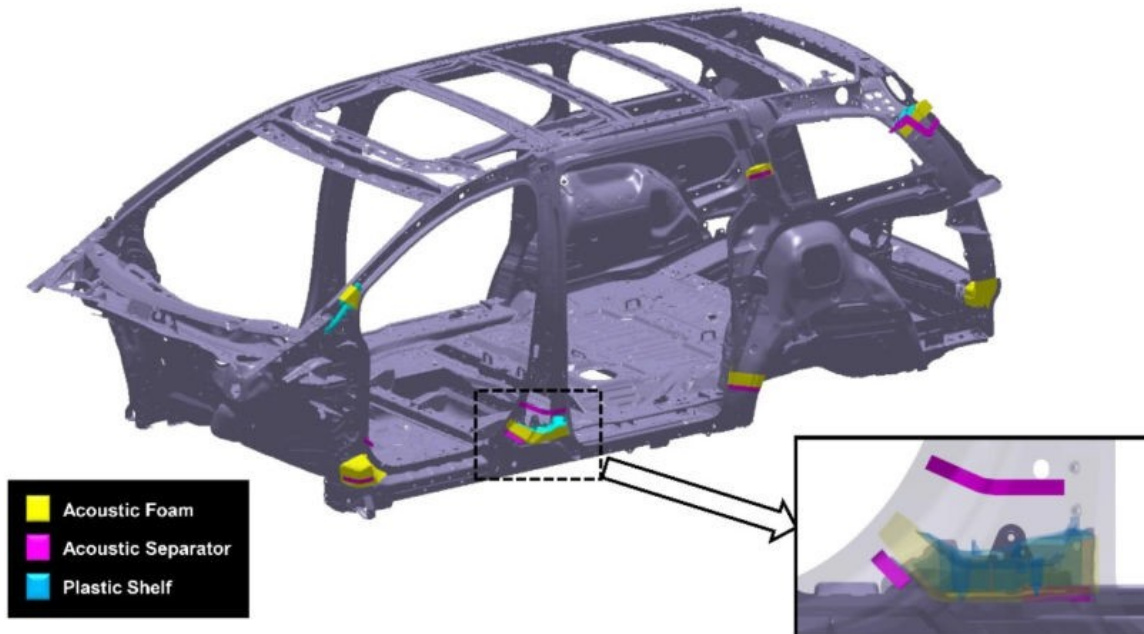
ACOUSTIC SEPARATOR LOCATIONS

A combination of molded, extruded, and tape acoustic separators are applied in various body locations.

- These are applied within the body pillars.
- They are designed to block the noise paths into the cabin from hollow body cavities.
- Repairs are similar to previous models using commercially available products.

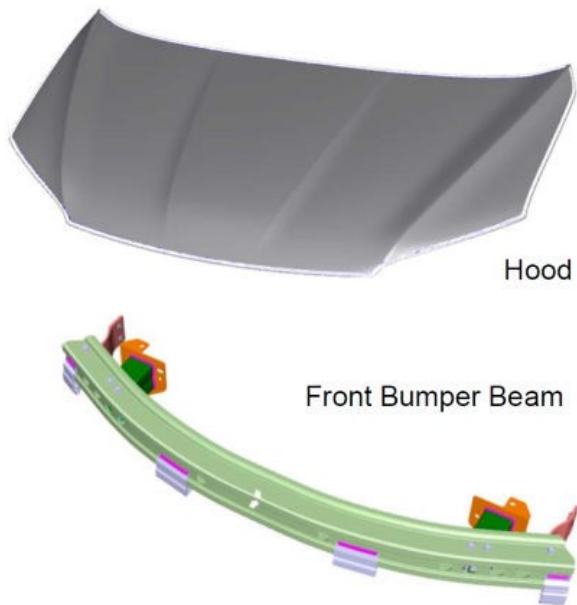
ALUMINUM PARTS & REPAIRABILITY

All of the parts shown use aluminum alloy construction.

- Do not repair bumper beams if they are damaged.
- Minor damage to the aluminum hood may be repaired by body shops that have dedicated aluminum repair facilities and tools.
- To prevent galvanic corrosion, some fasteners for aluminum parts are considered one-time use and must be replaced if removed.

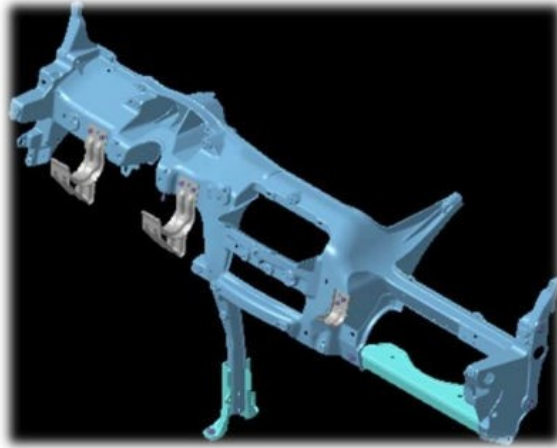
Steering Hanger Beam

The steering hanger beam provides mounting for the steering column and dashboard components.

- The beam is constructed from magnesium alloy for weight savings.
- Do not repair the steering hanger beam if it is damaged.
- Special threaded collar bolts are used in five body mounting locations of the beam to compensate for any variation in body dimensions.
- A specific installation and bolt tightening procedure is required.
- Refer to "Dashboard/Steering Hanger Beam Removal and Installation" in the electronic service manual for complete information.

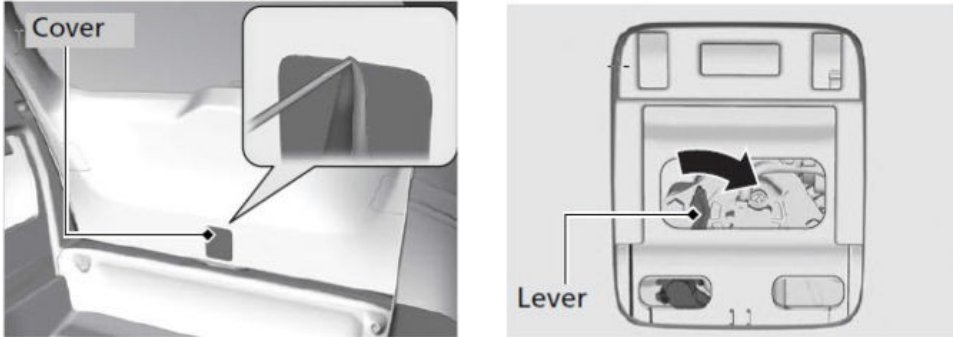
POWER TAILGATE INFORMATION

If you cannot open the power tailgate, use the following procedure:

1. Use a flat-tip screwdriver and remove the cover on the back of the tailgate.
2. To open the tailgate, push the tailgate while pushing the lever to the right.

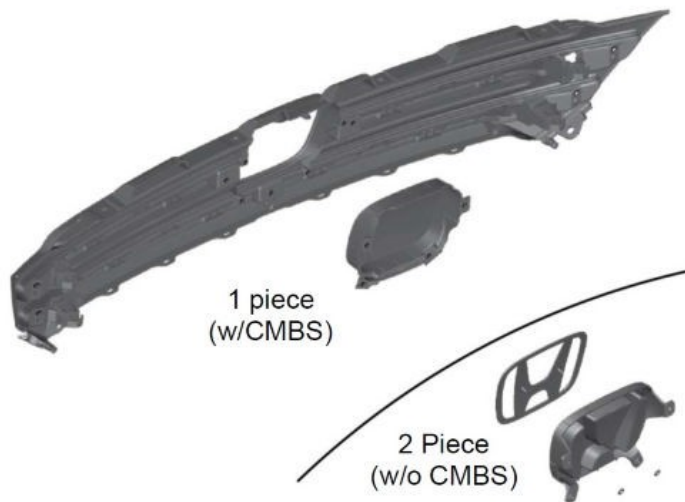
Front Grille Emblem & Bases

Models equipped with Adaptive Cruise Control and the Collision Mitigating Braking System™ use a millimeter wave radar unit.

- This unit senses through the front grille emblem base.
- This part, and its Honda emblem, are specially designed to prevent radar interference.
- Installing the wrong front grille emblem base will cause the CMBS indicator to come on and DTC P2583-97 (dust or dirt on the millimeter wave radar) to set.
- The Honda emblem with a flat lens integrated into the base is the correct radar-compatible part.
- The Honda emblem with the raised texture and is a separate part from the emblem base is the incorrect part.

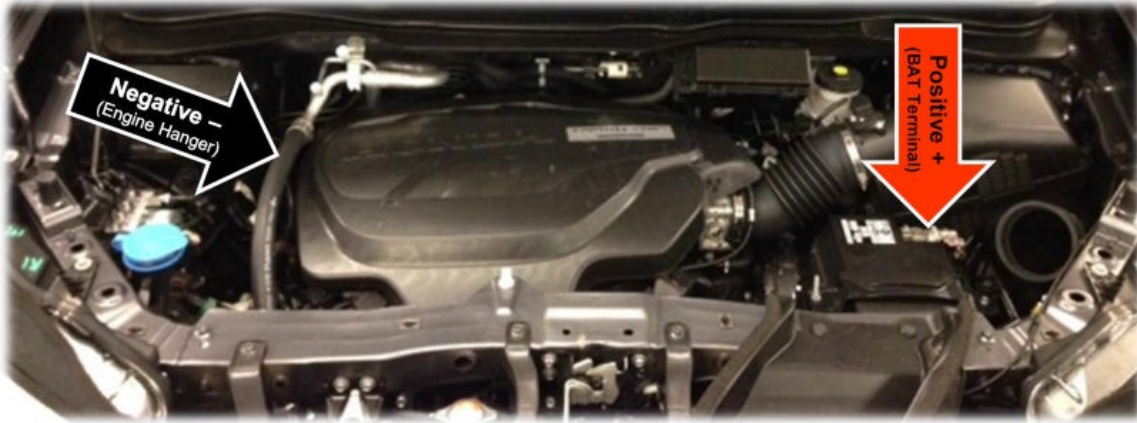
12-Volt Battery Under Hood Jump Starting/Charging/Testing Locations

This vehicle uses a 12-volt battery sensor on the negative battery cable at the battery terminal.

- This sensor is fragile and can be damaged during jump starting or battery charging/testing procedures.
- To avoid damage to the battery sensor and the chance of electrical sparks, do not use the negative battery post for these procedures. Instead, connect the negative jumper cable or the testing/charging equipment's negative cable to the engine hanger bracket located on the passenger's side of the engine under the plastic engine cover.
