2023 Accord Model Series: New Body Repair Information

2023 Accord Model Series

OVERVIEW OF BODY FEATURES

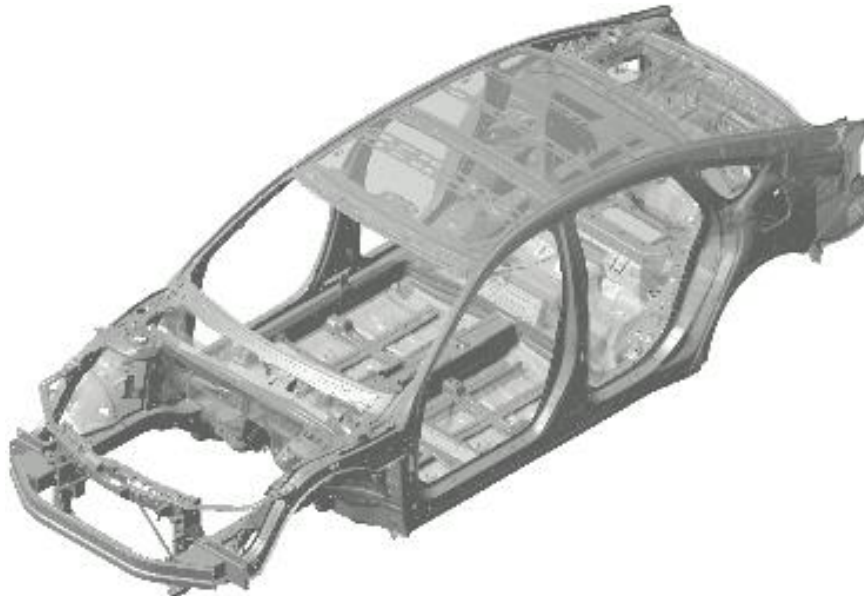
- Lightweight, high rigidity body structure with outstanding safety.
- Body construction using high-strength steel (HSS) and advanced high-strength steel.
- Improved body against side impact and high rigidity by load path strengthening of rear circular bulk.
- Crush mode bending points created on left and right of the RR frame changed into crushing structure from prior 3-point bend mode.
- Strong lead paths created through larger cross-sections to protect against side impact and high rigidity.
- Design enhancement against side impact and high rigidity by dashboard and seat cross member's lateral relation improvement.
- Bulkhead material change from steel to resin creates a 4kg weight reduction.
- Rationalization of adhesive coating area throughout structure, realizes high rigidity balance.

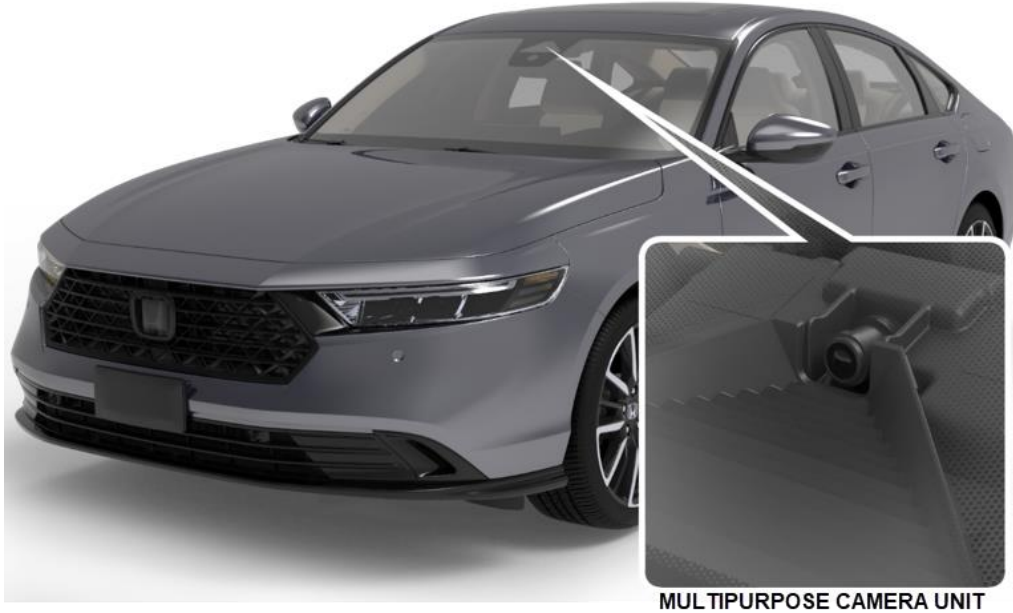
Multipurpose Camera Aiming

The 2023 ACCORD model series is equipped with a multipurpose camera unit and millimeter wave radar. The multipurpose camera allows both dynamic and static aiming. Technicians now have the option to do either type of aiming depending on what their repair facility allows, or weather and traffic conditions.
