Body Repair News

2017 NSX: BODY REPAIR INFORMATION

INTRODUCTION

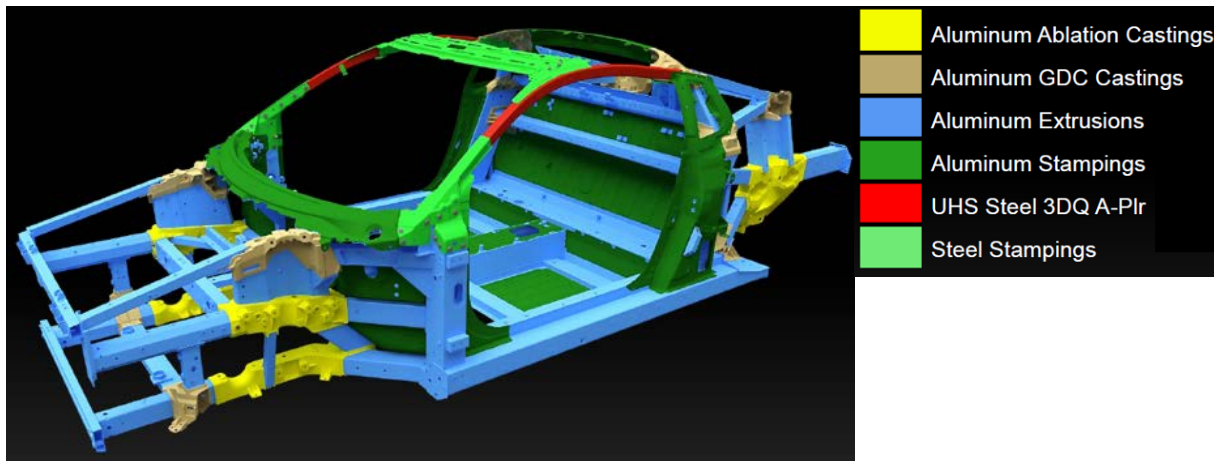
1. The main NSX structure consists of an aluminum space frame that is primarily MIG welded aluminum extrusions, joined at castings which act as nodes to link the extrusions
2. Additional structural components and sheet metal is held in place using Flow drill screws, (FDS) Self piercing rivets (SPR) bolts and traditional pop rivets.

NSX Multi-Material Space Frame

7 Parts Joining Technologies	
	Main Structure MIG, Spot, & Laser Welds
	Multi-Material Joints SPR, Bolts
	Single Side Access FDS (Flow Drill Screw)
	Datum Pop Rivet

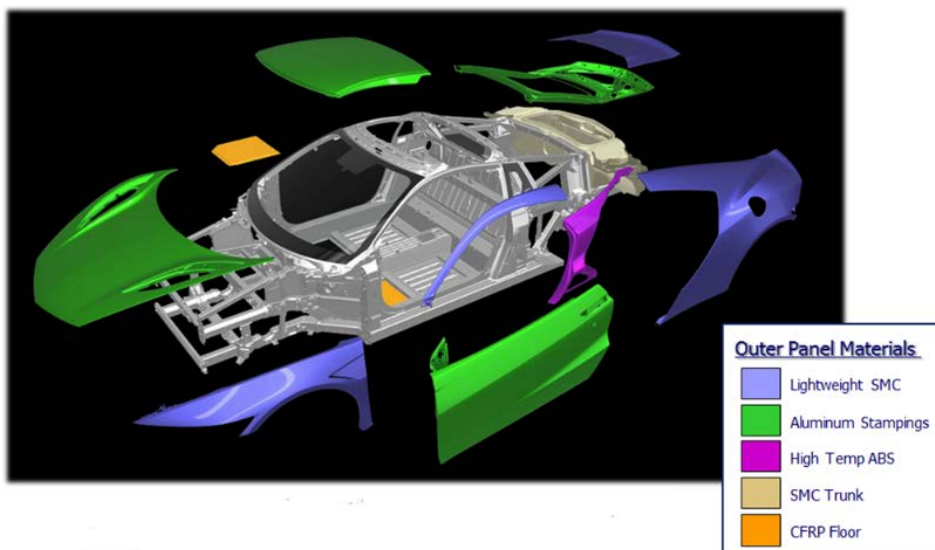
The non-structural or outer panels on NSX are a mixture of high temperature ABS plastic, Aluminum stampings, SMC (sheet molded composite) and CFRP (carbon fiber reinforced polymer) They are primarily bolted in place or held in place using urethane adhesive.

Only surface scratches should be repaired on CFRP parts. If the scratch is deep enough where it has reached the fibers, the part needs to be replaced. In addition to the carbon fiber floor pan shown above, A CFRP roof, engine cover, spoilers and diffuser are also available on NSX.
