2023 Pilot Model Series: New Body Repair Information

2023 Pilot Model Series

OVERVIEW OF BODY FEATURES

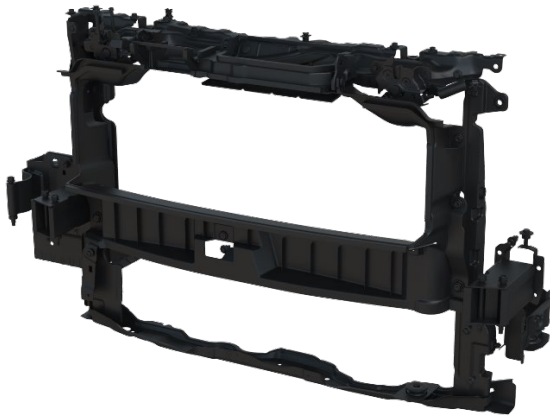
FRONT BULKHEAD

This vehicle has a front bulkhead assembly constructed of steel with a tensile strength of **270 MPa**.

- The bulkhead design improves engine compartment access during factory assembly and service.
- The cooling fans, radiator, A/C condenser, hood lock, outside air temperature sensor, and related piping/components are attached to the front bulkhead.
- A damaged bulkhead must be replaced.
- For more details, refer to front bulkhead replacement in the body repair manual.

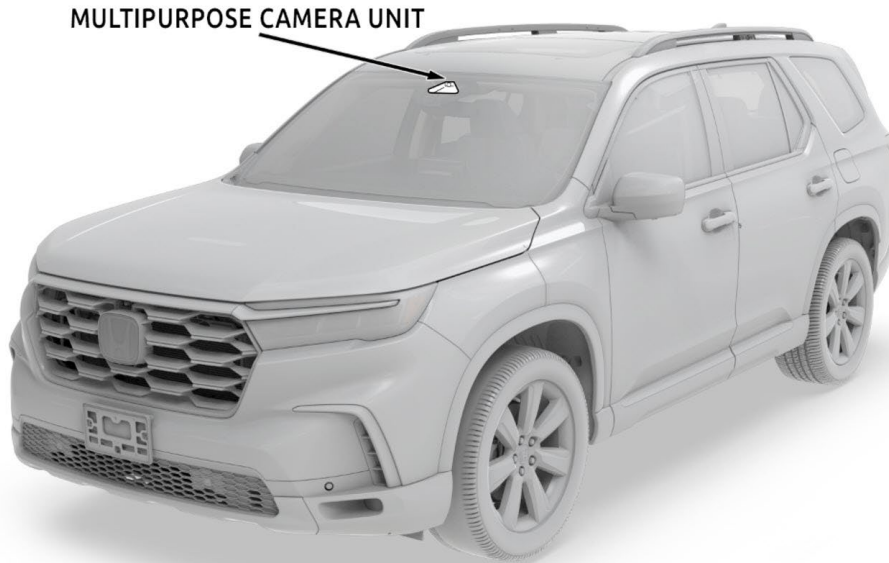
Multipurpose Camera Aiming

The 2023 PILOT model series is equipped with a multipurpose camera unit and millimeter wave radar. The multipurpose camera allows both dynamic and static aiming. Technicians now have the option to do either type of aiming depending on what their repair facility allows, or weather and traffic conditions.
