Body Repair News

2023 Integra Model Series: New Body Repair Information

2023 Integra Model Series

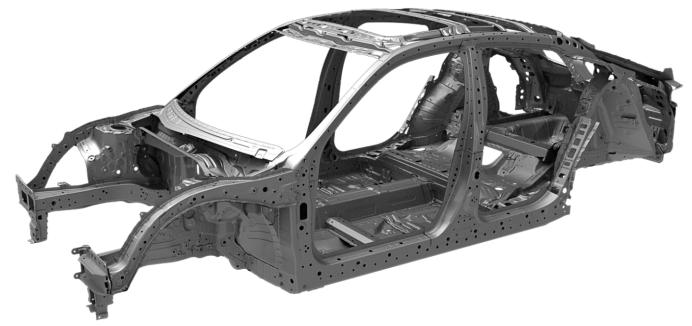
OVERVIEW OF BODY FEATURES

- Next-Generation Advanced Compatibility Engineering[™] (ACE[™]) body structure.
- Body construction using high-strength steel (HSS) and advanced high-strength steel.
- Aluminum hood panel, and front and rear bumper beams for weight reduction and improved fuel economy.
- 1500 MPa inner and outer door stiffener rings.

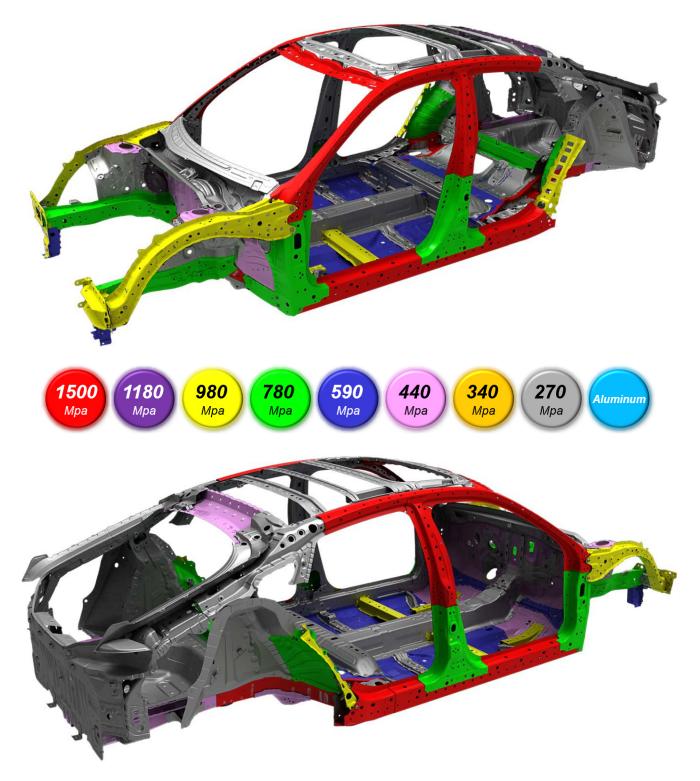
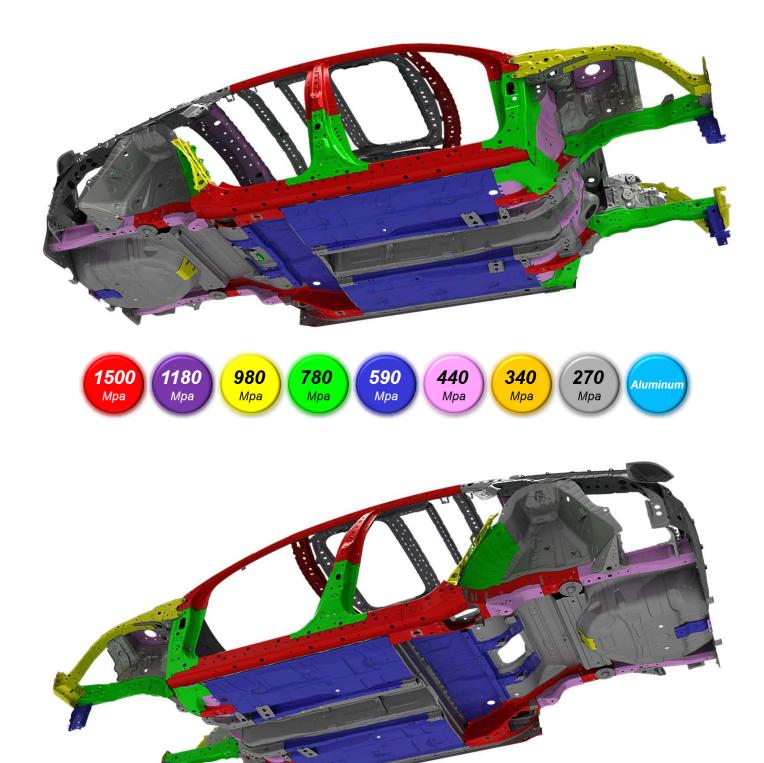
BODY CONSTRUCTION AND HIGH STRENGTH STEEL CONTENT

- Steel parts are color coded based on their tensile strength in megapascals (MPa).
- High-strength steel (HSS) is defined as any steel with a tensile strength of 340 MPa or higher.
- Ultra-high-strength steel (UHSS) is defined as any steel with a tensile strength of 980 MPa or higher.
- Steel repair and welding procedures vary depending on the tensile strength of the parts involved.

NOTE: The illustrations below are for general reference only. Some body parts are constructed from multiple layers of different tensile strength steels. Always refer to the body construction section of the BRM for specific steel tensile strength information.

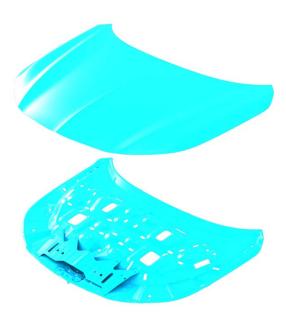
ALUMINUM PARTS & REPAIRABILITY

The hood of the 2023 Integra model series uses aluminum alloy construction. Minor damage to the aluminum hood may be repaired by body shops that have dedicated aluminum repair facilities and tools.

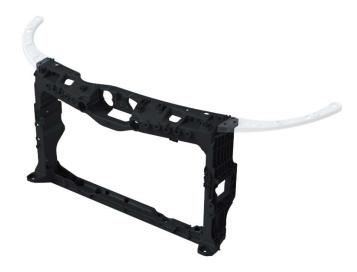
RESIN COMPOSITE FRONT BULKHEAD

This vehicle has a front bulkhead assembly constructed of resin composite material.

- The bulkhead design improves engine compartment access during factory assembly and service.
- The cooling fans, radiator, A/C condenser, hood lock, outside air temperature sensor, and related piping/components are attached to the front bulkhead.
- A damaged bulkhead must be replaced.
- For more details, refer to front bulkhead replacement in the body repair manual.

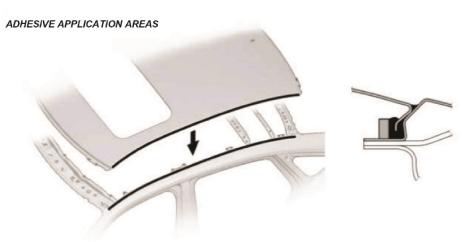
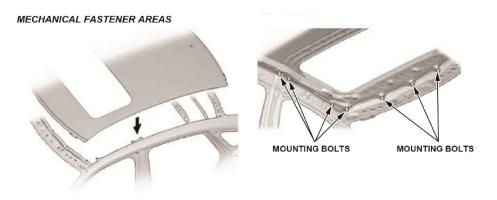
WELDING AREAS

Laser brazed roof panels require a combination of welding, and the use of adhesives and mechanical fasteners for replacement. Refer to the roof panel replacement procedure for more details.

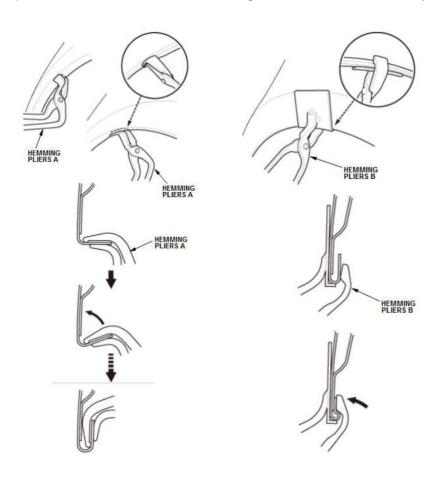
REAR WHEEL ARCH HEM JOINT

During the replacement of the rear side outer panel, it will be necessary to hem the entire wheel arch using Acura special tools or modified commercially available tools. Refer to the outer panel side area replacement procedure for additional details including information on how to modify existing hemming pliers.

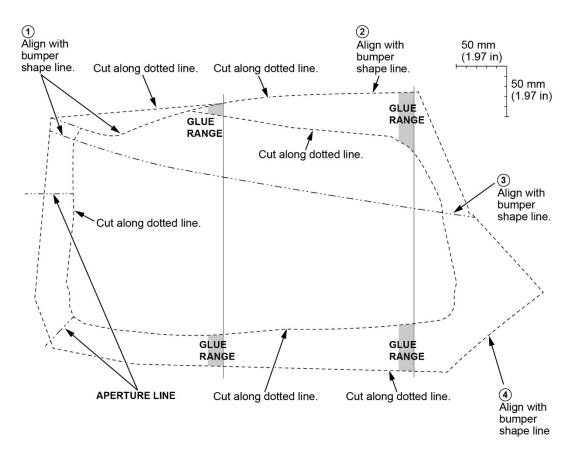
RADAR WAVE EMISSION RANGE

To assist technicians in determining where the radar wave emission area is, a printable template is provided in the body repair manual. This template can be taped onto the bumper and will help determine if the bumper can be repaired or will require replacement.

The radar waves passing through the rear bumper are more affected by the type and location of the repair. Cracks or dents within the radar wave emission range cannot be repaired and will require bumper replacement. Scratches inside or extending into the radar wave emission range will require the whole area to be painted and polished.

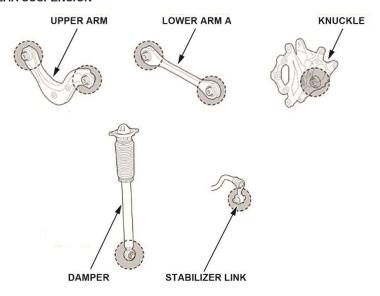
REAR SUSPENSION

In order to improve the ride, comfort, and avoid excessive twisting of the suspension bushings, the tightening of some specified suspension components must be done at the vehicle ride height with the driver seated. Depending on the bushing being tightened, the ride height can be simulated on the ground with weight in the vehicle, or the suspension component can be adjusted to ride height position.

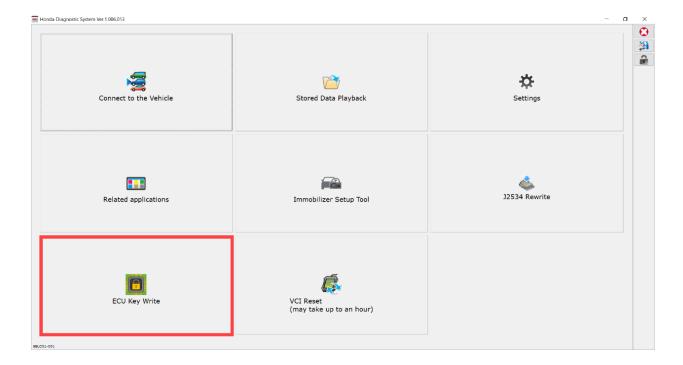
ECU KEY WRITE

When replacing control units like the VSA modulator control unit, you will need to access the **ECU Key Write** application in the i-HDS. For more information, refer to the job aid, *Using the ECU Key Write Application in the i-HDS*.
