Body Repair News

MODEL/YEAR MODÈLE / ANNÉE	DATE OF ISSUE DATE EN VIGUEUR	LETTER NUMBER NUMÉRO DE LA LETTRE
2014-15 RLX and 2014-18 RLX Sport Hybrid	DEC. 19, 2017	J-4-17

2014-15 RLX AND 2014-18 RLX SPORT HYBRID: NEW MODEL BODY REPAIR INFORMATION

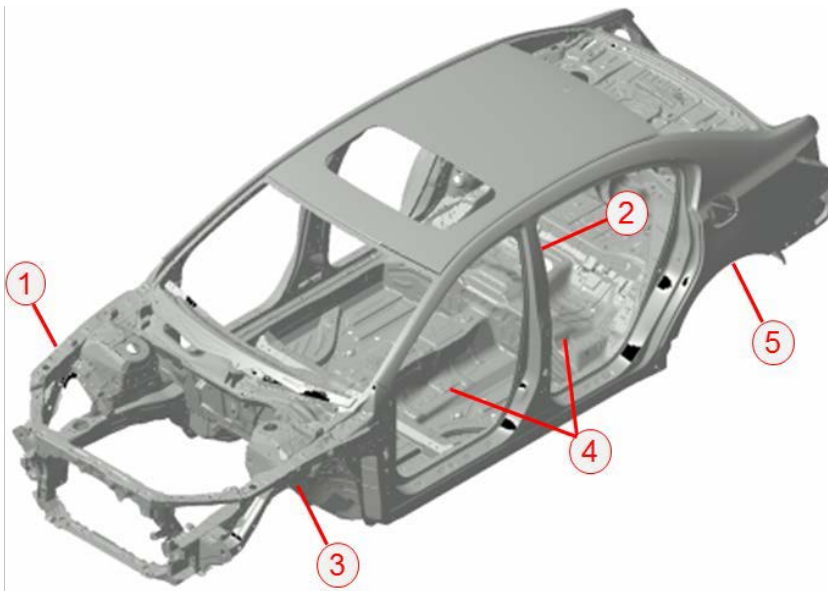
OVERVIEW OF BODY FEATURES

1. Next-Generation Advanced Compatibility Engineering™ (ACE™) body structure.
2. Body construction using 55% high tensile strength steel, including 20% in grades 780, 980, and 1,500 MPa.
3. Extensive aluminum components for weight reduction and improved fuel efficiency (not shown in this view).
4. Aluminum hybrid front and rear door construction (not shown in this view).
5. Hem-style rear wheel arch panel joint.

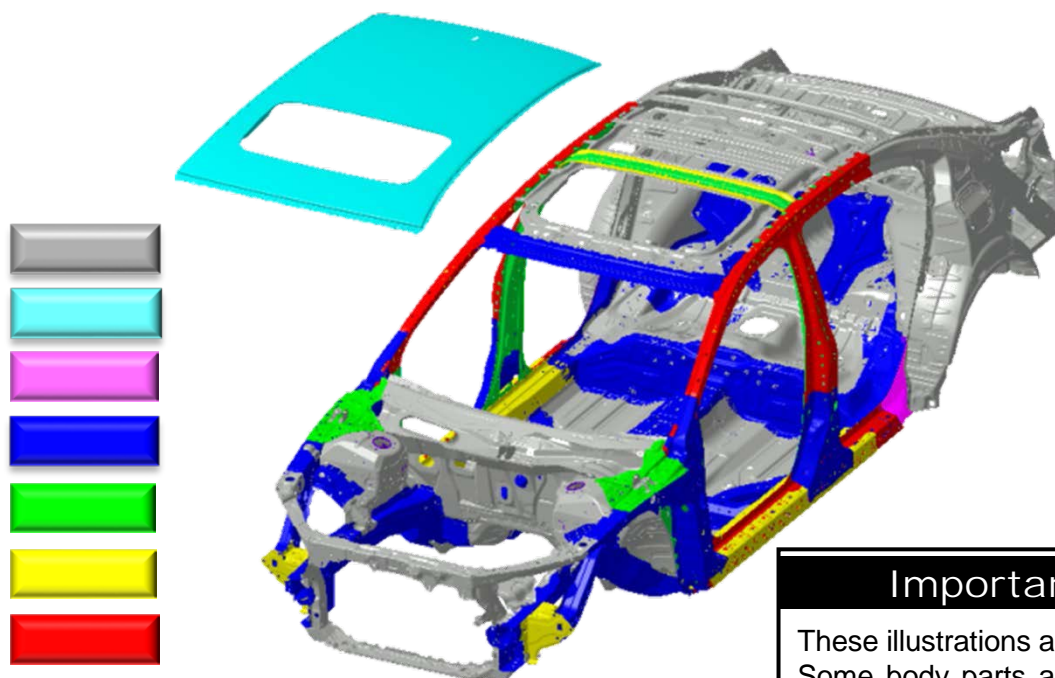
BODY CONSTRUCTION AND HIGH STRENGTH STEEL CONTENT

- Steel parts are color-coded based on their tensile strength in Megapascals (MPa).
- High strength steel is defined as any steel with a tensile strength of 340 MPa or higher.
- Steel repair and welding procedures vary depending on the tensile strength of the parts involved.

These illustrations are for general reference only. Some body parts are constructed from multiple layers of different tensile strength steels. Always refer to the body repair manual body construction section for specific steel tensile strength information.

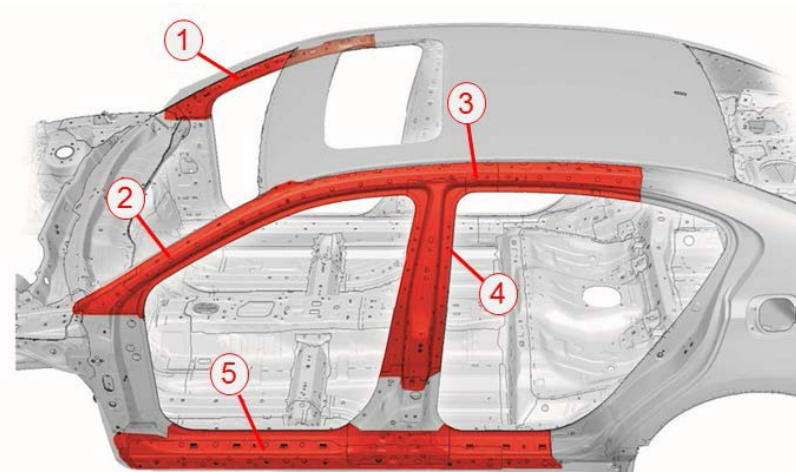
1,500 MPa (HOT STAMP) STEEL LOCATIONS

1,500 MPa steel is stronger than ordinary steel, so it can help protect vehicle occupants while reducing overall vehicle weight to improve fuel efficiency.

The numbered parts in the diagrams below are constructed of 1,500 MPa steel:

All Models	
1	Front Inner Upper Pillar
2	Front Pillar Upper Stiffener
3	Roof Side Stiffener
4	Center Pillar Upper Stiffener
5	Side Sill Stiffener

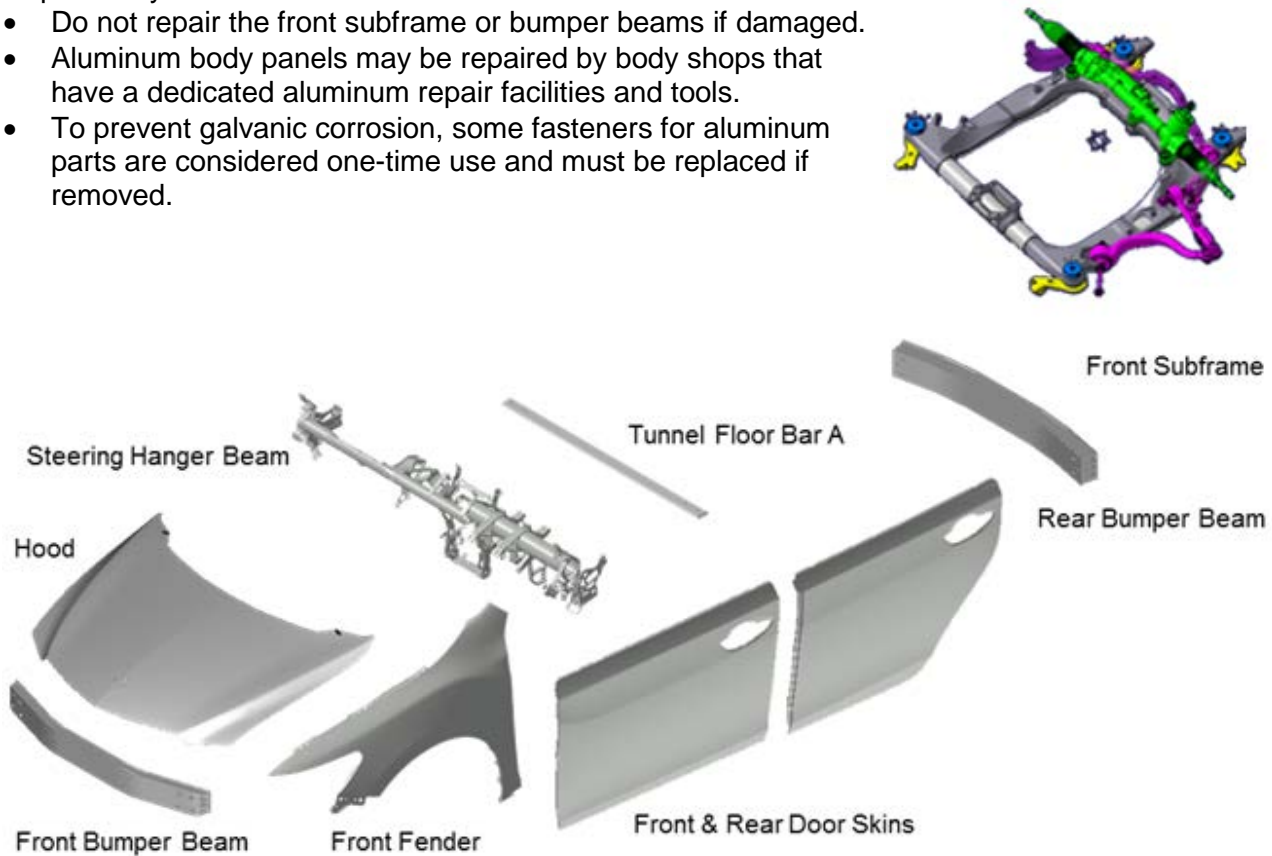
ALUMINUM PARTS & REPARABILITY

All of the parts shown below are constructed of aluminum alloy.

- Do not repair the front subframe or bumper beams if damaged.
- Aluminum body panels may be repaired by body shops that have a dedicated aluminum repair facilities and tools.
- To prevent galvanic corrosion, some fasteners for aluminum parts are considered one-time use and must be replaced if removed.

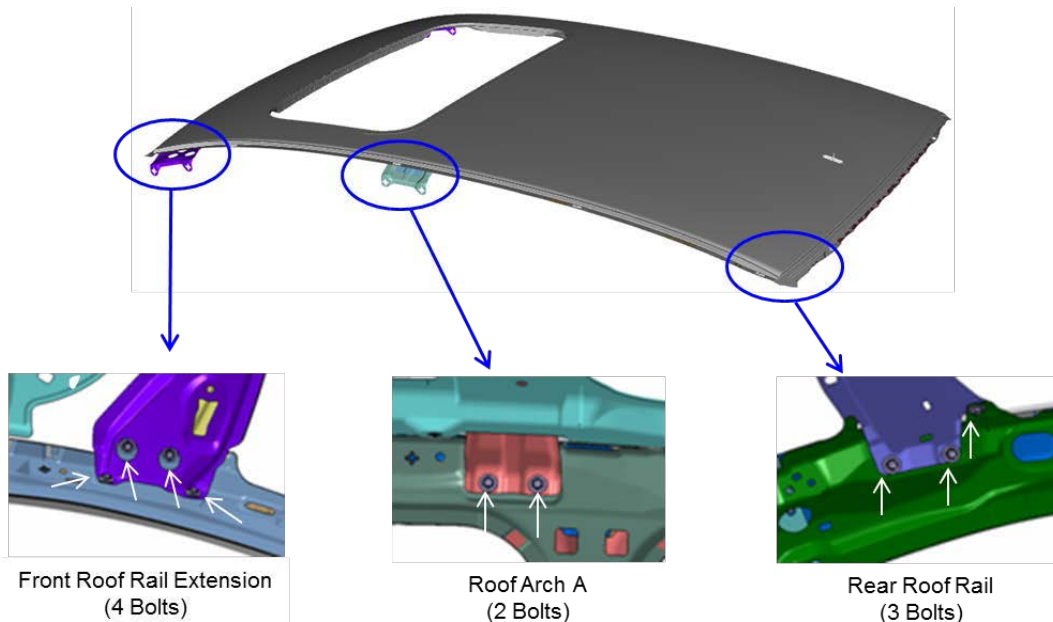
ROOF PANEL ATTACHMENT

The roof rail and roof arch extensions are integrated into the roof panel assembly. The roof panel bolts and spot welds must be removed and installed to the inner pillar and roof rail structure using a specific procedure. Refer to the body repair manual section titled "Roof Panel Removal and Installation" for complete information.

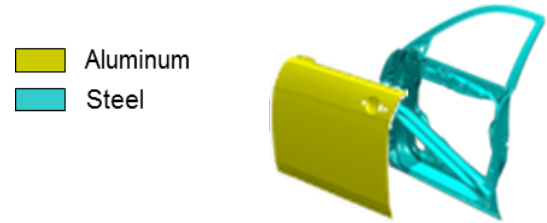
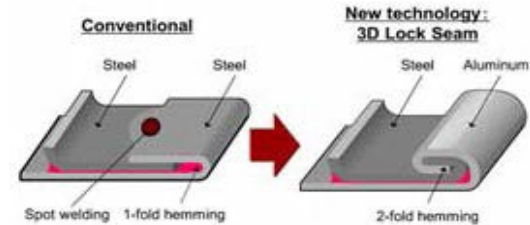
NEW DOOR STRUCTURE

The doors on this vehicle use new technology to join steel and aluminum panels.

- This is the world's first application of this technology to a door panel.
- Door panel weight is reduced by approximately 17 percent compared to all-steel doors, improving vehicle handling and fuel economy.
- The inner door panel is a conventional steel structure.
- The outer door panel is made of aluminum alloy.

The two panels are joined using adhesive and a special "3D lock seam" joint.

- The outer door panels are not serviced separately.
- Minor damage to aluminum door panels may be repaired by body shops that have a dedicated aluminum repair facility and tools.
- Major damage to the aluminum door panels may require door replacement.

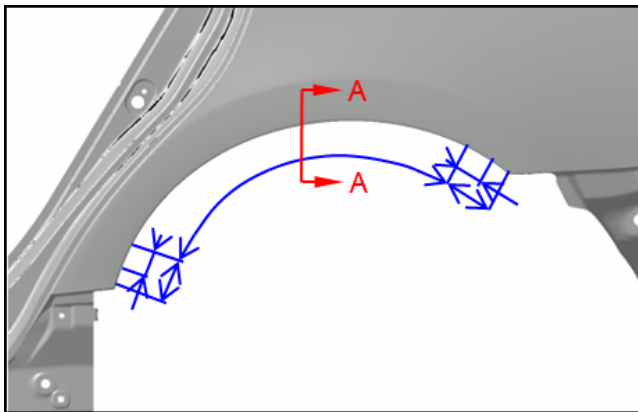
Rear Wheel Arch Hem Joint Area

To improve styling and tire clearance, a hemmed rear wheel arch joint is used.

- The outer and inner rear panels are joined using adhesive in the wheel opening area.
- The outer panel is then rolled and crimped over the inner panel, similar to a door panel crimp.
- Other vehicle manufacturers have previously used this technology, so rolling and flanging tools are commercially available.
- If the above tools are not available, instructions are provided in the body repair manual to make the set of hemming pliers necessary to complete this joint.
- Refer to the body repair manual section titled "Rear Side Outer Panel Removal and Installation" for complete information.

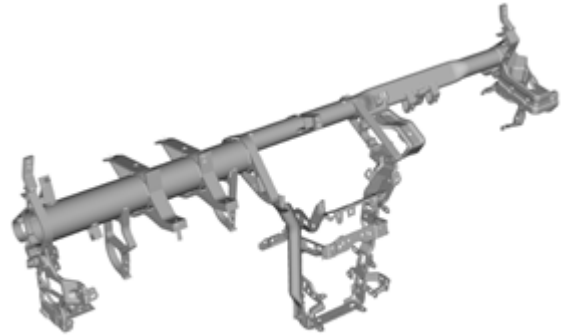
Aluminum Steering Hanger Beam

The steering hanger beam provides mounting for the steering column and dashboard components.

- The beam is constructed from aluminum for weight savings.
- Do not repair the steering hanger beam if it is damaged.
- Special threaded collar bolts are used on the passenger side of the beam to compensate for any variation in body dimensions.
- A specific installation and bolt tightening procedure is required.
- Refer to “Dashboard/Steering Hanger Beam Removal and Installation” in the service manual for complete information.

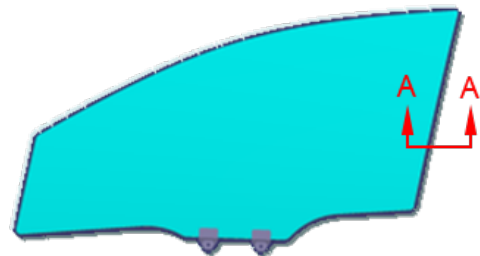
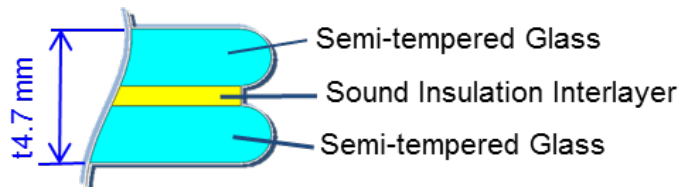
Section A-A Comparison Of Conventional & Acoustic Side Door Glass

Acoustic front side door glass is used for sound isolation on some trim levels.

- The glass has a sound insulation layer of PVB (polyvinyl butyral) sandwiched between two layers of semi-tempered glass.
- Acoustic side glass is thinner than conventional side glass.
- This type of glass is similar to laminated windshield glass. It does not shatter like conventional side window glass.
- To ensure the correct replacement glass is installed, provide the vehicle's VIN when ordering parts.

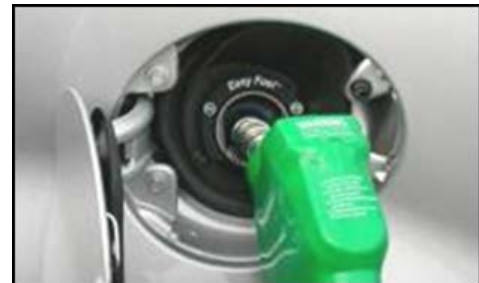
Capless Fuel Filler

This vehicle uses a capless fuel filler design. It does not have a conventional gas cap.

- If you need to refuel the vehicle from a portable fuel container, a funnel is provided in the trunk tool case.
- For more information, refer to “Refueling From a Portable Fuel Container” in the owner's manual.

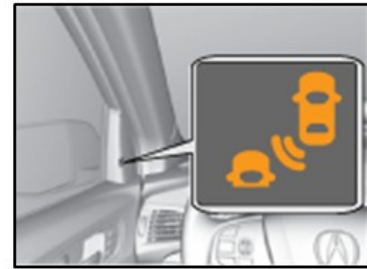
BSI Alert Indicator

Models equipped with this system can be identified by this BSI Alert Indicator, located on both front doors near the outside rearview mirror.

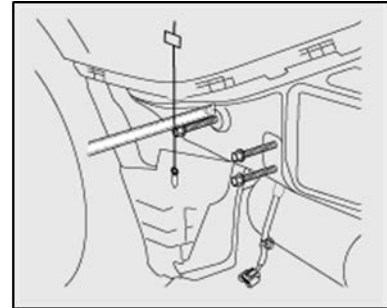
LH BSI Unit Mounting Area Check

- The system uses two radar units mounted on each side of the vehicle under the rear bumper.
- The system may malfunction and set DTCs because of damage, improper repairs, or excessive foreign material on any of the following:
 - Rear bumper
 - Outer side panels
 - Radar unit mounting locations
- Several checks and inspections must be done during repairs to the radar unit mounting area. If the mounting area check is not done, an Acura dealer may not be able to properly aim the radar units.
- For more information, refer to “BSI Radar Unit Mounting Area Check” in the service manual.

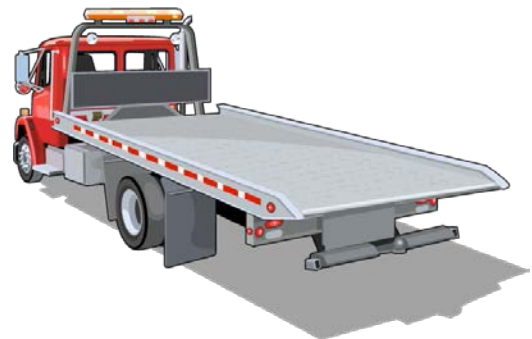
TOWING AND LIFTING PRECAUTIONS

- All models must be towed using flatbed towing equipment only, or the vehicle's drive system will be damaged.
- Do not lift or tow this vehicle by its bumpers, or serious damage will result.
- For more information, refer to “Lift and Support Points” in the appropriate service or body repair manual.

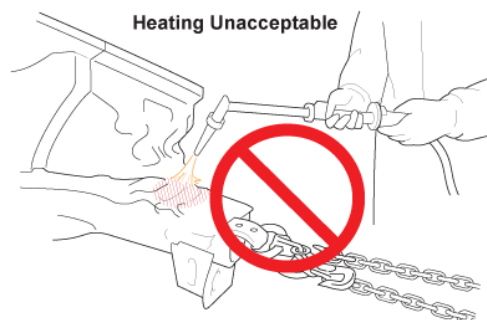
- DO NOT apply heat to any body part during straightening. This may compromise the internal structure and strength of high-strength steel parts.
- Any part that has heat applied to it during straightening MUST be replaced with new parts.
- Ignoring these instructions may significantly reduce occupant protection in any subsequent collision.

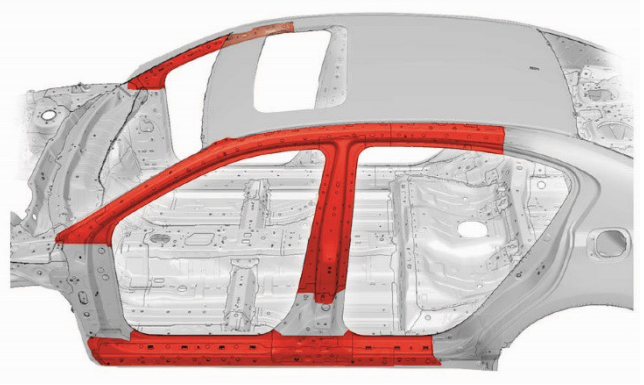
- NEVER perform MAG welding on 1,500 MPa steel. The heat generated during welding will significantly reduce the strength and structural integrity of 1,500 MPa steel parts.
- This photo shows tensile test results of welded 1,500 MPa steel. The 1,500 MPa steel fractured first, because the welding heat reduced its strength to far below 590 MPa.
- For more information, refer to "Hot Stamp (1,500 MPa) Parts Welding Specifications" in the body repair manual.

- NEVER attempt to straighten damaged 1,500 MPa steel parts because they may crack.
- 1,500 MPa steel parts MUST be replaced at factory seams using squeeze-type resistance spot welding (STRSW).
- MIG brazed joints should be used ONLY in locations not accessible by a spot welder.
- To assure adequate weld tensile strength, always set the spot welder to the specifications provided in the body repair manual.

Parts made of Ultra High Strength Steel (UHSS/1,500MPa/ USIBOR) must be installed as a complete part. No sectioning allowed. Ultra High Strength Steel requires special welding equipment, procedures, and settings. See the welding section of the appropriate body repair manual. Failure to use the proper equipment or follow the proper procedures can result in an unsafe repair.

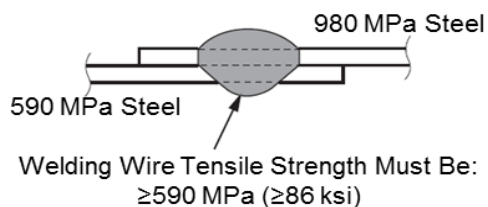
MAG Plug Welds

- The welding wire used must have a tensile strength equal to, or greater than, the lowest tensile strength of the parts being welded. This conversion chart shows the relationship of steel tensile strength (MPa) to the minimum welding wire tensile strength (ksi).
- Typical ER70S-6 MIG wire has a minimum tensile strength of 70 ksi (483 MPa). It can be used when welding up to 440 MPa steel parts. Refer to the diagrams shown below:

- MAG plug welding may be done when joining body components to 590-980 MPa steel parts.
- Follow the recommendations described in the body repair manual section "MAG welding specifications for high-strength steel parts 590 MPa and higher."

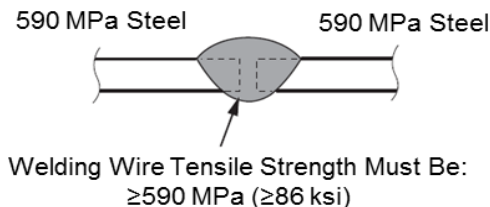
MAG Butt Welds

- MAG butt welding may be done only on steel parts with a tensile strength of 780 MPa and lower.
- Welding speed is critical to achieve the correct weld strength and minimize the heat affected zone (HAZ).
- Follow the recommendations described in the body repair manual section "MAG welding specifications for high-strength steel parts 590 MPa and higher."

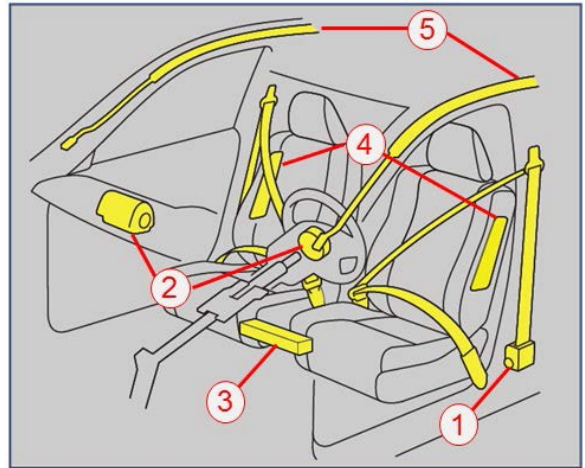
AIRBAG SYSTEM COMPONENTS

The airbag system in this vehicle includes the following components that may deploy in a collision:

1. Driver and front passenger seat belt tensioners (may deploy independently from any airbags).
2. Driver and front passenger SRS airbags.
3. Driver's knee SRS airbag.
4. Side airbags mounted in the outer driver and front passenger seat-backs.
5. Left-and-right-side curtain airbags mounted above the side windows under the headliner.

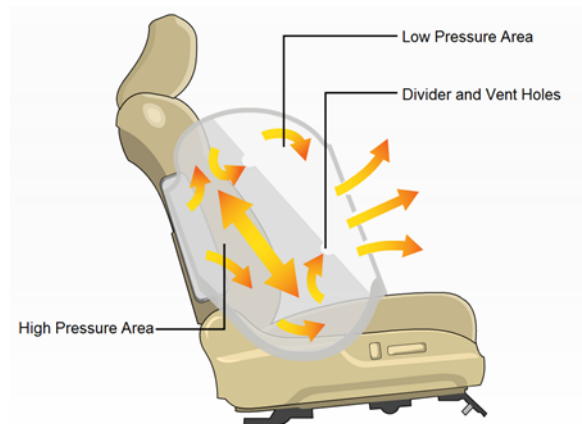
SmartVent Side Airbag

This vehicle is equipped with SmartVent side airbag construction:

- This airbag design helps mitigate the risk of excessive airbag deployment force and risk of injury to smaller front passenger seat occupants.
- Eliminates the need for the Occupant Position Detection System (OPDS) sensor located in the front passenger's seatback.

- Special seat covers and/or breakaway thread are used to ensure proper deployment path.
- Damaged front seat covers should be replaced, not repaired.
- Do not install non-factory seat covers, because they may alter the airbag's intended deployment path.

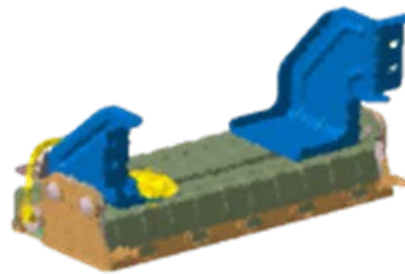
Driver's Knee Airbag

The driver's knee SRS airbag helps keep the driver in the proper position and to help maximize the benefit provided by the vehicle's other safety features.

- The driver's knee SRS airbag is mounted to the steering hanger beam below the steering column.
- It is designed to inflate in a moderate to severe frontal collision.
- Normally, it inflates with the driver's front airbag, but may also inflate alone under certain conditions.

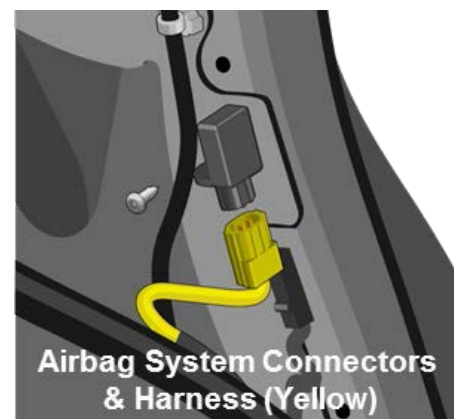
Airbag System Connectors & Harness (Yellow)

- For easier identification, electrical connectors that contain only airbag system wiring are yellow in color.
- Many harnesses that contain primarily airbag wiring are also wrapped in yellow tape.
- Airbag system wiring that runs through a common harness, such as a floor harness, is generally not marked.
- NEVER attempt to modify, splice, or repair airbag system wiring. If airbag system wiring is damaged, replace the wiring harness(es).

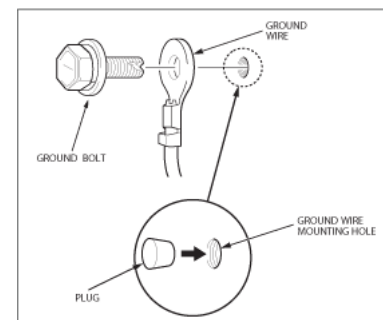
ELECTRICAL GROUND WIRE PROTECTION

- Painting over electrical ground locations may cause electrical systems, such as Vehicle Stability Assist (VSA), to malfunction and set DTCs that may be difficult to diagnose.
- Protect the ground wire and the ground wire mounting hole threads with a bolt or plug when priming or painting.

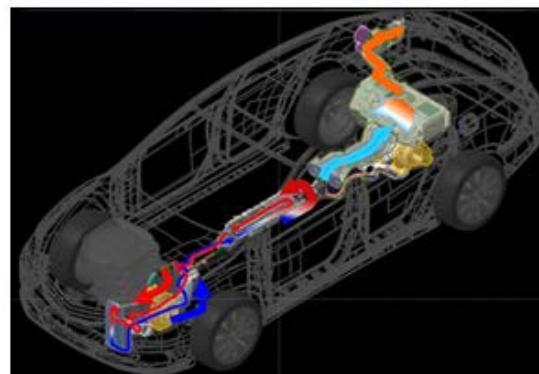
Electric Power Plant (EPP) Cooling System

- Separate engine and electric power plant (EPP) cooling systems.
- Several electric coolant pumps are used to circulate coolant when the gasoline engine is not running.
- Special coolant fill procedures are required during component replacement.

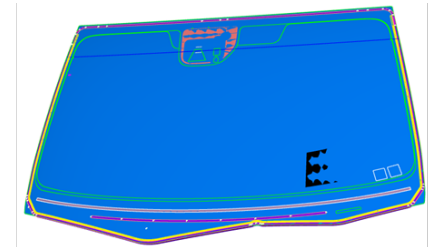
Head-Up Display Windshield

A head-up display system provides the driver an expanded view of vehicle operating parameters projected onto the windshield.

- The windshield is specially designed to correctly project the HUD image and must be replaced with a HUD windshield.
- If an incorrect windshield is installed, the HUD display will appear as a “double image”.
- There is no visual difference between a HUD and non-HUD windshield.
- Aftermarket replacement windshields may also cause abnormal HUD display appearance.
- To ensure the correct replacement windshield is installed, provide the vehicle’s VIN when ordering parts.

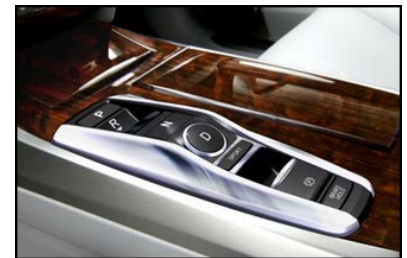
Electronic Gear Selector

To enter car wash mode:

- Push and hold the neutral button for more than 5 seconds.
- While continuing to hold the neutral button, push the Engine Start/Stop button.
- The vehicle will now remain in neutral with the ignition in the accessory position.

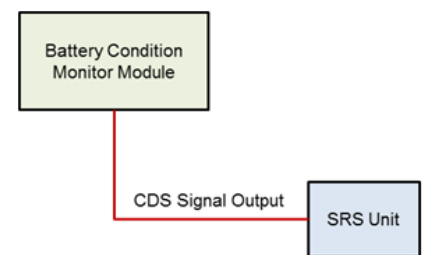
Collision Power Shutdown System Diagram

- When the SRS unit detects a collision, it sends collision information to the battery condition monitor module via a hardwired crash detection signal (CDS) output.
- If the battery condition monitor module judges that the CDS signal meets a programmed threshold, the high voltage contactors are shut off for safety and a DTC (P1D65) is set.
- Check the high-voltage battery and cables for damage and replace any damaged components.
- After repairs are completed, the vehicle will not restart until the DTC has been cleared using the HDS (or equivalent) scan tool.

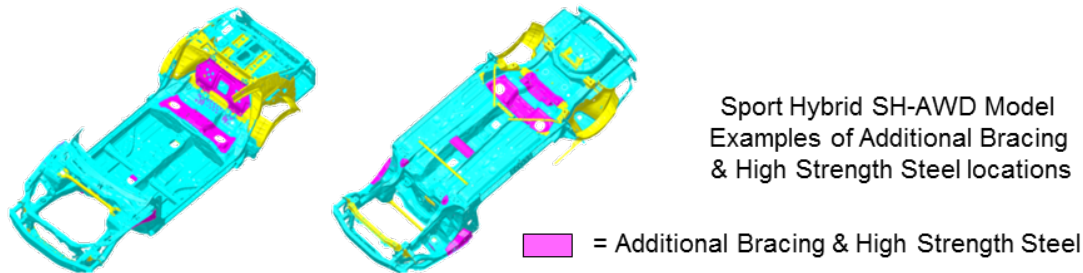
ADDITIONAL BRACING AND HIGH STRENGTH STEEL LOCATIONS

- The body includes additional bolt-in braces to accommodate the high voltage battery and drive components.
- The front pillar, center pillar, and front floor assemblies contain additional 590 and 980 MPa stiffeners.
- Always refer to the correct parts catalog when ordering replacement structural parts.

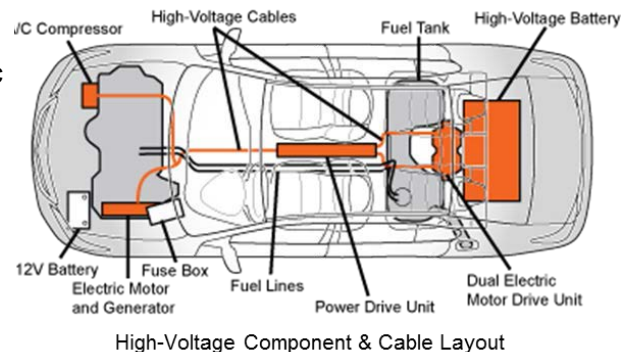
ELECTRIC POWERTRAIN SYSTEM

The electric powertrain system uses a lithium-ion battery and intelligent power unit (IPU), located behind the rear seat. High voltage circuits route power to the engine compartment. The high voltage system operates at up to approximately 260 volts.

- High voltage is identified using bright orange colored cables and coverings.
- A damaged high-voltage lithium-ion battery can emit toxic fumes, and the organic solvent used as electrolyte is flammable and corrosive. Always wear protective equipment.
- High temperatures may damage the high voltage battery module.
- For example, when drying paint in a heated paint booth, the temperature must not exceed 150 °F (65 °C).

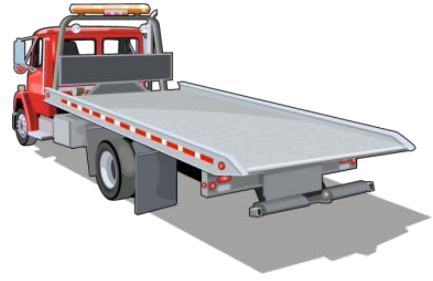
ADDITIONAL SPORT HYBRID SH-AWD TOWING AND LIFTING PRECAUTIONS

- When rolling a damaged Sport Hybrid SH-AWD model with any of the wheels on the ground, the electric motor can produce electricity and remains a potential source of electric shock even when the high voltage system is turned off.
- Sport Hybrid SH-AWD models do not have a manual switch to disable the system. Whenever service work requires spinning the front or rear wheels with the engine, always lift and support the vehicle so all four wheels are off the ground.
- For more information, refer to “Emergency Towing” in the owner’s manual.
