2023 CR-V and CR-V Hybrid Model Series: New Body Repair Information

2023 CR-V and CR-V Hybrid Model Series

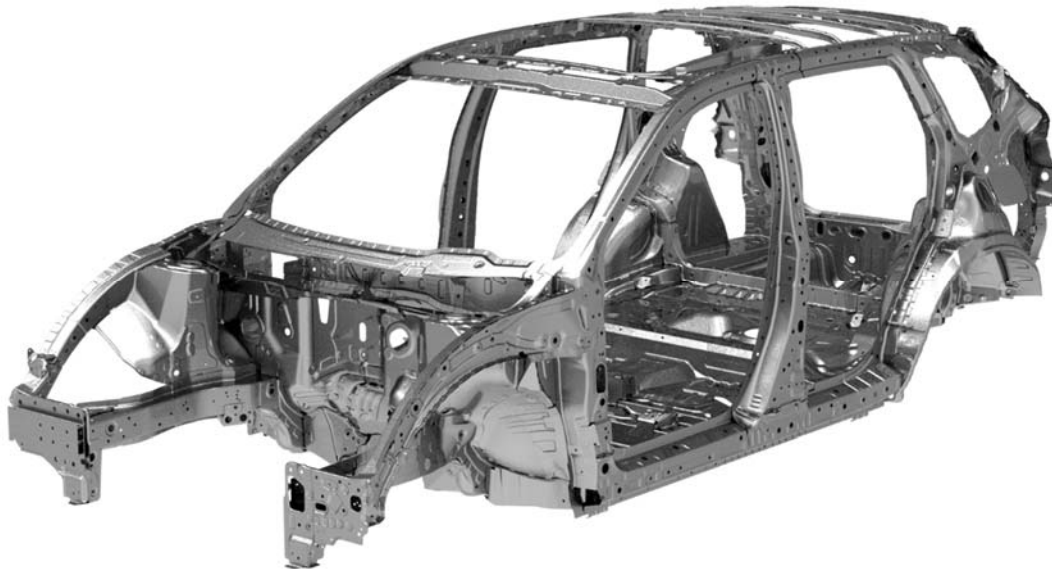
OVERVIEW OF BODY FEATURES

- Next-Generation Advanced Compatibility Engineering™ (ACE™) body structure.
- Body construction using high-strength steel (HSS) and advanced high-strength steel.
- Weight-saving 1,500 MPa rear frame rails with soft zones for crash performance that may be sectioned in specified areas during collision repairs.
- The front bulkhead assembly is made of a composite resin.

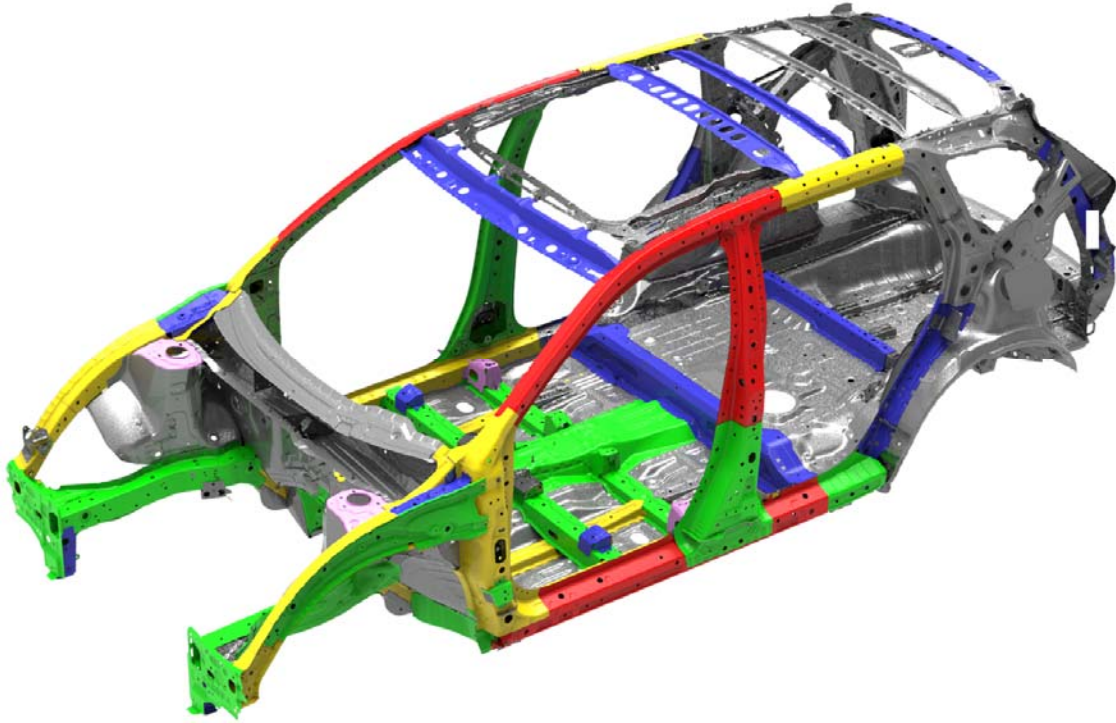
BODY CONSTRUCTION AND HIGH STRENGTH STEEL CONTENT

- High-strength steel (HSS) is defined as any steel with a tensile strength of **340 MPa** or higher.
- Ultra-high-strength steel (UHSS) is defined as any steel with a tensile strength of **980 MPa** or higher.
- Steel repair and welding procedures vary depending on the tensile strength of the parts involved.
- Steel parts are color-coded based on their tensile strength in megapascals (MPa).

NOTE: Some body parts are constructed from multiple layers of different tensile strength steels.
Always refer to the body construction section of the BRM for specific steel tensile strength information.

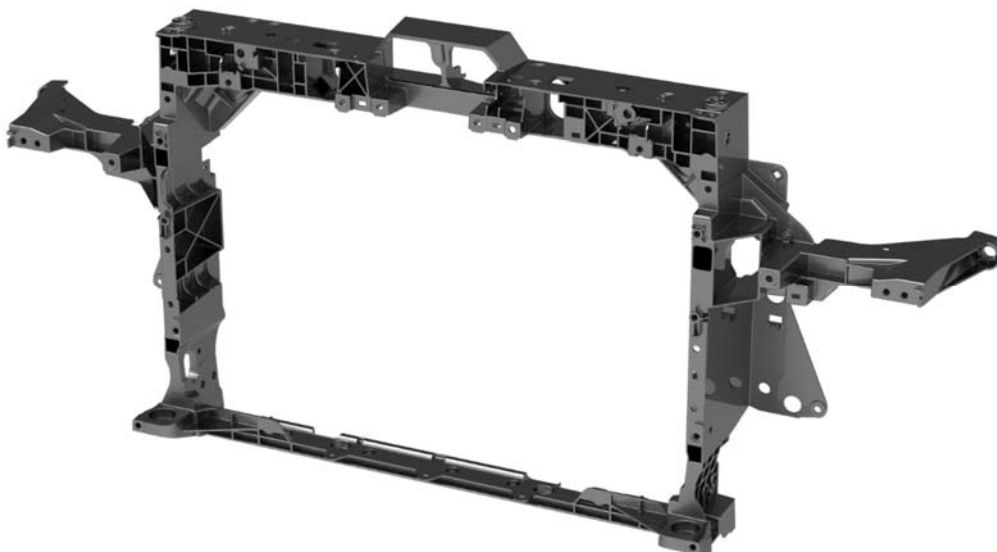
RESIN COMPOSITE FRONT BULKHEAD

This vehicle has a front bulkhead assembly constructed of resin composite material.

- The bulkhead design improves engine compartment access during factory assembly and service.
- The cooling fans, radiator, A/C condenser, hood lock, outside air temperature sensor, and related piping/components are attached to the front bulkhead.
- A damaged bulkhead must be replaced.
- For more details, refer to front bulkhead replacement in the body repair manual.

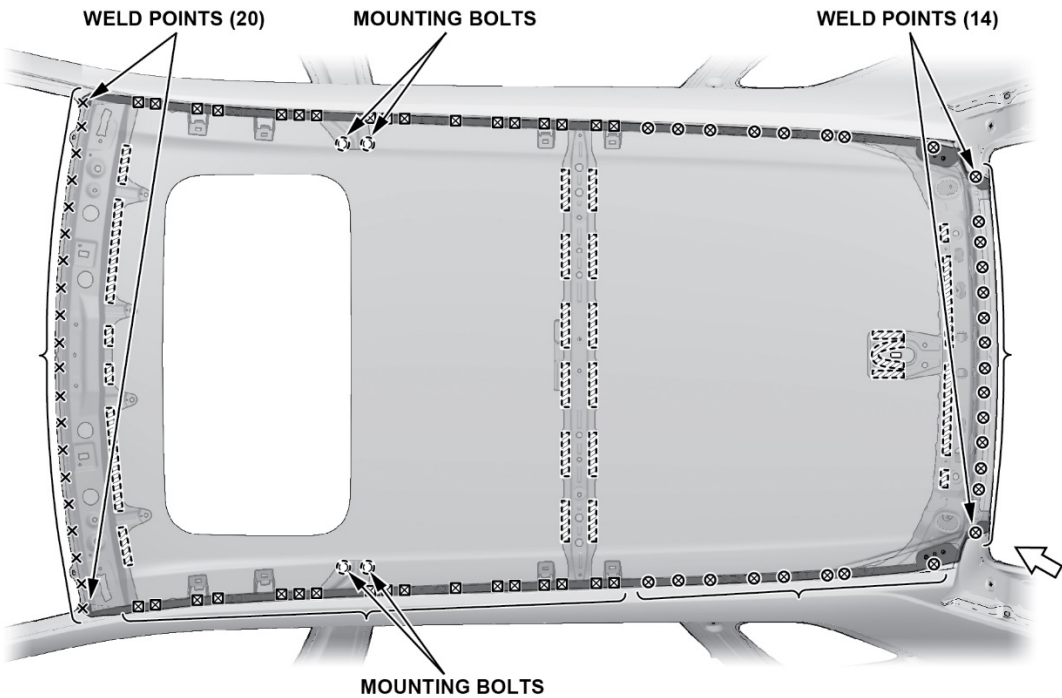
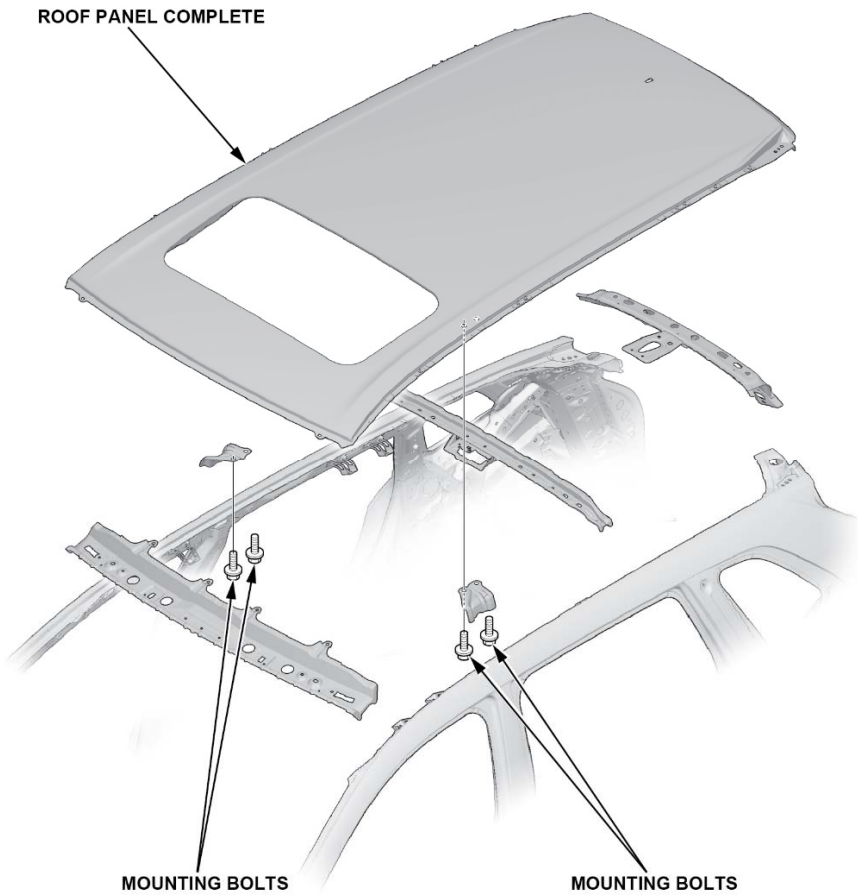
LASER-BRAZED ROOF PANEL

Laser brazed roof panels require a combination of welding, and the use of adhesives and mechanical fasteners for replacement. Refer to the Roof Panel Replacement procedure for more details.

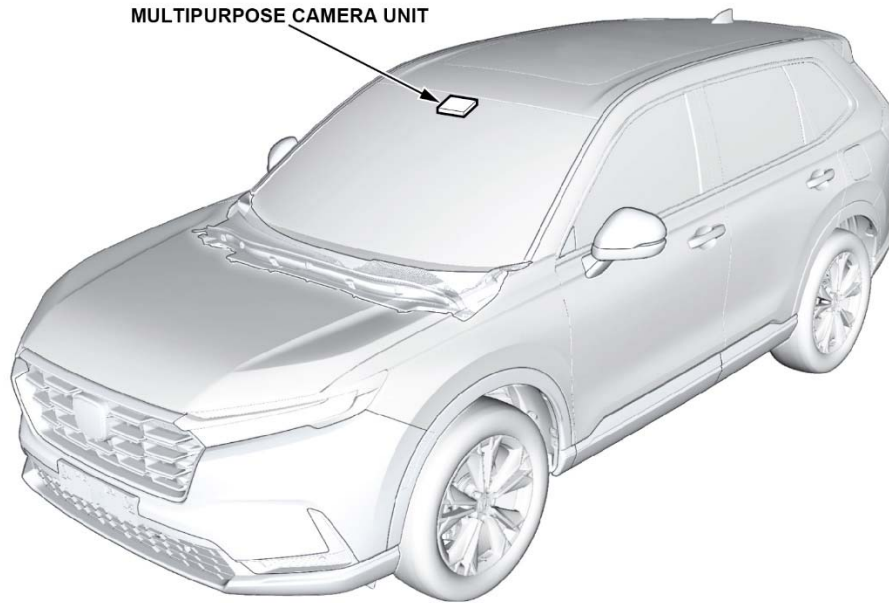
Multipurpose Camera Aiming

The 2023 CR-V model series is equipped with a multipurpose camera unit and millimeter wave radar. The multipurpose camera allows both dynamic and static aiming. Technicians now have the option to do either type of aiming depending on what their repair facility allows, or weather and traffic conditions.

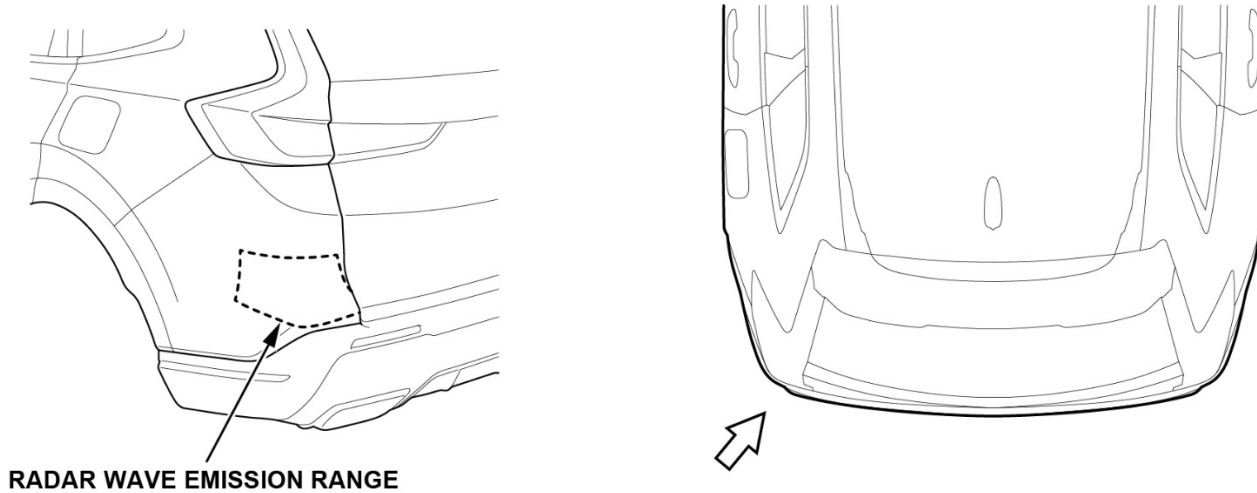
Blind spot Information (BSI) Rear Bumper Repair Templates

The 2023 CR-V model series Blind Spot Information radar units behind the rear bumper extend the detection range of previous systems but require extra consideration when repairing the rear bumper.

The radar waves passing through the rear bumper are more affected by the type and location of the repair. Cracks or dents within the radar wave emission range cannot be repaired and will require bumper replacement. Scratches inside or extending into the radar wave emission range will require the whole area to be painted and polished.

To assist technicians in determining where the radar wave emission area is, a printable template is provided in the body repair manual. This template can be taped onto the bumper and will help determine if the bumper can be repaired or will require replacement.

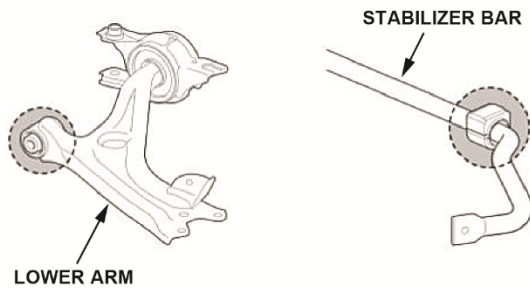
FRONT SUSPENSION

To improve ride comfort and avoid excessive twisting of the suspension bushings, the tightening of some specified suspension components must be done close to vehicle ride height with the driver seat. Depending on the bushing being tightened, the ride height can be simulated on the ground with weight in the vehicle, or the suspension component can be adjusted to ride height position.

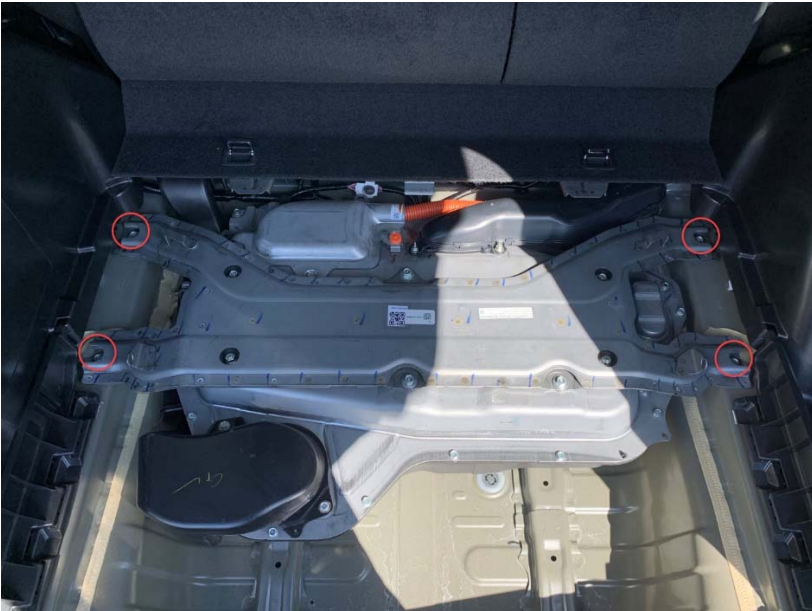
The four bolts shown below are the mounting bolts for the IPU and also act as a body ground.

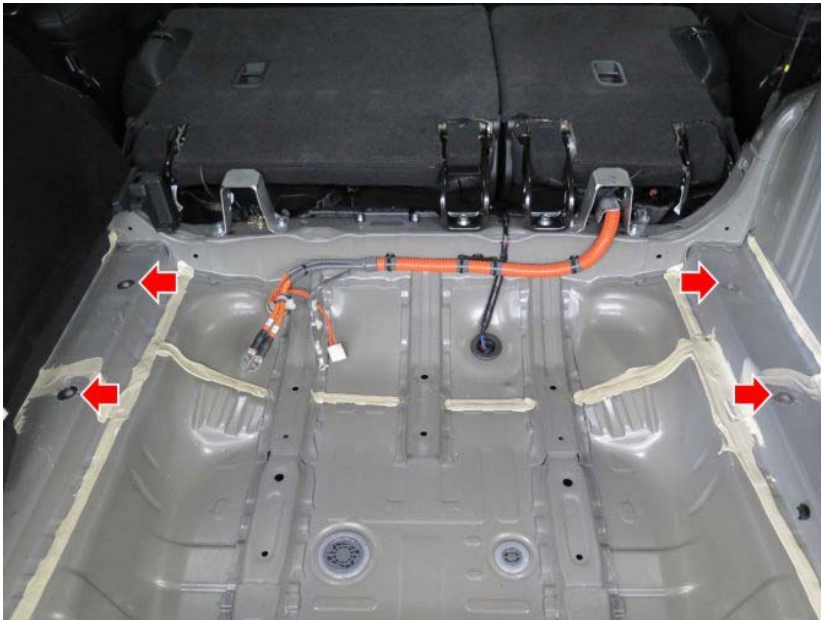
NOTE: When doing repairs in this area (rear upper frame, upper stiffener), do not primer or paint the areas indicated below. In addition, make sure those areas are free of corrosion.

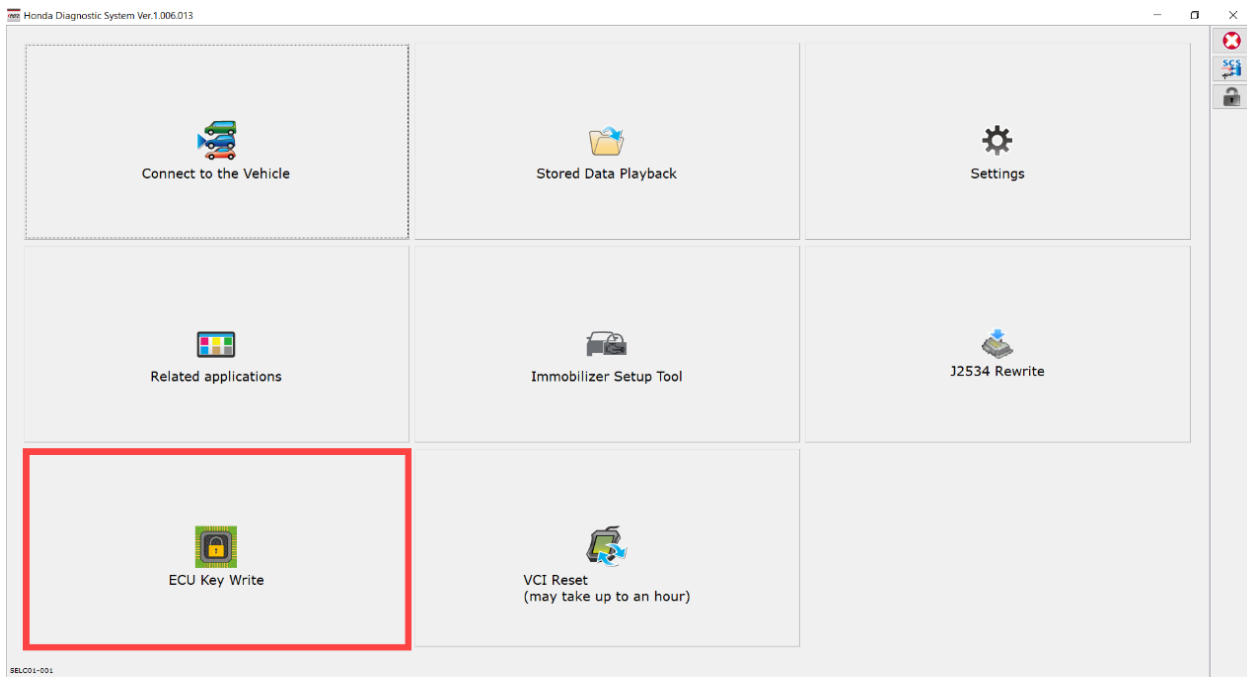
ECU KEY WRITE

A security key code protocol is being introduced for certain electronic control units (ECUs). This protocol provides secured communication between control units, helping to prevent cyberattacks from outside sources.

When replacing control units like the VSA modulator control unit, you will need to access the **ECU Key Write** application in the i-HDS. For more information, refer to the job aid, *Using the ECU Key Write Application in the i-HDS*.
