MODEL/YEAR MODÈLE /ANNÉE	DATE OF ISSUE DATE EN VIGUEUR	BULLETIN NUMBER NUMÉRO DU BULLETIN
2013-2015 RDX	AUG. 22, 2014	BRN-14-4

## 2013-2015 RDX: New Model Body Repair Information

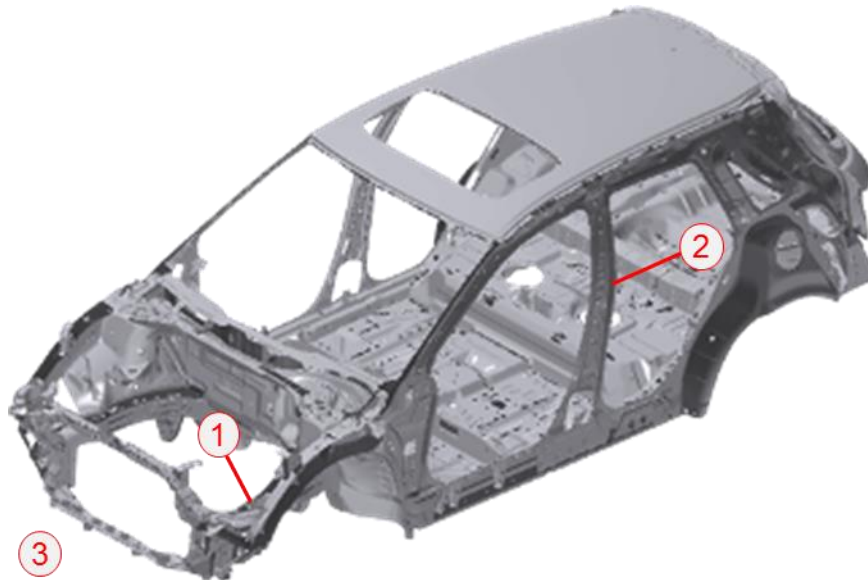
1. Advanced Compatibility Engineering™ (ACE™) body structure.
2. Body construction using 56% high tensile strength steel, including 25% in grades 780, and 1,500 MPa.
3. Aluminum hood panel and front bumper beam for weight reduction and improved fuel efficiency (not shown in this view).

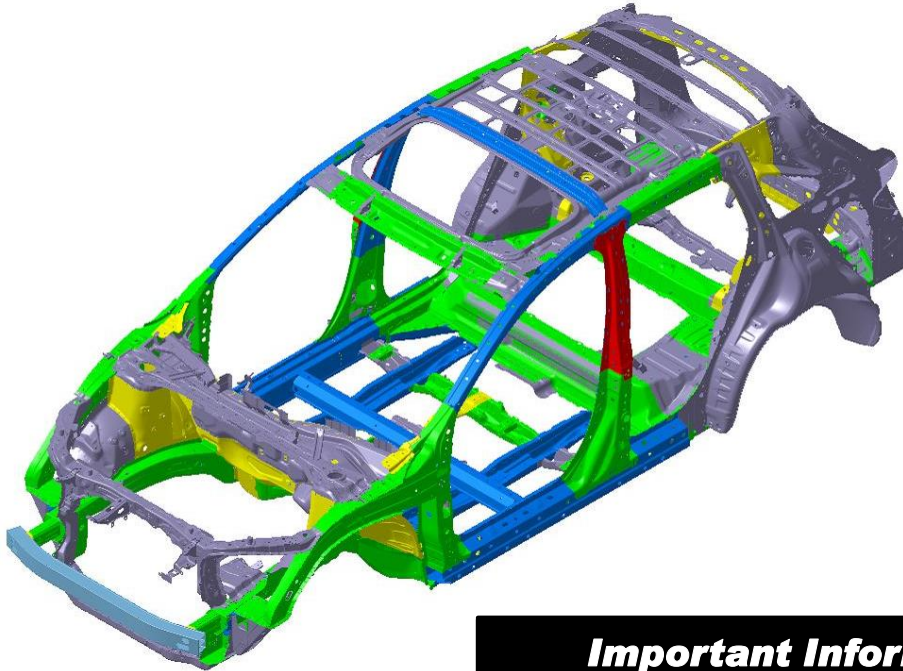
Steel Tensile Strength Legend

- Steel parts are color-coded based on their tensile strength in megapascals (MPa).
- High strength steel is defined as any steel with a tensile strength of 340 MPa or higher.
- Steel repair and welding procedures vary depending on the tensile strength of the parts involved.
- The door and rear bumper reinforcement beams are also made from high-strength steel.

270 MPa
440 MPa
590 MPa
780 MPa
1,500 MPa

These illustrations are for general reference only. Some body parts are constructed from multiple layers of different tensile strength steels. Always refer to the body repair manual body construction section for specific steel tensile strength information.

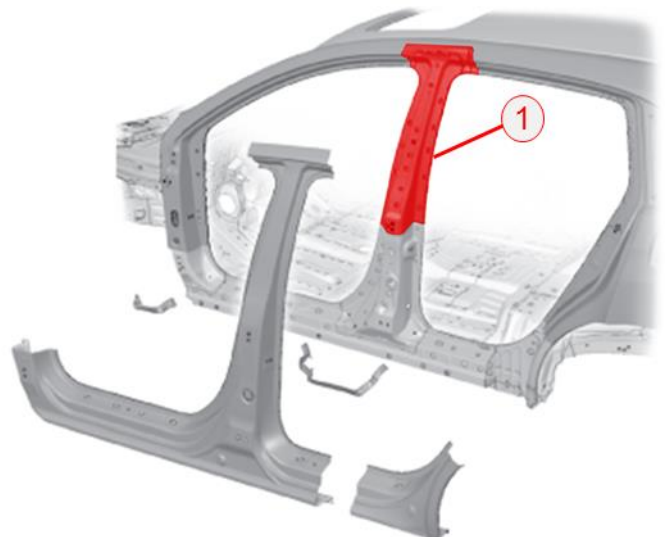
The numbered part in the diagram shown here is constructed of 1,500 MPa steel:

All Models	
1	Center Pillar Upper Stiffener (Both Sides)

1,500 MPa steel is stronger than ordinary steel, so it can help protect vehicle occupants while reducing overall vehicle weight to improve fuel efficiency.

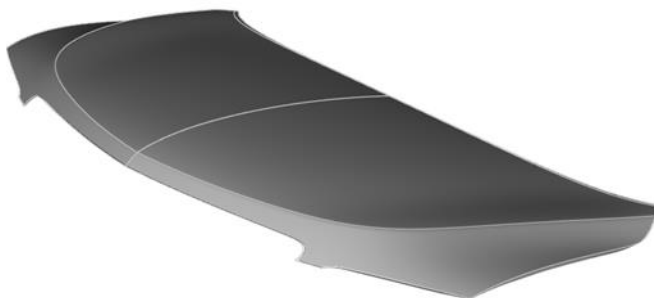
The hood panel and front bumper beam are constructed of aluminum alloy.

Hood Panel

Front Bumper Beam

- Do not repair damaged bumper beams.
- The aluminum hood may be repaired by body shops that have a dedicated aluminum repair facility and separate tools.
- To prevent galvanic corrosion, some fasteners for aluminum parts are considered one-time use and must be replaced if removed. Refer to the service or body repair manual for more information.

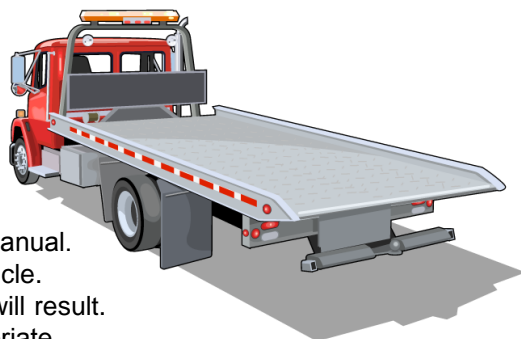
- Lift or jack only at the specified points to avoid damaging the vehicle.
- Do not lift or tow this vehicle by its bumpers, or serious damage will result.

For more information, refer to “Lift and Support Points” in the appropriate service or body repair manual.

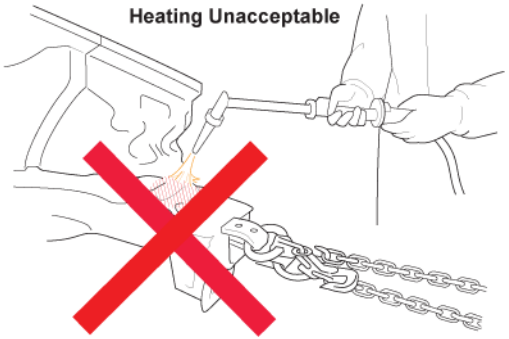
- DO NOT apply heat to any body part during straightening. This may compromise the internal structure and strength of high-strength steel parts.
- Any part that has heat applied to it during straightening MUST be replaced with new parts.
- Ignoring these instructions may significantly reduce occupant protection in any subsequent collision.

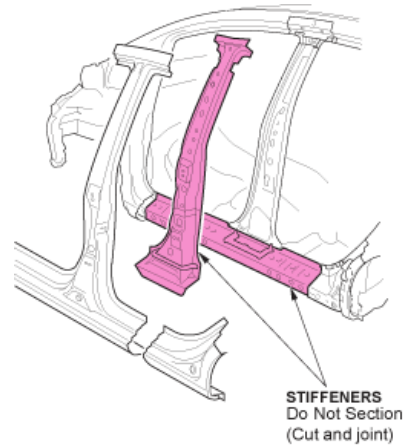
- Avoid sectioning (cut and joint) except for outer panels and floor panels unless a specific procedure is provided in the body repair manual.
- Replace body structural components as assemblies that match the replacement parts configuration.
- Refer to "Front Side Frame and Rear Frame Cutting and Splicing" in the body repair manual for sectioning opportunities.

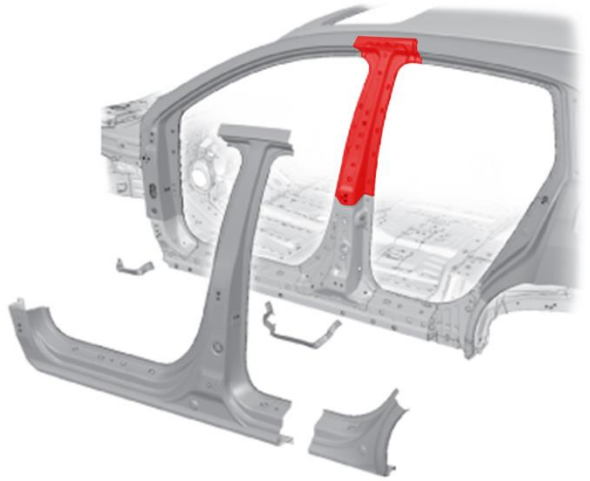
- NEVER attempt to straighten damaged 1,500 MPa steel parts because they may crack.
- 1,500 MPa steel parts MUST be replaced at factory seams using squeeze-type resistance spot welding (STRSW).
- MIG brazed joints should be used ONLY in locations not accessible by a spot welder.
- To assure adequate weld tensile strength, always set the spot welder to the specifications provided in the body repair manual.

Parts made of Ultra High Strength Steel (UHSS/1,500MPa/ USIBOR) must be installed as a complete part. No sectioning allowed. Ultra High Strength Steel requires special welding equipment, procedures, and settings. See the welding section of the appropriate body repair manual. Failure to use the proper equipment or follow the proper procedures can result in an unsafe repair.

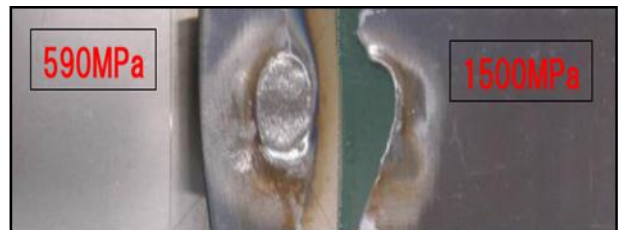
Tensile Test Results of Welded 1,500 MPa Steel

- NEVER perform MAG welding on 1,500 MPa steel. The heat generated during welding will significantly reduce the strength and structural integrity of 1,500 MPa steel parts.
- This photo shows tensile strength test results of welded 1,500 MPa steel. The 1,500 MPa steel fractured first, because the welding heat reduced its strength to far below 590 MPa.
- For more information, refer to “Hot Stamp (1,500 MPa) Parts Welding Specifications” in the body repair manual.

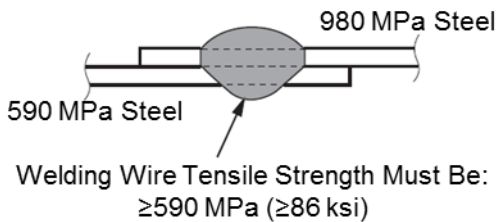
#### MAG Plug Welds

- The welding wire used must have a tensile strength equal to, or greater than, the lowest tensile strength of the parts being welded. This conversion chart shows the relationship of steel tensile strength (MPa) to the minimum welding wire tensile strength (ksi).
- Typical ER70S-6 MIG wire has a minimum tensile strength of 70 ksi (483 MPa). It can be used when welding up to 440 MPa steel parts. Refer to the diagrams shown below:

Steel Tensile (MPa)	Wire Tensile (ksi)
590	≥86
780	≥113
980	≥142

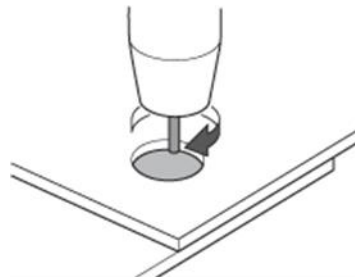
MAG Plug Welding

- MAG plug welding may be done when joining body components to 590-980 MPa steel parts.
- Follow the recommendations described in the body repair manual section "MAG welding specifications for high-strength steel parts 590 MPa and higher."

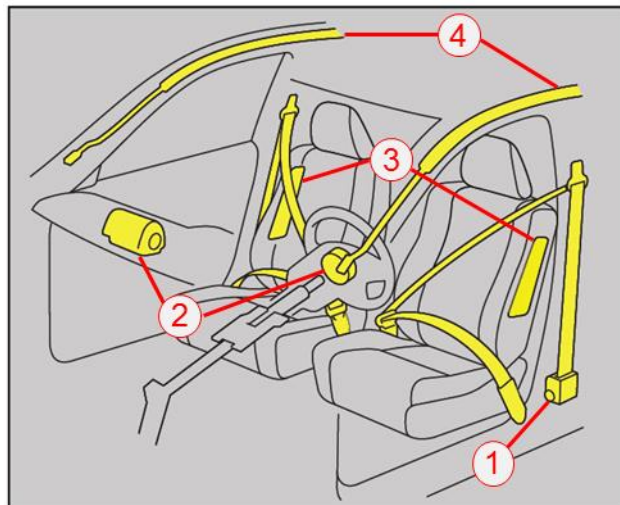
1. Driver and front passenger seat belt tensioners (may deploy independently from any airbags).
2. Driver and front passenger SRS airbags.
3. Side airbags mounted in the outer driver and front passenger seat-backs.
4. Left- and right-side curtain airbags mounted above the side windows under the headliner.

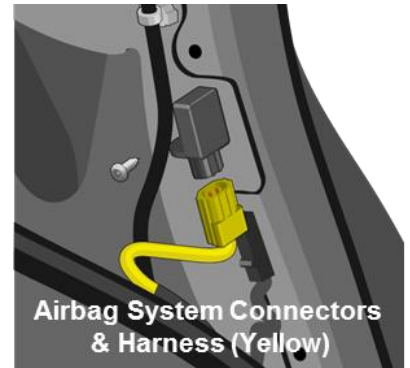
- For easier identification, electrical connectors that contain only airbag system wiring are yellow in color.
  - Many harnesses that contain primarily airbag wiring are also wrapped in yellow tape.
  - Airbag system wiring that runs in a common harness, such as a floor harness, is generally not marked.
  - NEVER attempt to modify, splice, or repair airbag system wiring.
- If airbag system wiring is damaged, replace the wiring harness(es).

Except when doing electrical inspections that require battery power, always turn the vehicle to the OFF (LOCK) mode, disconnect the negative battery cable, then wait at least 3 minutes before starting work.

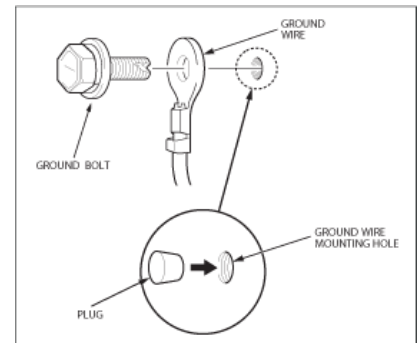
- Painting over electrical ground locations may cause electrical systems, such as Vehicle Stability Assist (VSA), to malfunction and set DTCs that may be difficult to diagnose.
- Protect the ground wire and the ground wire mounting hole threads with a bolt or plug when priming or painting.
