# **Body Repair News**

September 2021 Version 2

## 2022 Civic Model Series: New Body Repair Information

2022 Civic Model Series

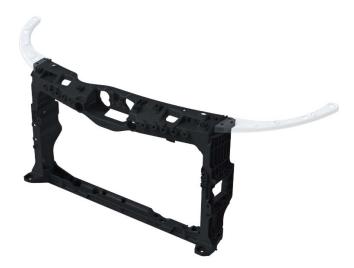
This vehicle has a front bulkhead assembly constructed of resin composite material.

- The bulkhead design improves engine compartment access during factory assembly and service.
- The cooling fans, radiator, A/C condenser, hood lock, outside air temperature sensor, and related piping/components are attached to the front bulkhead.
- A damaged bulkhead must be replaced.
- For more details, refer to front bulkhead replacement in the body repair manual.

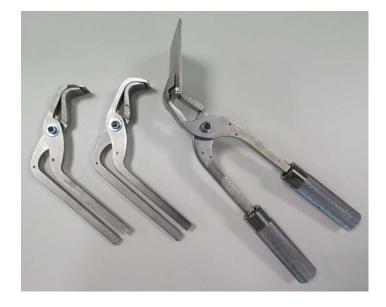
If needed, the Honda Special Service Tool set below is available for purchase from your local Honda dealer.

Tool Number	Description	Note
07AAC-TY2A100	PLIER SET, HEMMING	3-Piece set

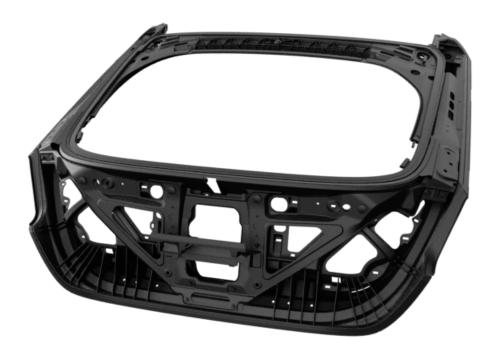
The 2022 Civic model series 5-door features a resin tailgate.

If using a replacement tailgate, paint it to match the body color of the vehicle before installation. The tailgate must be masked to ensure no paint is on areas that do not have base coat applied by supplier. The following areas will need to be masked.

- The rear window opening
- The tailgate frame
- The rear view camera
- The tailgate open switch and license light area
- The holes in rear lid light areas
- The license plate holes
- The holes in the high mount stop lamp area
