MODEL/YEAR MODÈLE /ANNÉE	DATE OF ISSUE DATE EN VIGUEUR	BULLETIN NUMBER NUMÉRO DU BULLETIN
2017 CR-V	DEC. 6, 2019	J-7-19

2017 CR-V Model Series: New Model Body Repair Information

APPLIES TO: 2017 CR-V model series

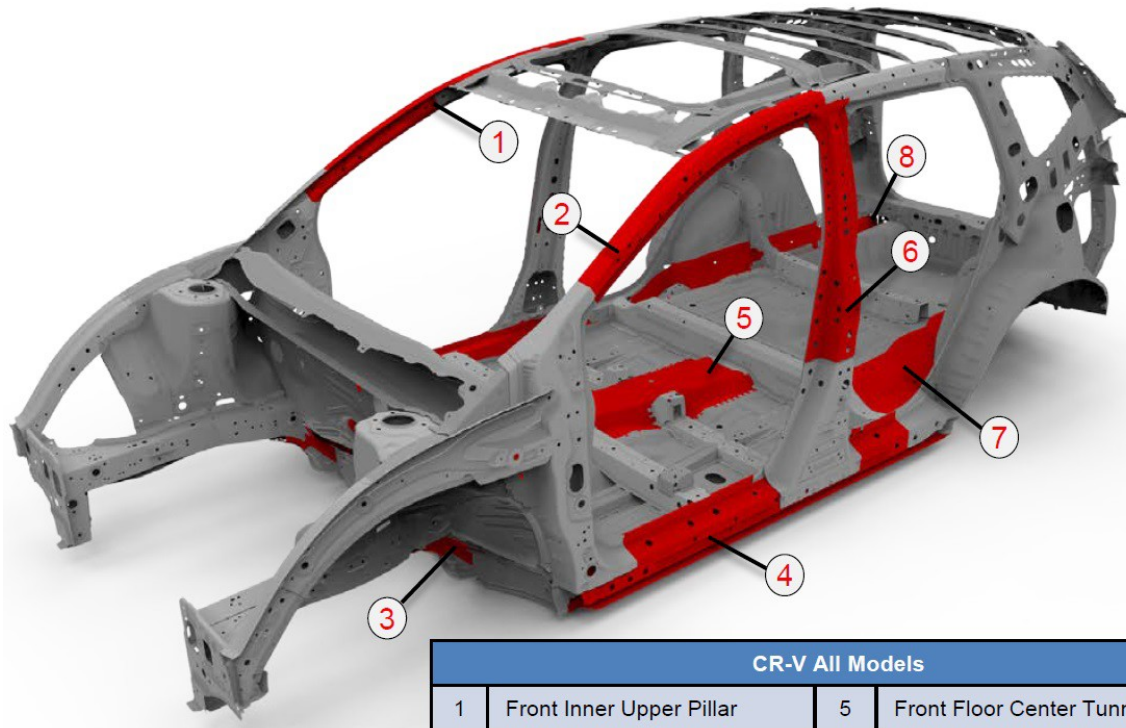
1,500 MPa (HOT STAMP) STEEL LOCATIONS

1,500 MPa steel is stronger than ordinary steel, so it can help protect vehicle occupants while reducing overall vehicle weight to improve fuel efficiency.

CR-V All Models			
1	Front Inner Upper Pillar	5	Front Floor Center Tunnel
2	Front Pillar Upper Stiffener	6	Center Pillar Upper Stiffener
3	Front Side Frame Extension	7	Rear Frame A
4	Side Sill Reinforcement	8	Rear Frame Upper Stiffener A&B

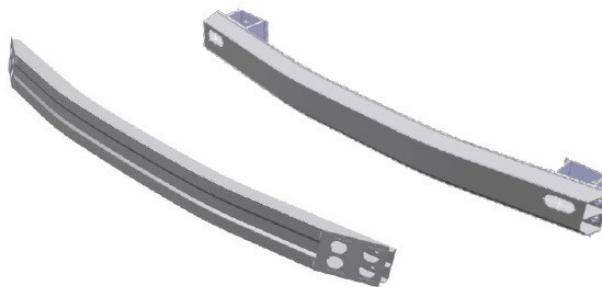
Front and Rear Bumper Beams

The front and rear bumper beams are constructed from aluminum alloy.

- Do not repair bumper beams if they are damaged.
- To prevent galvanic corrosion, some fasteners for aluminum parts are considered one-time use and must be replaced if removed.

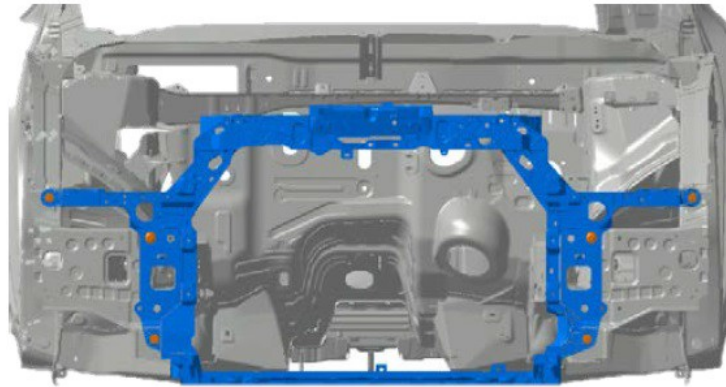
Resin Composite Front Bulkhead

This vehicle has a lower bulkhead assembly constructed of resin composite material.

- The bulkhead design improves engine compartment access during factory assembly and service.
- The front bulkhead is attached with multiple bolts and is sold and replaced only as a complete assembly.
- The cooling fans, radiator, A/C condenser, hood lock, outside air temperature sensor, and related piping/ components are attached to the front bulkhead using molded-in M6/M8 threaded inserts.
- Over-torqueing or using power tools may break these inserts loose, requiring front bulkhead replacement.
- A damaged bulkhead must be replaced, not repaired.
- For more information, refer to Exterior Parts Removal and Installation in the service information.

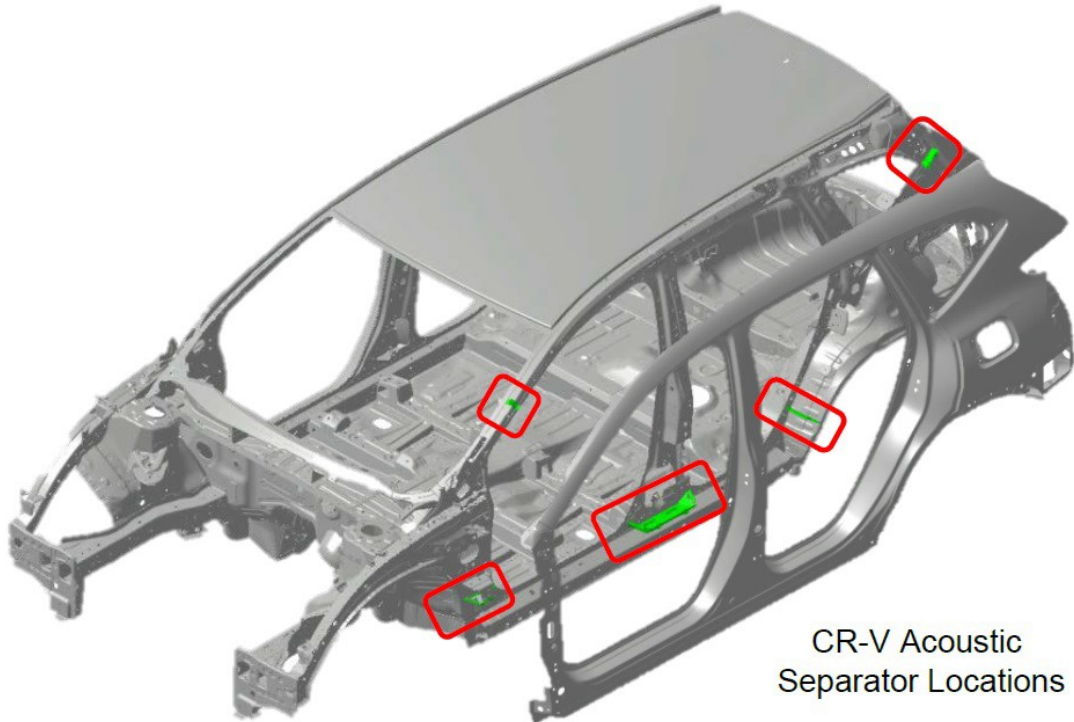
ACOUSTIC SEPARATOR LOCATIONS

A combination of molded, extruded, and tape acoustic separators are applied in various body locations.

- These are applied within the body pillars.
- Locations are shown in the diagram below.
- They are designed to block the noise paths into the cabin from hollow body cavities.
- Repairs are similar to previous models using commercially-available products.
- Refer to the Replacement section of the service information for specific procedures.

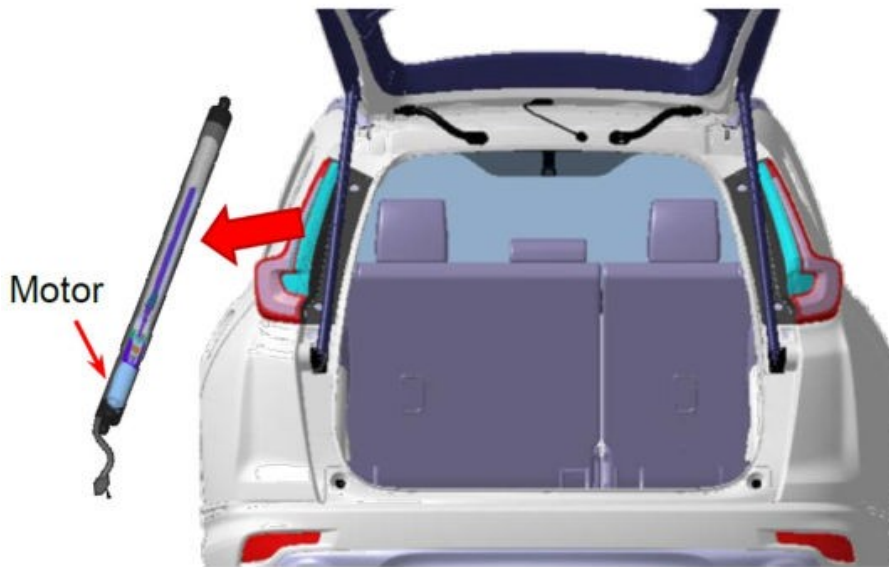
Spindle-Type Power Tailgate Actuator

- EX-L and Touring trim levels include a spindle-type power tailgate.
- The motor and actuator are integrated into the driver's side tailgate support strut for weight reduction.
- The Touring trim level also includes a hands-free feature that is activated using a kicking motion under the rear bumper.
- Until it is reset, the power tailgate will not open or close automatically under the following conditions:
 - The battery is disconnected, or the No. 18 BACKUP (10 A) fuse in the under-hood fuse/relay box is removed while the tailgate is operating.
 - Certain power tailgate components have been replaced.
- Refer to Resetting the Power Tailgate Control Unit in the service information.
